Sandstone Heritage in a Climate Change(d)
Future: Weathering of Torridonian and Devonian
building stone and its implications for
conservation

David Crawford McCaughie

Thesis submitted for the degree of Doctor of
Philosophy

Biological and Environmental Science
School of Natural Sciences
University of Stirling
Scotland

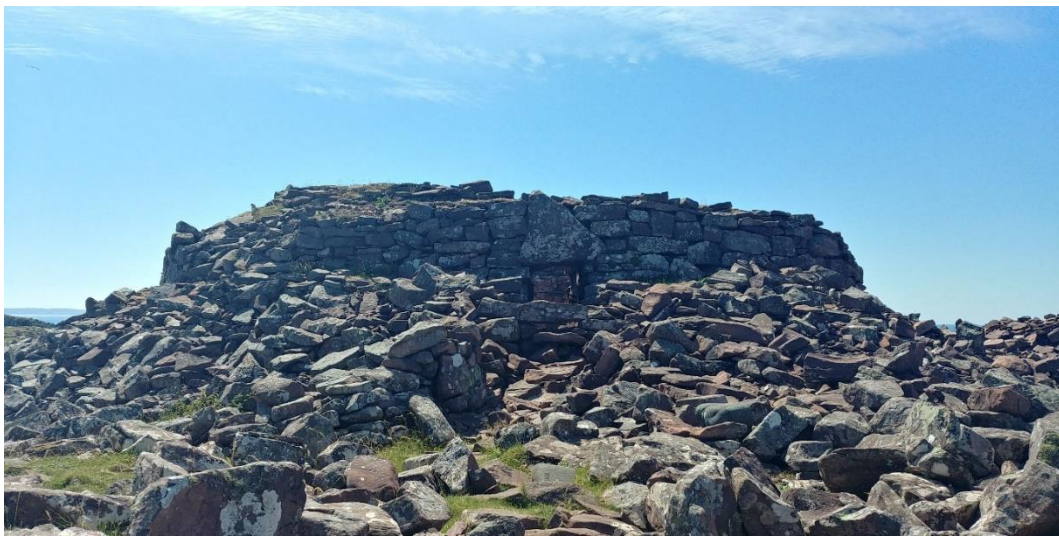
Figure 2.5 - Clachtoll Broch entrance and surrounding archaeological spoil

To arrest decomposition and record significant Iron Age deposits, AOC Archaeology undertook excavation work at Clachtoll Broch (Figure 2.5 and Figure 2.6), commencing in 2015 through to September 2017. Inspection of the site before excavation work noted that the broch was heavily damaged with loss of the south wall through coastal erosion and additional damage inflicted by visitors, largely through trampling.

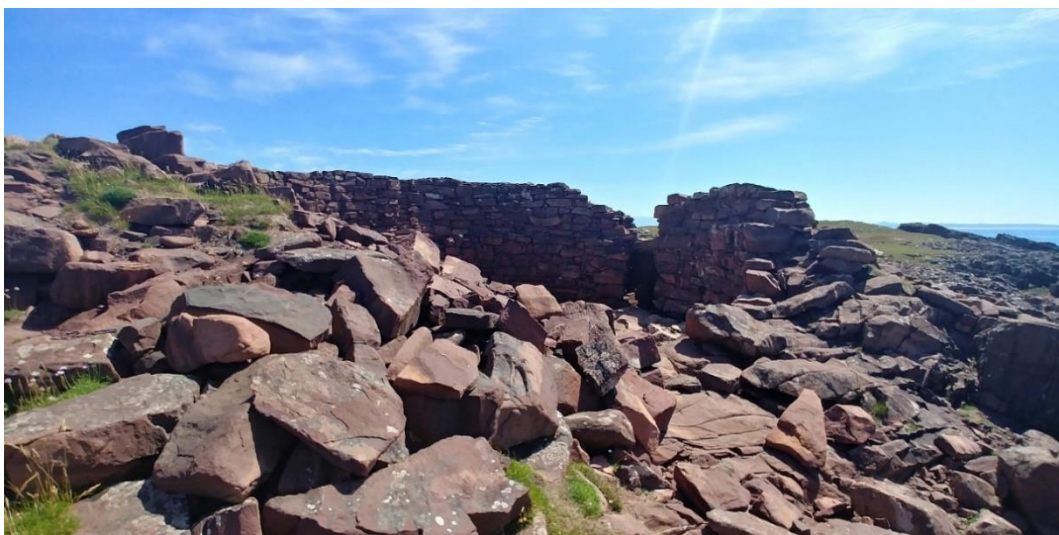
Figure 2.6 - Collapsed seaward facing wall of Clachtoll Broch

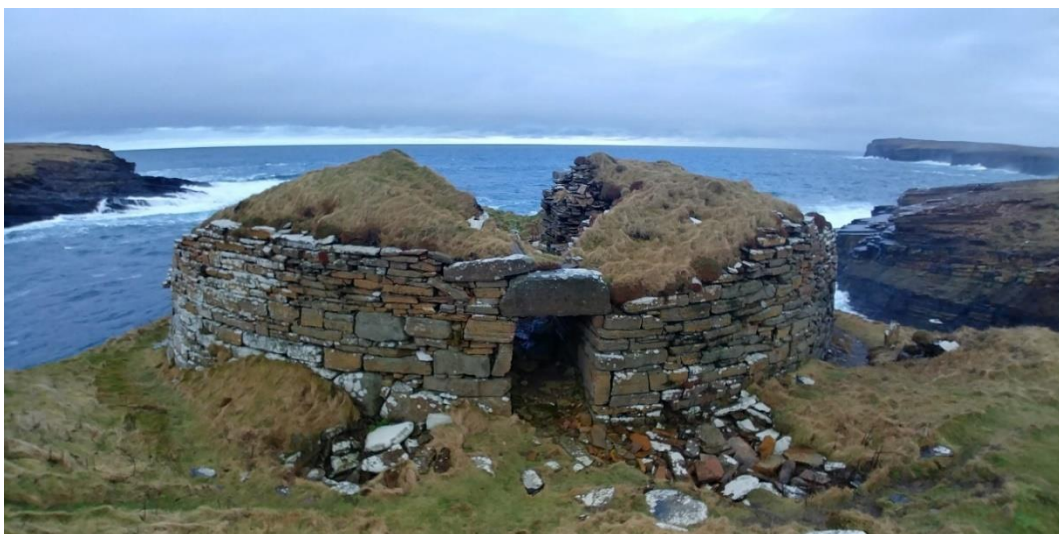
Figure 2.7 - Borwick Broch, located on a large promontory, Western Mainland, Orkney

Borwick Broch (Figure 2.7) was first described in the late nineteenth century by Watt, (1882), who detailed a broch situated on an 80-90ft promontory and that took the appearance of a grassy mound of around 20ft in height. The location of the structure at a cliff edge gave the site significant defensive qualities and an area for boats to dock. Furthermore, a freshwater burn nearby brought a source of clean water for the broch dwellers, while added protection was achieved by the inclusion of a wall on the landward side of the structure (Ritchie and Royal Commission on the Ancient and Historical Monuments of Scotland., 1996).

Watt noted that the broch was part of a larger network of outhouses located within around 60ft of the main tower. Similar to Clachtoll, the prevalence of marine erosion at Borwick and its impact on the site was noted; measurements taken in 1882 indicate that the broch stood at a height of between 11 and 16ft, subsequent measurements, such as in 1935, detailed the broch to be significantly smaller, around 8.5ft in height, highlighting the relatively rapid rate of degradation and material loss.

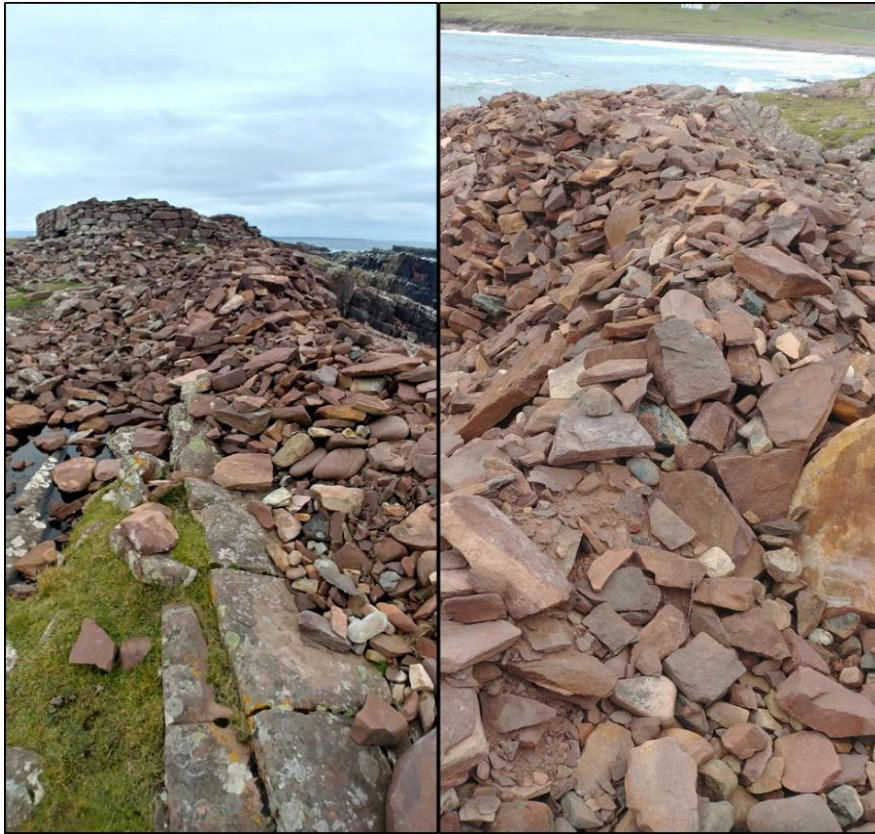
Figure 2.10 - Spoil heap (NC 03675 27858) at Clachtoll with Clachtoll Broch in the background (L), spoil heap (R) viewed from Clachtoll Broch

The spoil heap at Clachtoll is extensive and easily identifiable on the northern side of the structure (Figure 2.10), stretching around 10m in length and varying in height (NC 03675 27858). Given the instability of the spoil heap and its proximity to a rocky slope leading into the ocean, care was taken not to step on the heap, or to be too investigative of stone lying underneath the immediate heap surface. Through an examination of stones on the surface, care was taken to gather a sample range in keeping with the compositionally varying nature of the Torridonian Sandstone present in the broch.

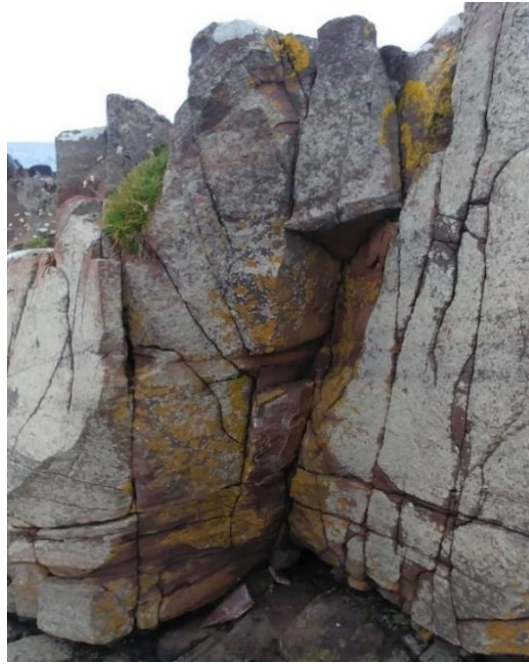
Figure 2.11 - Torridonian Sandstone outcrop in Clachtoll Bay, immediately south of the broch. Background geology samples were obtained here using a geology hammer at NC 03648 27836.

Background geology samples to accompany the broch material were collected at a Torridonian outcrop immediately south of the broch (NC 03648 27836). It can be seen from Figure 2.11 that the exposed rock face has been affected by biological colonisation, therefore, where possible, the non-exposed face of rock obtained is examined as it remains relatively pristine.

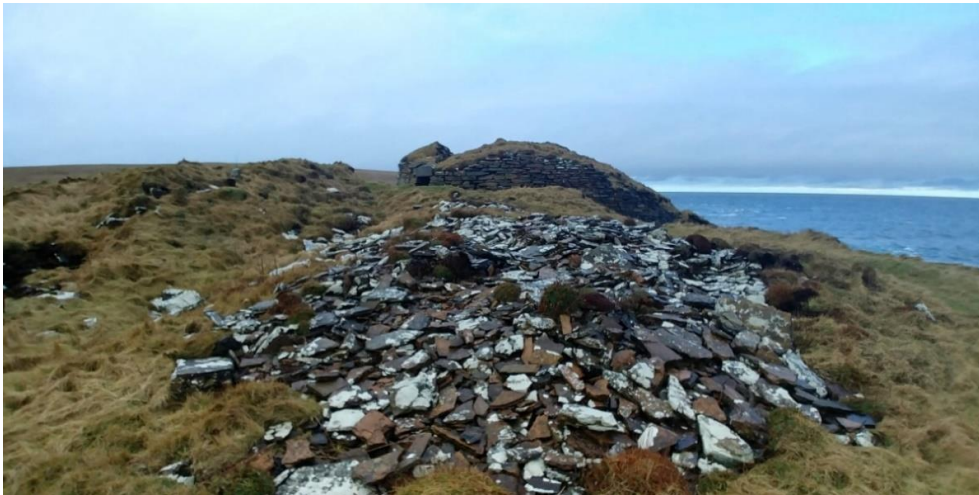
Figure 2.13 - Spoil heap at Borwick with Borwick Broch in the background on top of a promontory

The same procedure occurred at Borwick as at Clachtoll, with stone from the surface of the excavation spoil heap being removed (Figure 2.13). The constraints placed on the research through SMC meant only 3 pre-selected samples of sandstone (10cm x 10cm x 5cm) from rubble associated with the broch could be removed. Therefore, three compositionally varying samples, encompassing a range of stone found on the surface of the spoil heap and fitting the size restrictions were photographed and sent for approval to HES, which was accepted, allowing samples to be collected the following day.

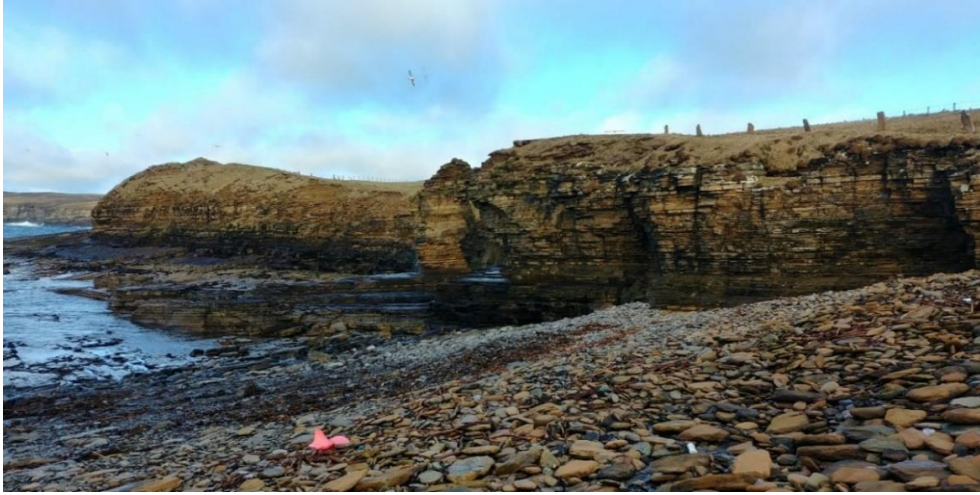
Figure 2.14 - Stromness Flagstone outcrop on the Western Mainland of Orkney, background geology samples obtained from here with a geology hammer (HY 22415 16625).

Borwick Broch is located at the top of the promontory pictured above (Figure 2.14), therefore control samples of relatively pristine Lower Stromness Flagstone were obtained with the use of a geology hammer on safely accessible areas of the outcrop which was accessed from the rocky beach on the southern side of the broch (HY 22415 16625).

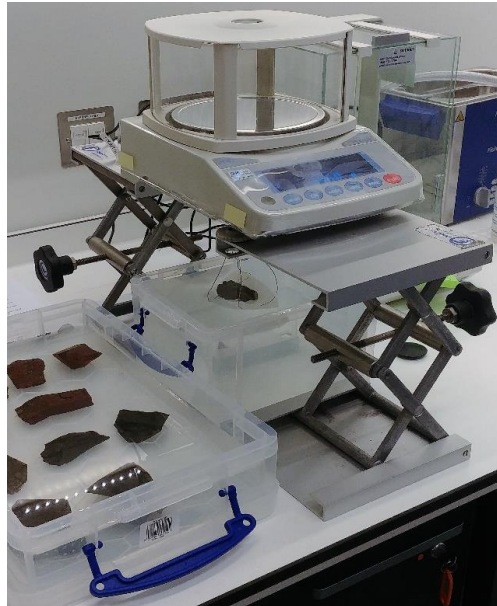
Figure 2.15 - Sample being weighed under water by hanging a cradle from the underside of the weighing scales and placing the specimen in the cradle submerged under water

Each sample was weighed (m_d) then placed in an evacuation vessel where the pressure was lowered to 2kPa which was maintained for 2hrs to remove the air contained in the sample's open pores. Over 15 minutes. Demineralised water was introduced into the vessel until the

samples were immersed, while a pressure of 2kPa was maintained. After immersion, the vessel was returned to atmospheric pressure and samples were left immersed for 24hrs. Each sample was then weighed under water (m_h), quickly wiped with a damp cloth to remove excess water and weighed while saturated with water (m_s) (British Standard Institution, 2006) (Figure 2.15).

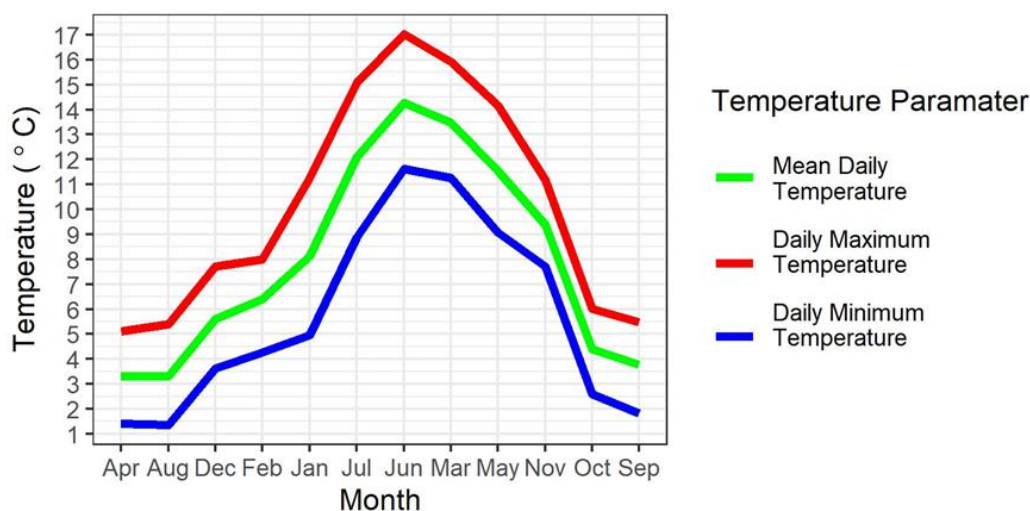
Figure 2.23 - Temperature at study sites in N. Scotland, 2018 (UKCP18)

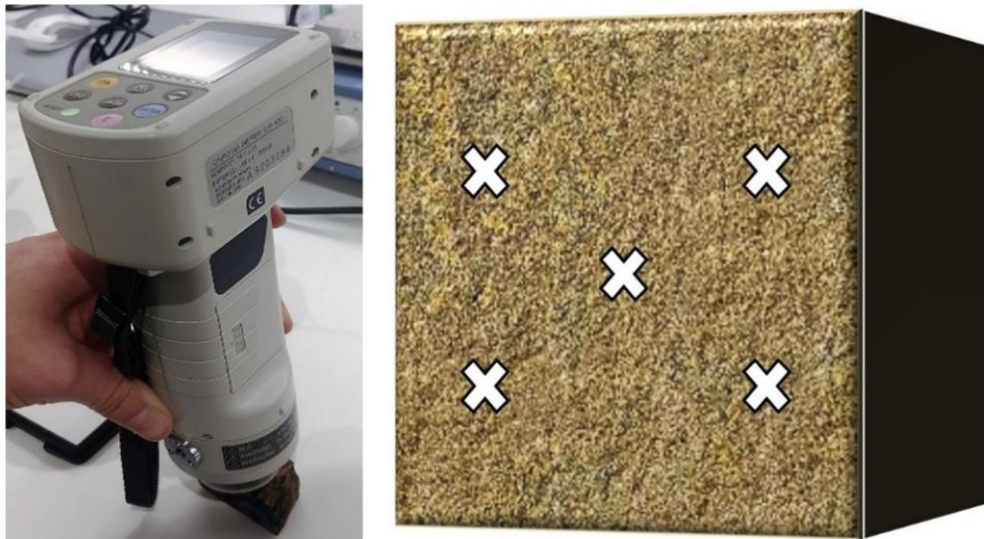
Figure 2.28 - Konica Minolta Chroma Meter CR-400 being used to determine sample surface colour. Sample locations marked on exemplar block

The instrument measures L^* - lightness value, a^* - red-green colour value, b^* - yellow-blue colour value, all of which can be visualised on a colour coordinate diagram (Figure 2.29). Five readings were taken at five different points on each stone surface, from which mean L^* , a^* and b^* values were obtained. These numerical colour codes were then converted into Munsell notation allowing them to be plotted on a colour wheel. Any change in colour after the experiment can be defined and related to the treatments that the samples have been exposed to.

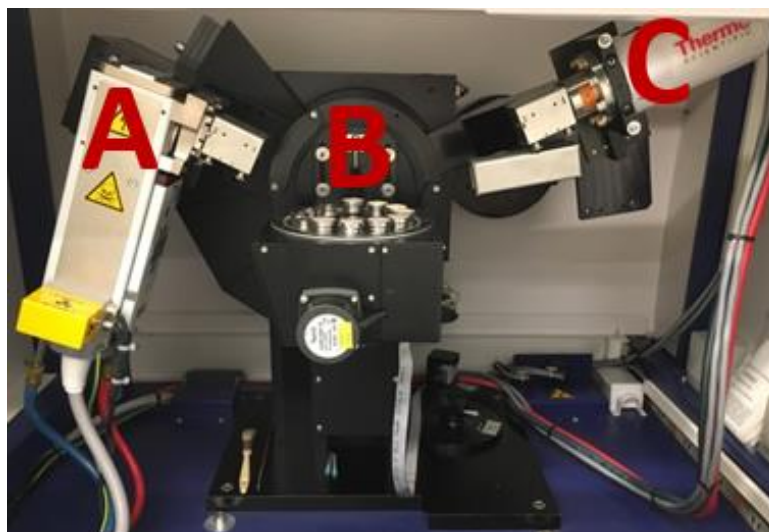
Figure 2.30 - X-ray diffractometer with X-ray tube (A), sample holder (B) and X-ray detector (C)

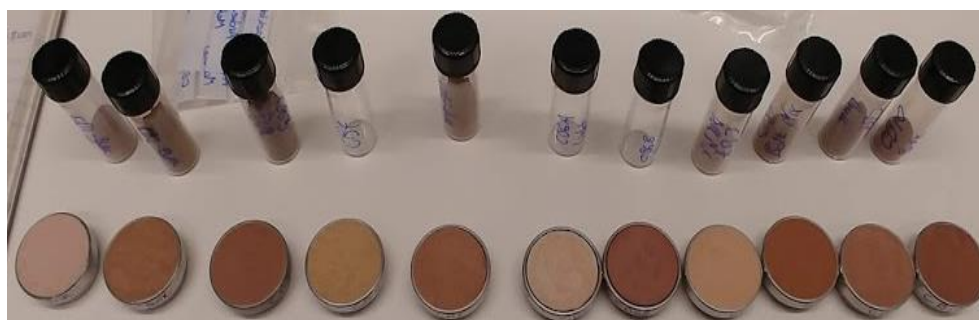
Figure 2.31 - Fine powder Torridonian Sandstone samples in their sample holders before XRD analysis

Sample preparation is key in the analysis, ensuring the correct particle size is vital in achieving a good signal-to-noise ratio. Fine particle size also maximises the amount of particle detection in the analysis process, therefore, sandstone samples from Clachtoll and Borwick were ground to a fine powder (typically below 63 μm) using a mortar and pestle. Ground sandstone was placed on a standard XRD sample holder, care was taken to ensure the holders were packed with a flat surface to maximise the analysis (Figure 2.31).

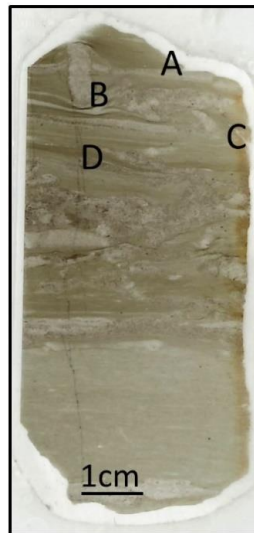
Figure 3.26 - Petrographic thin section scan of BCI, Borwick Control rock

Based on estimate percentage composition of Borwick samples, it falls into the Wacke category of sandstone based on Folk's classification, due to its high carbonate content and extremely fine-grained matrix (Folk, 1980). Distinct differences between Borwick control and broch material are visualised through petrographic thin section analysis. The control samples (Figure 3.26 - Figure 3.31) are characteristic of typical Devonian sediment deposition and subsequent lithification. Literature on the formation of the Stromness Flagstone has already been discussed; through petrographic thin section analysis, their formation in these samples is visualised clearly as a low to medium energy lacustrine deposit. There are distinct fluid beds of primarily fine quartz held in a dolomite cement, with grain size varying slightly between layers. Seen in BC1 and BC2 (Figure 3.26 & Figure 3.29), beyond these layers the sample becomes homogenous, similar in characteristics to the broch samples. Microcracks are visible along bedding planes in the control rock, indicating areas of

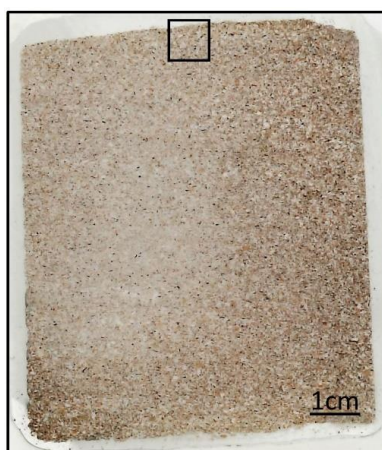
Figure 3.56 - Scan of CB3 with the mapped area highlighted

Similar to other broch samples, there are very few distinctive features. The upper surface of the stone appears slightly discoloured compared with the rest of the sample, therefore, mapping focused on this area. Maps and spectra are presented below.

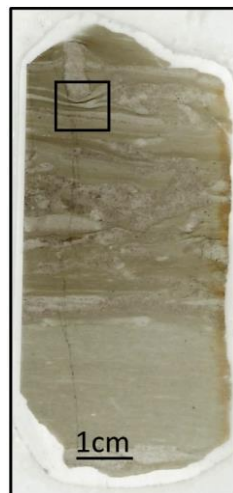
Figure 3.58 - Scan of BC1 with the mapped area highlighted

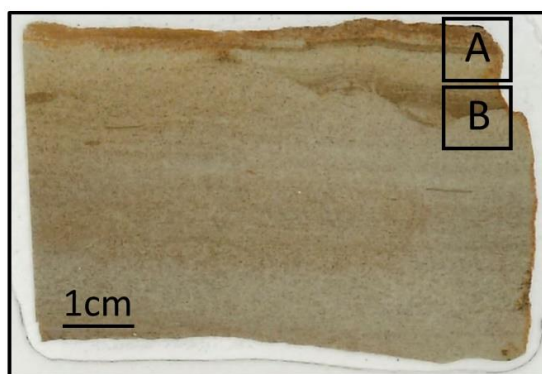
Figure 3.66 - Scan of BB3 with the mapped areas highlighted

The surface of BB3 appears complex, with two distinct dissolution fronts (A) and (B). To understand the progression between the weathered areas, two maps were generated side by side. From this, understanding is gained into how the elemental composition of the sample varies with depth and any differences in the weathered areas are identified. The maps are presented in Figure 3.67, maps from site A are on the left-hand side of the figure and maps from site B are on the right-hand side, forming a transect of the upper surface of the stone.

BB3 is mapped slightly differently from the other broch samples to detect two dissolution zones. A very slight dissolution area can be seen on the edge of the sample in the map, and this is reflected in ImageJ analysis (Figure 3.79 and Figure 3.81) where the grey value for magnesium and calcium is low at the immediate surface before quickly spiking with depth. A second dissolution area at a depth of 1.5mm is only detectable in the calcium grey value intensity. It is unusual to see a dolomite dissolution zone, albeit a small one, at such a depth within the stone, however, from the thin section scan of BB3 (Figure 3.66), it has likely developed along a distinct weakness plane or microcrack where water can penetrate the minor pore space and facilitate dolomite dissolution.

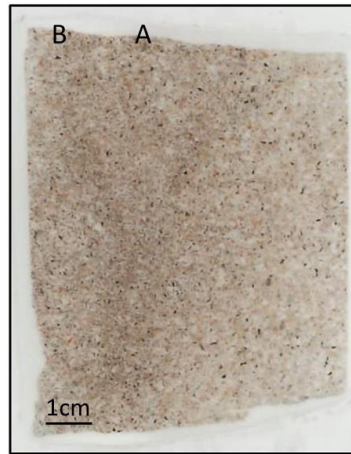
Figure 4.15 - Petrographic thin section scan of CC2 (5), with A and B focussing on two areas of the sample surface

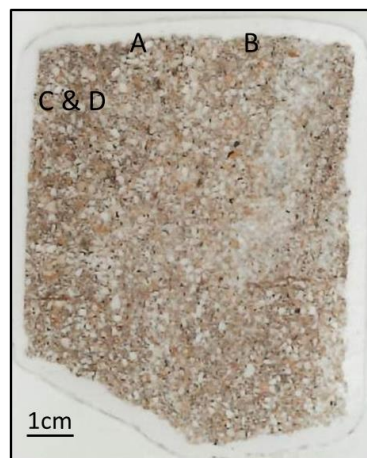
Figure 4.19 – Petrographic thin section scan of CB1 (1), with sites A and B focussing on fractured quartz grains while C and D focus on a lateral microcrack

Both CC1 (1) (Figure 4.13 Figure 4.14) and CB1 (1) (Figure 4.19 and Figure 4.20) exhibit microcracks, in the former, the microcrack penetrates through quartz grains, while in the latter the feature meanders around grain boundaries, likely following an inherent weakness within the cementing of the stone. This indicates that the microcrack in CC1 (1) has exerted greater force on the rock fabric, generating enough energy to fracture and split quartz grains. It would be unrealistic to assume that these microcracks are a direct consequence of experimental work; similar features were observed in untreated samples in Chapter 3. Regardless of the origin of the microcracks, it is clear that in both instances, the samples remain intact with no sign of surface failure or authigenic clay formation within the microcracks. The Torridonian Sandstone is a robust building stone, nevertheless, microcracks do occur and can be considered areas of weakness, however, experimental work in this instance has not shown these weaknesses to undermine the overall strength of the sandstone after a year of climate change exposure. It stands to reason, nonetheless, that if microcracks are a ubiquitous feature in the sandstone type, as demonstrated, then with accelerating climate change and compounded exposure, they will likely become more prevalent and carry with them a greater chance of triggering partial or complete sample failure.

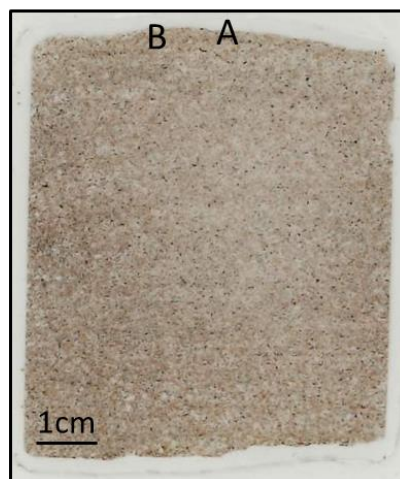
Figure 4.23 - Petrographic thin section scan of CB3 (9), with A and B focussing on two areas of the sample surface

A further characteristic of interest is visible in CB3 (9) (Figure 4.23 and Figure 4.24), one of the samples which exhibited granular loss; highlighted and discussed in section 4.2 Visible Alterations. In this instance, however, the occurrence of an opaque layer at the surface of the stone which separates the fine-grained immediate surface of the stone, and the course-grained remainder of the stone can be seen. This feature has, thus far, been observed exclusively in untreated control samples, making CB3 (9) unique. As discussed throughout Chapter 3, these distinct opaque, likely clay-rich bands, are a potential weakness that could lead to a surface loss. As is the case with the aforementioned microcracks in CC1 (1) and CB1 (1), this apparent weakness layer in CB3 (9) has not failed or been altered microscopically as a result of experimental work undertaken. It is important, however, to reaffirm the point that the weathering simulation undertaken is equivalent to a single year of exposure to climate change. It is anticipated that with increased and compounded exposure, these clay layers could indeed be significant weak points and when they reach a tipping point, could prove to exacerbate the degradation of an important building stone in Northern Scotland.

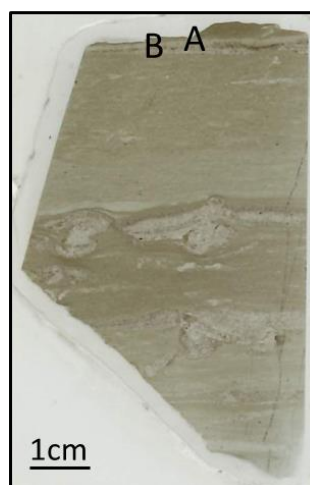
Figure 4.38 - Petrographic thin section scan of BCI (1), with A and B focussing on two areas of the sample surface

As highlighted throughout this thesis, Stromness Flagstones are characterised by an abundance of microcracks scattered throughout samples taken. Although obvious weak points within the material, the numerous microcracks within control samples (Figure 4.38 - Figure 4.43), have remained intact throughout experimental work. Interestingly, the same cannot be said for broch samples. As highlighted in section 4.2 Visible Alterations, BB1 (1) (Figure 4.44 and Figure 4.45) and BB3 (8) (Figure 4.48 and Figure 4.49) failed at distinct weak points during the CEF experiment. The thin section photomicrograph (Figure 4.45 and Figure 4.49) clearly show the failing microcracks, which in both instances appear to be surrounded by limited dolomite dissolution, this is seen most clearly in BB1 (1) where it appears that a dark material, likely iron, has precipitated around the microcrack. This contrast between microcracks present in both control and broch samples exposed to the same treatment provides a clear example of the vulnerabilities within pre-weathered samples compared with relatively pristine samples of the same lithology type. This carries important implications for

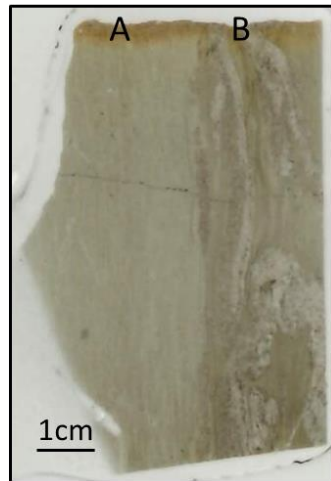
Figure 4.42 - Petrographic thin section scan of BC3 (8), with A and B focussing on two areas of the sample surface where dolomite dissolution appears prevalent

BC3 (8) (Figure 4.42 and Figure 4.43) provides the first example in this research of minor secondary porosity formation, triggered by dolomite dissolution. However, secondary porosity is seen most extensively in BB2 (5) (Figure 4.46 and Figure 4.47). Importantly, this has formed around a particularly large sulphide nodule, indicating just how severely the weathering of these features can exacerbate stone material loss through sulphuric acid formation intensifying dolomite dissolution. Interestingly, secondary porosity of this extent has not been observed in untreated samples in Chapter 3, indicating that exposure to climate change conditions has, at least in part, contributed to this phenomenon.

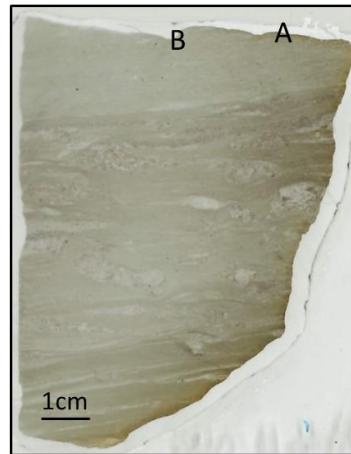
Figure 4.74 - Petrographic thin section scan of BCl (4), with A and B focussing on two areas of the sample surface

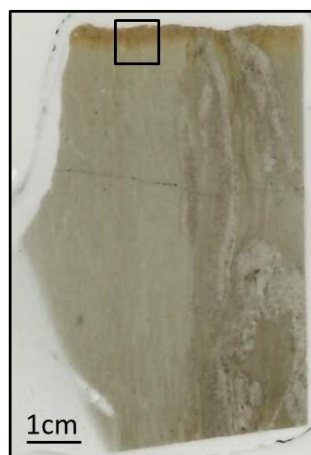
Figure 4.89 - Scan of BC3 (8) showing the location of SEM-EDX mapping, focussing on the surface exposed in the CEF

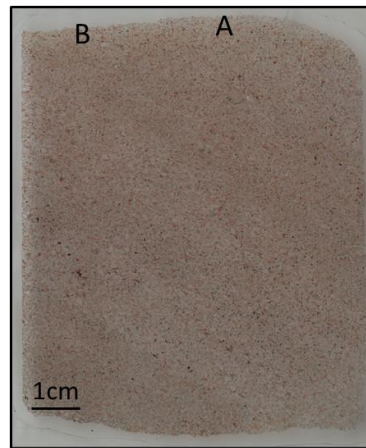
Figure 5.14 - Petrographic thin section scan of CB2 (7), with A and B focussing on two areas of the sample surface

Both CB2 (7) (Figure 5.14 and Figure 5.15) and CB3 (11) (Figure 5.16 and Figure 5.17) appear to display indications of increased granular loss compared with baseline samples analysed in Chapter 3. Loose grain fragments are noted at the sample surfaces and areas are indicated on relevant figures where sections of the surface have been lost. The occurrence of granular loss has been pinpointed as one of the few weaknesses within Clachtoll samples, evidenced through comparison images and mass loss analysis. It can be seen clearly in these samples that at the surface, grains have become detached through a weakening of the grain supported fabric of the stone, causing secondary porosity formation and the loss of some small surface sections. This is seen particularly in CB3 (11) which was investigated further through SEM-EDX analysis to determine the depth of granular loss (Section 5.6 SEM-EDX Analysis).

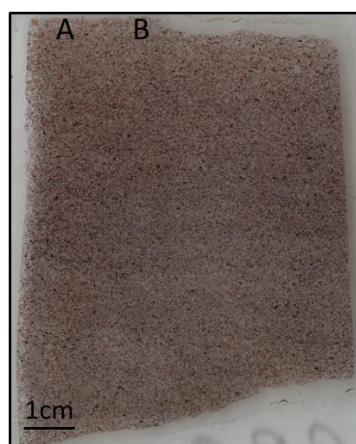
Figure 5.16 - Petrographic thin section scan of CB3 (11), with A and B focussing on two areas of the sample surface

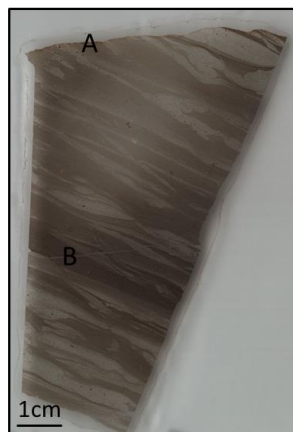
Figure 5.30 - Petrographic thin section scan of BC3 (11), with A focussing on the sample surface and B focussing on a vertical microcrack at depth

Comparisons can be made between climate sensitised samples and those exposed to repeated cycling of 2018 conditions. In BC3 (11) (Figure 5.30 and Figure 5.31), no surface dissolution is evident, however, it will take focused SEM-EDX analysis to quantify this at the micro-scale. Microcracks present within the sample (Figure 5.31 B) run parallel to bedding and are characteristic of Borwick control microcracks seen throughout analysis undertaken in this research. They contrast starkly to microcrack features highlighted in climate sensitised control samples, which are wider and run perpendicular to sample bedding.

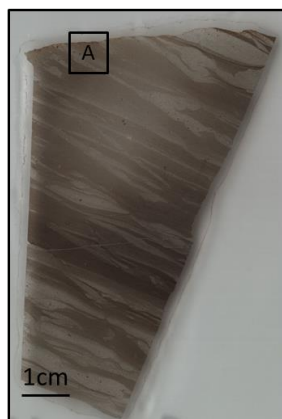
Figure 5.55 - Scan of BC3 (11) showing the locations of SEM-EDX mapping, focussing a potential dissolution area at the surface

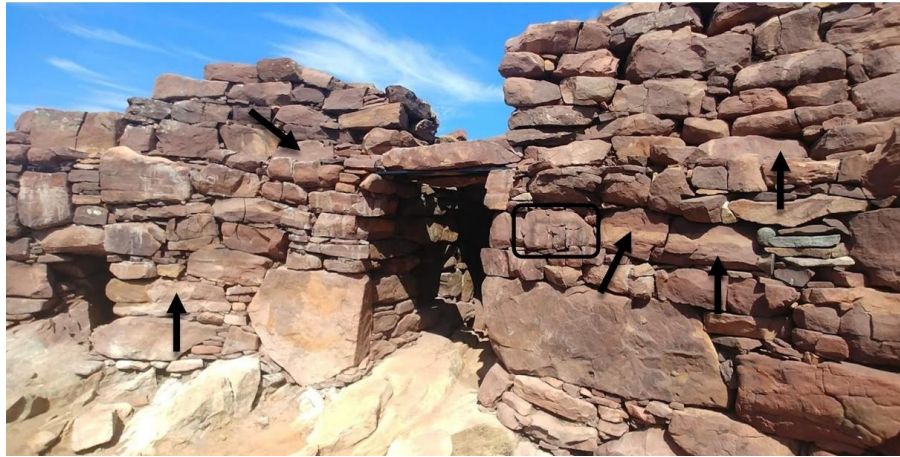
Figure 6.2 - Clachtoll Broch wall face, packing stone sits proud of larger face bedded blocks, some examples of which are highlighted. The block shown in Figure 6.3 is circled

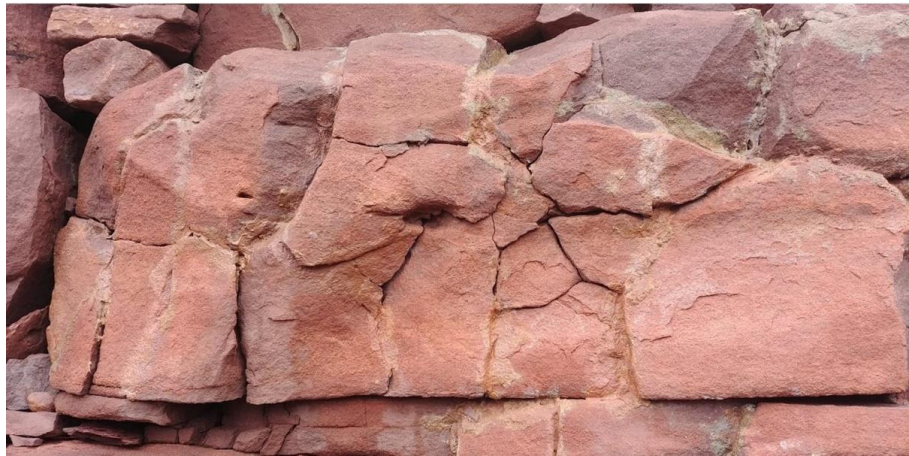
Figure 6.3 - Face bedded block within Clachtoll Broch, showing signs of extensive surface cracking and flaking

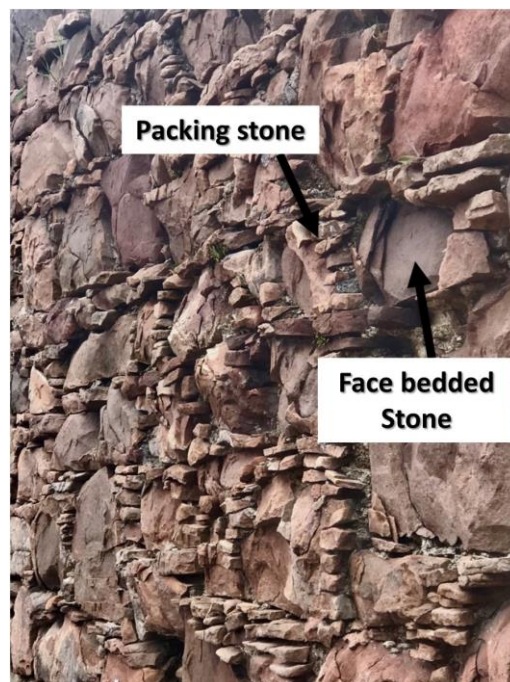
Figure 6.4 - Face bedded Torridonian Sandstone at Tanera Mòr Herring Station. Packing stones sit proud of the larger face bedded block. Image courtesy of Timothy Meek

This example from Tanera Mòr highlights once more that face bedded Torridonian Sandstone manifested within a built structure suffers from surface losses, causing the packing stones to sit proud of the larger face bedded blocks. It must be noted, therefore, that although Torridonian Sandstone from Clachtoll Broch remained intact and appeared robust during CEF experiments, when exposed in the real environment, decay may occur at an accelerated rate, especially in a climate changed future.

abandoned in the mid-20th Century. Although a far more contemporary structure when compared with Clachtoll Broch, the same face bedded stone regress is seen (Figure 6.4).

Comparisons made between Figure 6.6 and Figure 6.4 showcase the protective qualities of surface finish. In Figure 6.4, as highlighted, face bedded stone has suffered from surface loss leading to stone regress. Conversely, as demonstrated in Figure 6.6, areas of stone protected by surface finish remain intact and do not suffer from surface regress. Applying a surface finish could be an important factor in ensuring the longevity of structures composed of Torridonian Sandstone. However, in the case of Clachtoll Broch, a historically bare stone building, applying surface finish would lack authenticity. In the wider environment, buildings such as the Herring Station at Tanera Mòr which can be seen to have been covered by a surface finish in the past, a feasible conservation strategy would be to reapply such a finish and protect the face bedded stone from further regress and decay.

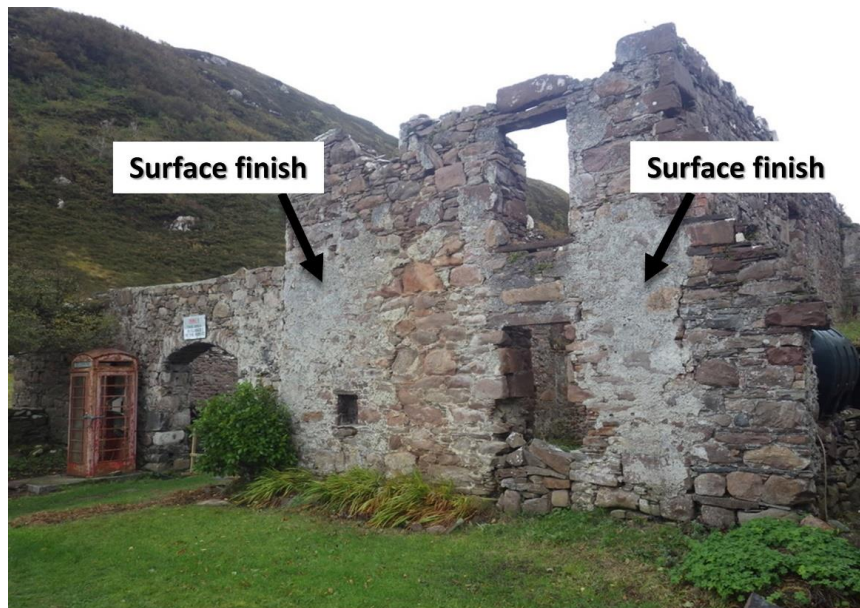
Figure 6.6 - Tanera Mòr Herring Station building, comparative lack of Torridonian Sandstone weathering seen on areas of the building that have a surface finish. Image courtesy of Timothy Meek
