Comparative imaging of European eels (*Anguilla anguilla*) for the evaluation of swimbladder nematode (*Anguillicoloides crassus*) infestation

This study compares diagnostic imaging tools in detecting the parasitic swimbladder nematode *Anguillicoloides crassus* in *Anguilla anguilla* (L.) and focuses on ultrasound in an attempt to develop a non-destructive, field diagnostic test. Ultrasound use could allow the parasite to be diagnosed without decreasing the number of critically endangered European eels through post-mortem. In the preliminary study, eels were examined with computed radiography, computed tomography, magnetic resonance imaging, 14 MHz high-end ultrasound and 5 MHz low-end portable ultrasound, and the results were compared with post-mortem findings. This ultrasound scanning technique did not produce any promising results. A second batch of eels was examined using the same high-end and low-end ultrasounds, but employing a different scanning technique and comparing the results with post-mortem. This second study, scanning along the midline from below, allowed for the detection of anomalies associated with moderately infected animals. None of the eels used in this study

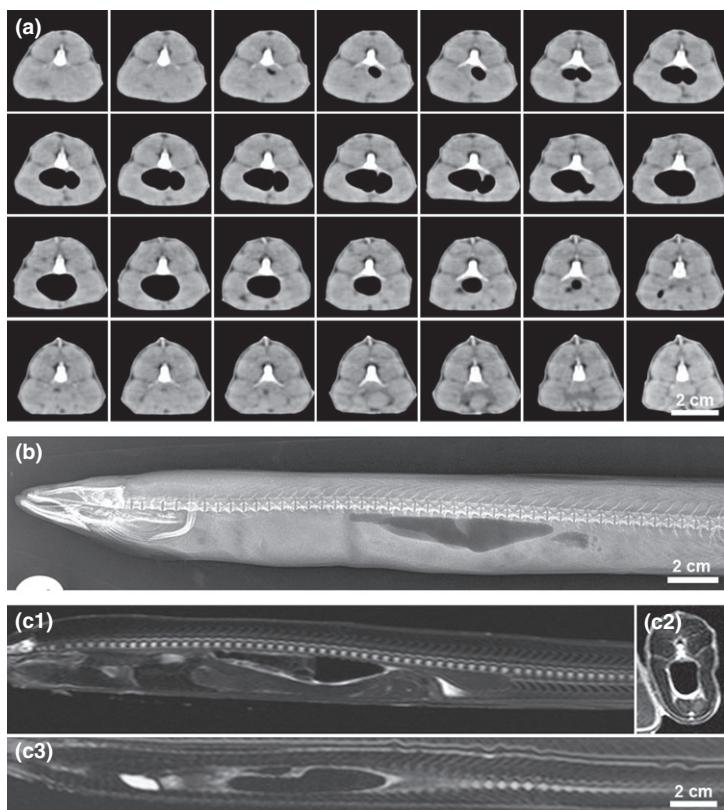
Figure 1 *Anguilla anguilla*, no. 5. (a) Computed tomography showing a clearly discernible parasite-free swimbladder. (b) Lateral radiograph of the cranial half of the same eel with a distinct radiographic shadow of the swimbladder and no visible worms. (c1) Lateral, (c2) transverse and (c3) dorsal T2 MRI images of the same eel showing a clearly visible parasite-free swimbladder in all three views.

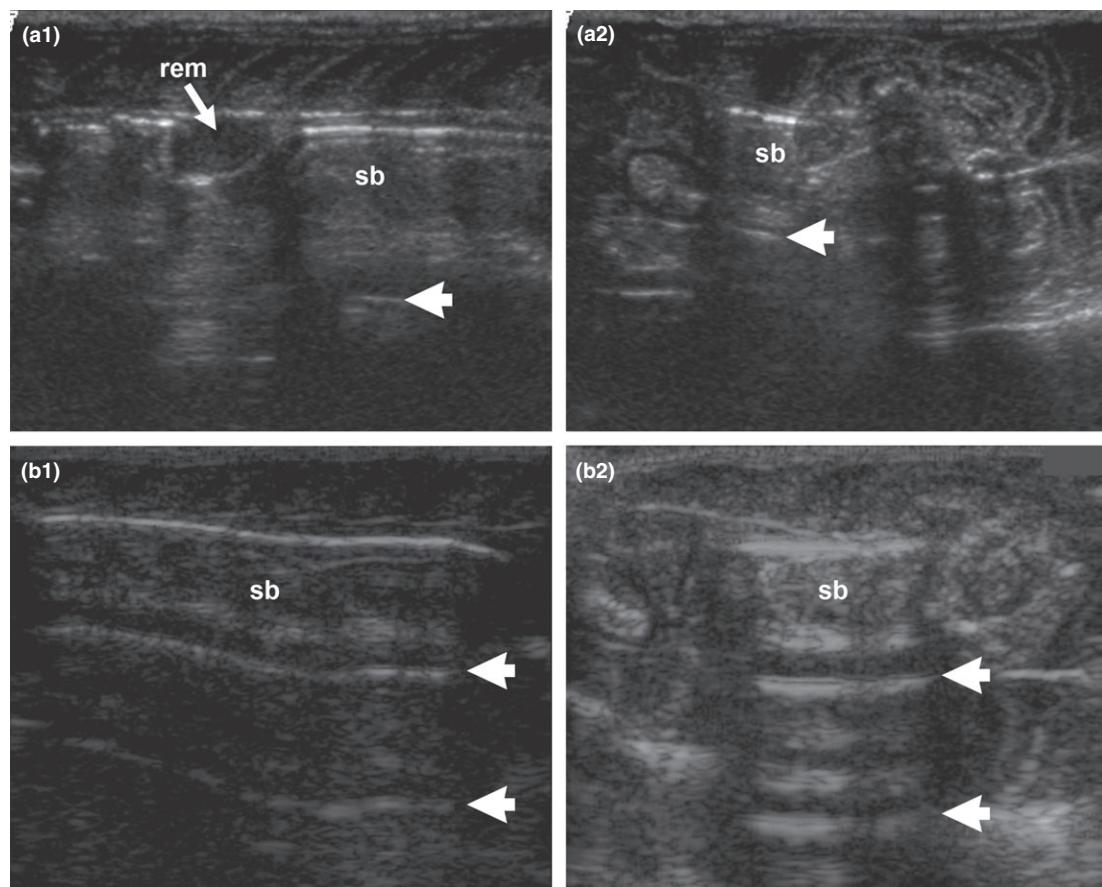
Figure 2 *Anguilla anguilla*, no. 5. (a1) Longitudinal and (a2) transverse high-end ultrasonic images halfway through the swimbladder from eel in Fig. 1 taken with a 14 MHz linear transducer, showing the swimbladder (sb) and the rete mirabile (rem) with reverberation artefacts (short arrows). (b1) Longitudinal and (b2) transverse low-end ultrasonic images of the same swimbladder taken with a 5 MHz linear transducer, showing the swimbladder (sb) with reverberation artefacts (arrow heads).

section and atrophied at the caudal end. It was also partially opaque and had a small amount of pigmentation throughout. There were large worms and exudate within the lumen (Fig. 6). The other eel with a moderately infected swimbladder (fish no. 2) showed some irregularities on the surface of the swimbladder on the longitudinal view, which could also be seen on the low-end ultrasonic examination. The transverse views did not show these irregularities, but the organ surface in these images was hyper-reflective when compared with the uninfected swimbladder (Fig. 2).

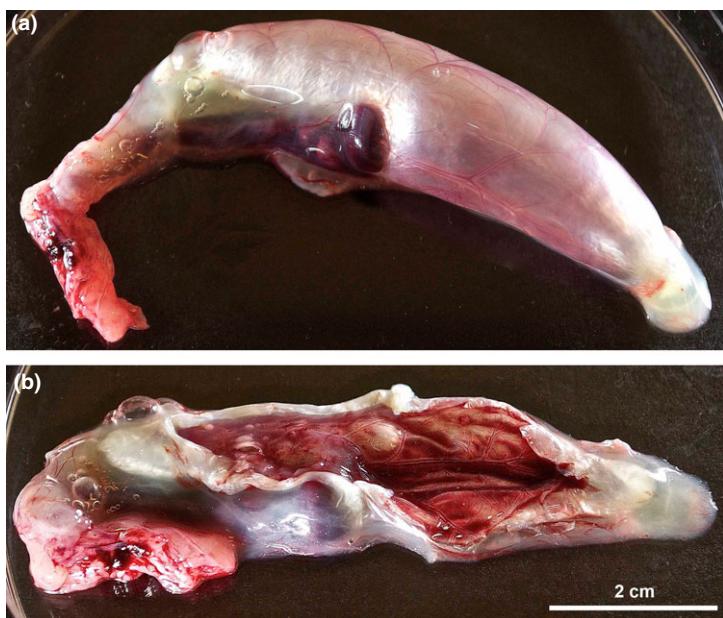
Figure 3 *Anguilla anguilla*, no. 5. (a) Unopened and (b) opened swimbladders dissected from eel in Fig. 1. Wall is transparent and thin walled, and lumen is worm free.

was transparent and thin walled (wall thickness < 1 mm) (Fig. 3).

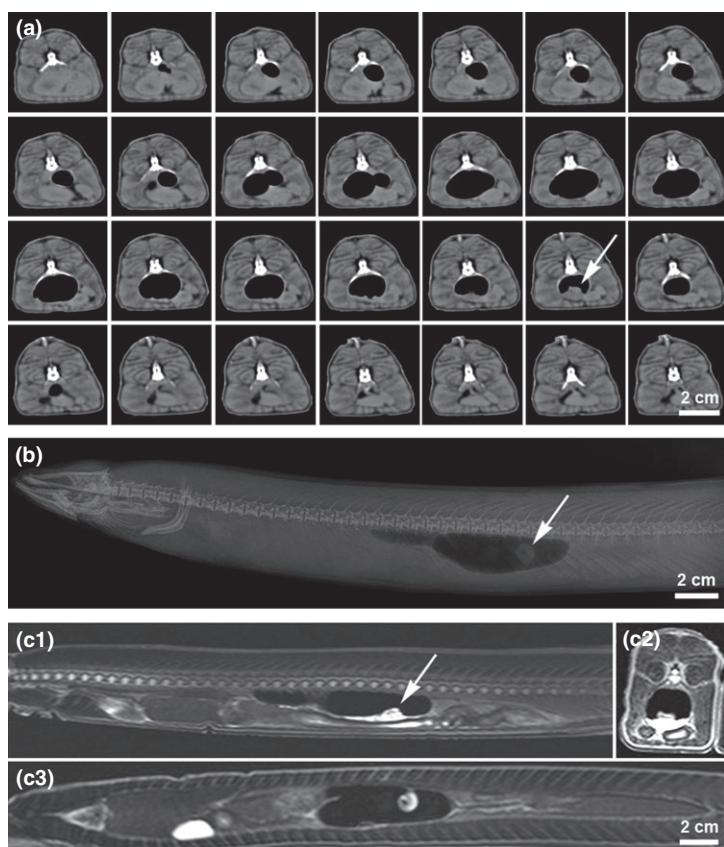
Figure 4 *Anguilla anguilla*, no. 1. (a) Computed tomography showing a clearly discernible swimbladder of a moderately infected eel; segment 20 contains a distinctly visible specimen of *Anguillicoloides crassus* (arrow). (b) Lateral radiograph of the cranial half of the same eel with a distinct radiographic shadow of a coiled worm (arrow). (c1) Lateral, (c2) transverse and (c3) dorsal T2 MRI of the same eel showing a clearly discernible swimbladder containing at least one adult worm in all three views (arrow) and fluid in the lumen.

One of the moderately infected eels (fish no. 1) had a swimbladder that showed contours of worms, a thickened wall and rounded shape of the whole organ on CT (Fig. 4a) and radiographic (Fig. 4b) examination. The MRI images had the

same findings, but also showed fluid in the lumen and the caudal end of the swimbladder to be collapsed and fibrotic (Fig. 4c). The high-end and low-end ultrasound examinations showed no observable anomalies (Fig. 5). On post-mortem examination, the swimbladder wall was slightly thickened (1 mm thickness) in the gas-filled

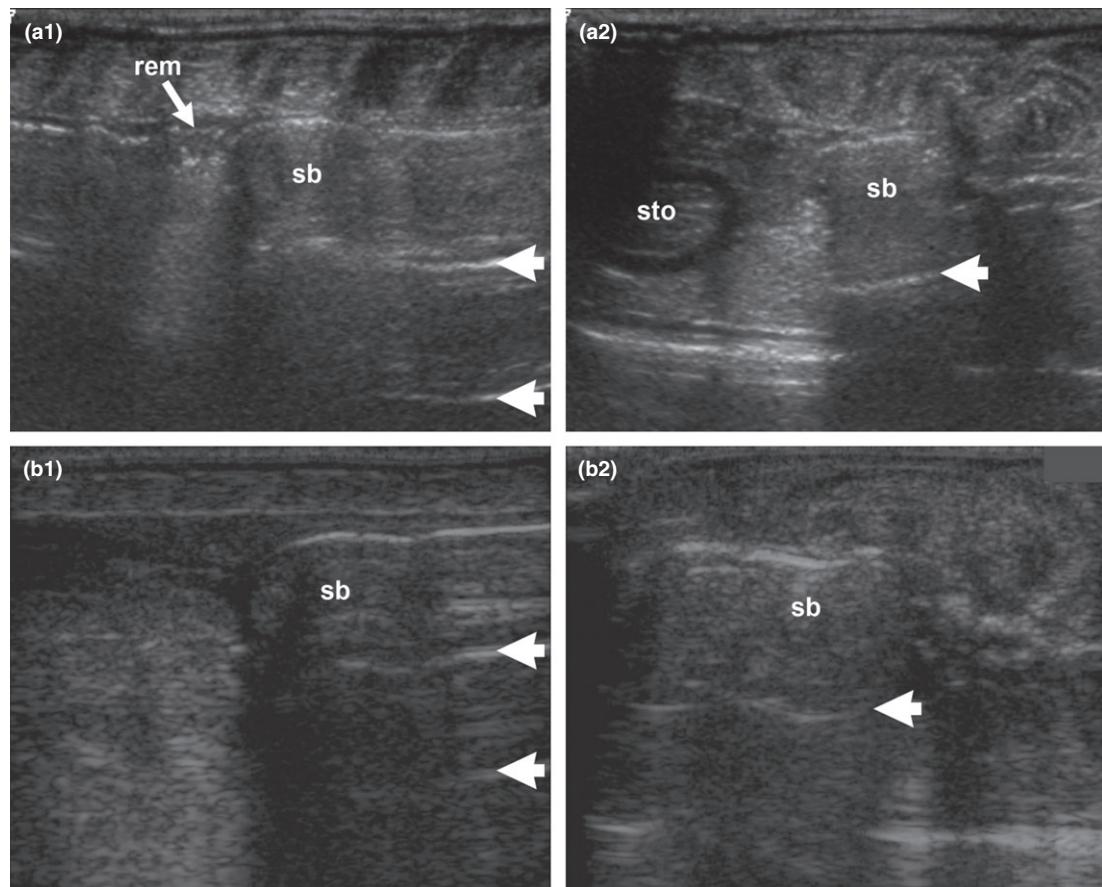
Figure 5 *Anguilla anguilla*, no. 1. (a1) Longitudinal and (a2) transverse high-end ultrasonic images of halfway through the swimbladder in Fig. 4 taken with a 14 MHz linear transducer, showing the swimbladder (sb) and stomach (sto) with reverberation artefacts (short arrows). (b1) Longitudinal and (b2) transverse low-end ultrasonic images of the same swimbladder taken with a 5 MHz linear transducer showing the swimbladder (sb) with reverberation artefacts (arrow heads).

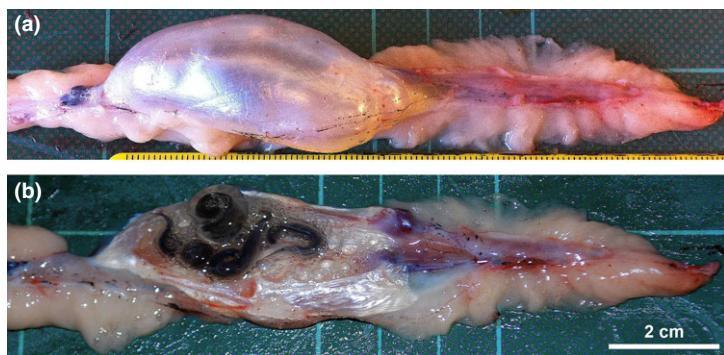
Figure 6 *Anguilla anguilla*, no. 1. (a) Unopened and (b) opened swimbladders dissected from eel in Fig. 4. Wall is opaque and thickened, the caudal end is atrophied (right image side), and the lumen is filled with worms (arrow) and some exudate.
