34th International Conference on Ground Control in Mining

The Effect of Discontinuities Characteristics on Coal Mine Stability and Sustainability: A Rock Fall Prediction Approach

Case study: Roof fall accident in Eshkeli coal mine

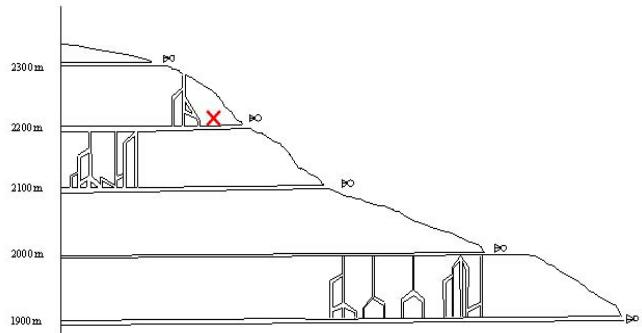
Eshkeli coal mine is located in Iran (Figure 1). The geological formation of the mine belongs to the middle Jurassic period. The lithology of the formation includes sandstone, siltstone, mudstone, and coal. The proven reserve has been estimated at 3 million tons of coal. The mine's region has been tectonized by tectonic processes and 11 main faults have been identified, and the average thickness and dip of the coal bed are 3 m and 35° respectively in the mine. The mine has 4 levels from 2,300 m to 1,900 m.

Figure 1. Sketch of Eshkeli coal mine (X: accident place).

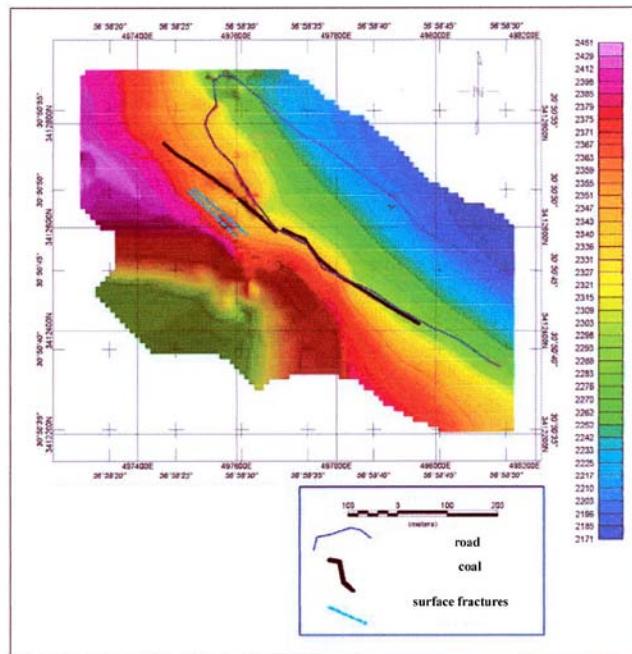
Figure 2. Topography map of the mine region.

The region's topography is rough and many hills and valleys are in the region, as shown in Figure 2.

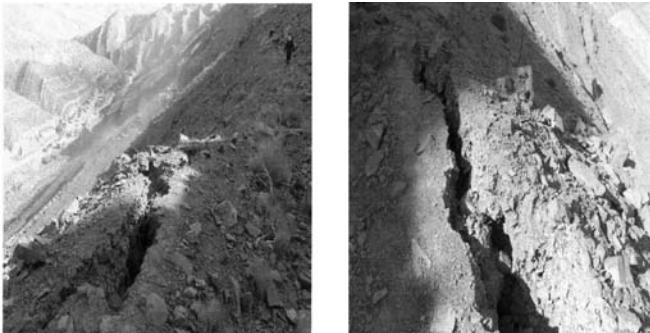
were retrieved four months later after drilling a rescue tunnel. The failure was so severe that it caused some cracks on the earth (Figure 3). A sketch of the collapsed stope (stope 103) (level 1 of the mine) is shown in Figure 4.

Figure 3. The cracks that were displayed on surface of failure zone.

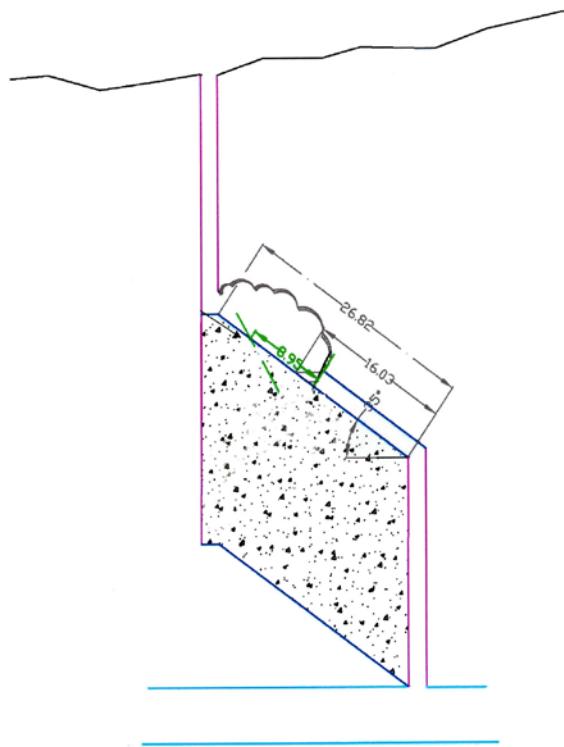
Figure 4. The collapsed stope (stope 103).

The green lines show the collapsed part of the stope, and 8.95 m of stope length (26.82 m) was covered by the debris of the failure. The yielding steel sets that supported the haulage tunnel that was on level 2200 m (see Figure 1) were affected by the failure and they were compacted as much as 30 cm, and the struts were also deformed relatively (Figure 5).

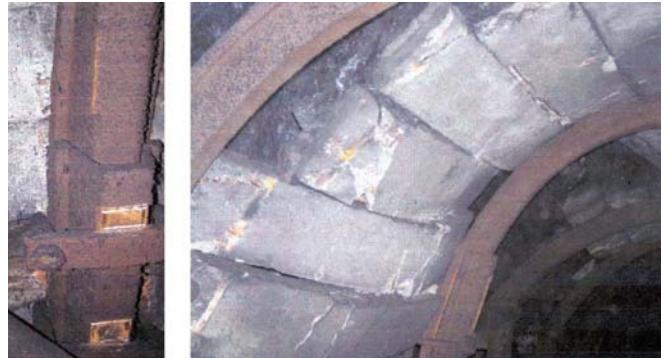
Figure 5. The displacement in the yielding steel sets and deformation in struts on the beneath level of the fractural zone (level 2200 m).

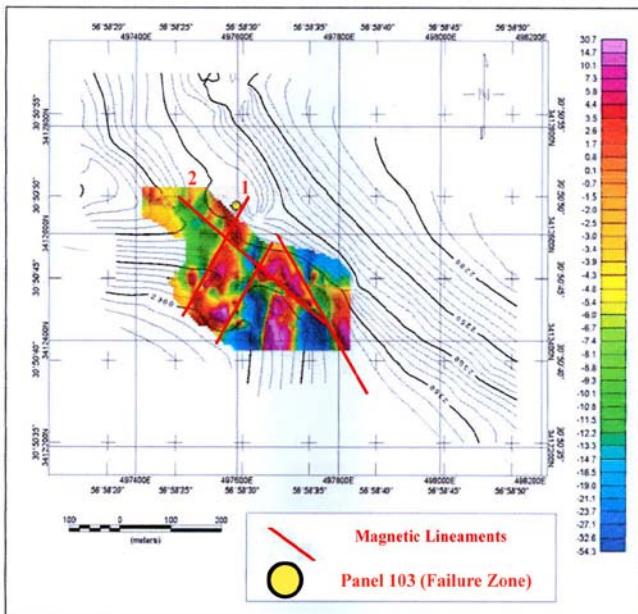
Magnetic lineaments were found by magnetic method and are shown in Figure 6, which depicts geophysics' horizontal profile. The two main separate faults that affected the failure zone are shown as 1, 2 discontinuities in Figure 6, where the location of the collapsed stope is shown by the yellow circle. The third discontinuity was not uncovered by the magnetic method, so the resistivity method was applied as the additional measurement.

Figure 6. Magnetic horizontal profile.

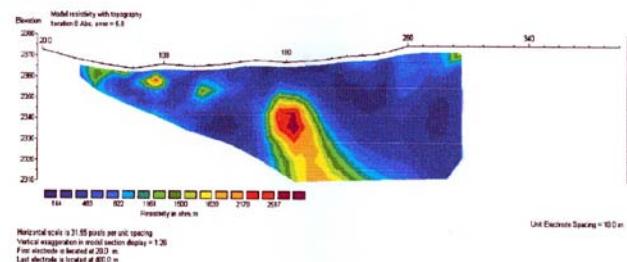
The vertical profile of the failure zone is shown in Figure 7. Failure zone started from the level of 2355 m (Figure 7), and the height between top and bottom of the failure zone is estimated as 20 m (from 2375 to 2355) and extended to the level of 2200 m, where there was the coal bed. Thus, this coal bed acted as a weakness plane or discontinuity.

Figure 7. Electrical resistivity vertical profile.

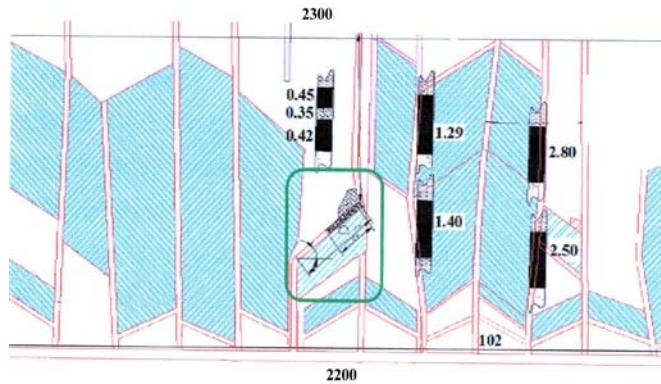
Bed separation and failure can occur along the bedding planes in stratified deposits, especially when the thickness of the coal seam is not uniform. It is, therefore, possible that coal bed released from the hanging wall. In the present case study, the thickness of the coal bed fluctuated vastly between the level of 2300 m and 2200 m in the mine. The changes in thickness are shown in Figure 8 (from 2.80 to 0.45 or 2.50 to 1.40 to 0.42 m) [9].

Figure 8. The section of changes in thickness of coal bed.

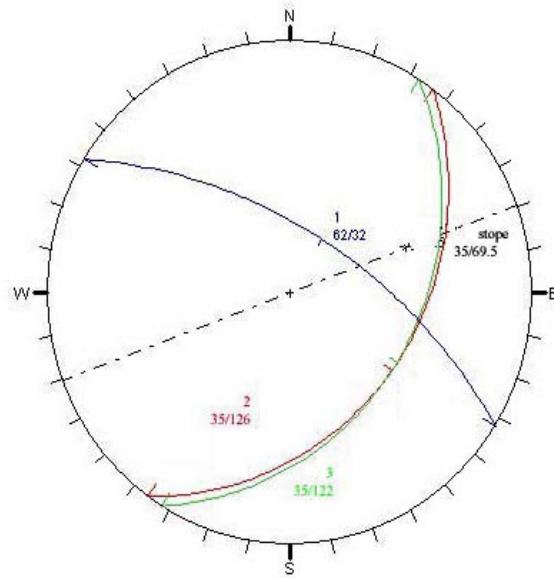
A full screen stereographic projection of the discontinuities orientations and stope axis are shown on the stereonet Figure 9.

Figure 9. Stereographic projection of the discontinuities orientations and stope axis.

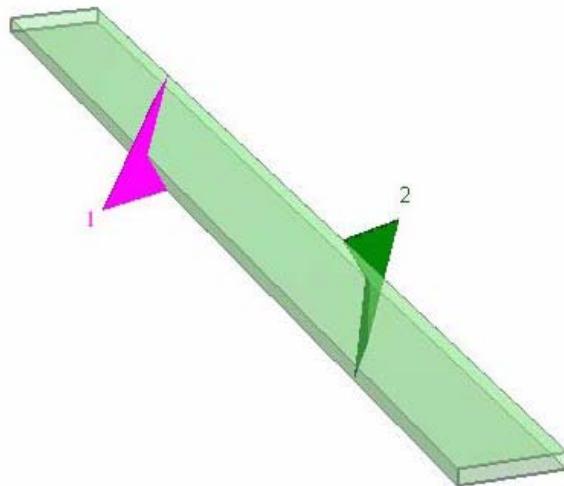
Workers are directly exposed to potentially unstable ground in the stope in traditional underground mining methods such as stull stoping. The stability design must be strict and as perfect as possible as a safety issue in artisanal small-scale mines. Determine the maximum sized wedges that can be formed in roof and sidewalls of the stope 103 by the given discontinuities are shown in Figure 10.

Two perimeter wedges are made by discontinuities, wedge #1 (upper left wedge) and wedge #2 (lower right wedge). In this case, wedge #1 has been scaled by the discontinuity 3 (bedding plane), and its volume and shear force are estimated 267 m³and 230 tones respectively while wedge #2 is stable completely. The occupational accident in stope 103 is a result of falling wedge#1.

Figure 10. Perspective view of the stope and its wedges.

Coal is often well bedded and, as such, the intensity of layering in coal may be much greater than that of any of the other discontinuities. Thus, with regard to excavation stability, layering and control of this structure may require additional ground support and must be conducted very carefully.
