**Cultural and physical factors in the history and  
development of traditional external wall  
coatings in Scotland**

Timothy John Meek  
MA

Thesis submitted for the degree of Doctor of Philosophy

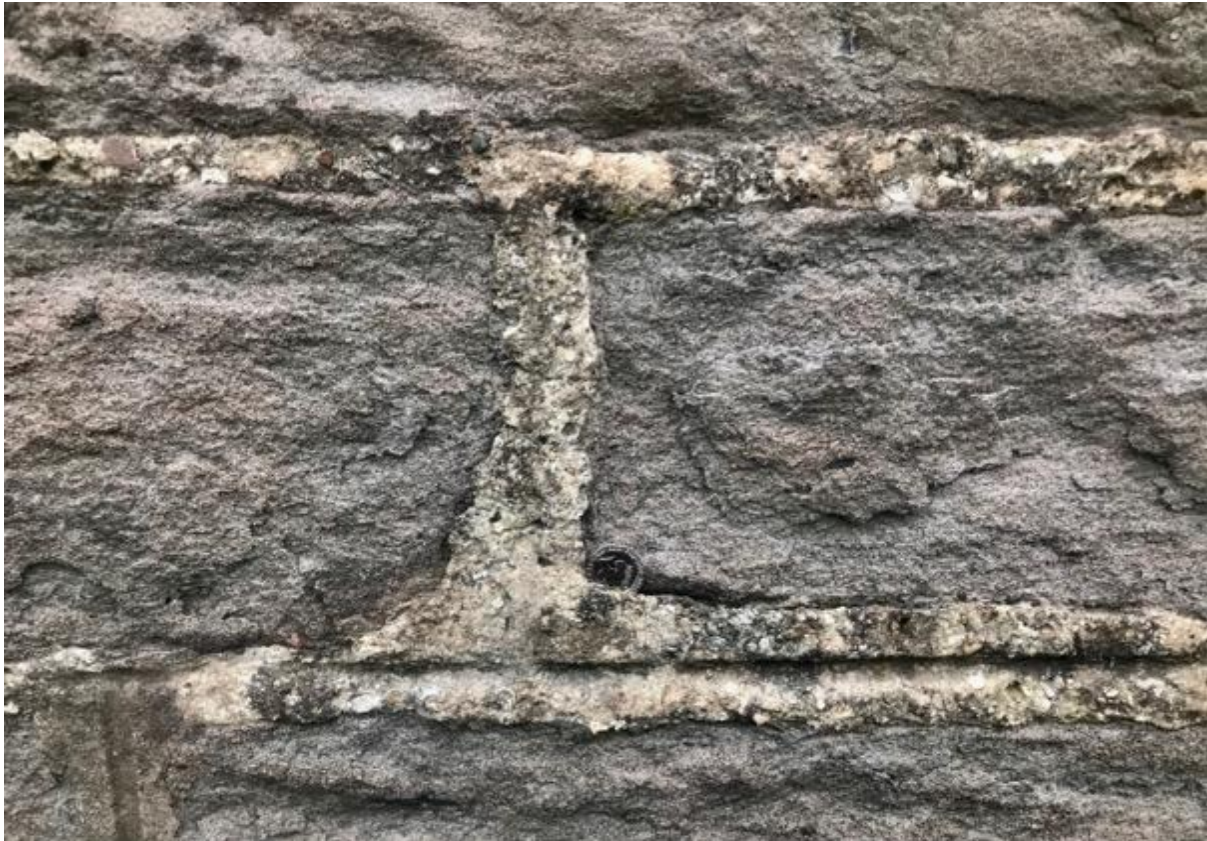
Figure 1.0. Church of Scotland Bridge of Allan, Stirlingshire c.1860, decay of exposed Victorian stone.

The significance of an adverse climate relative to a bare stone paradigm can be measured by the decay of Victorian sandstone buildings in a period of less than two hundred years (Fig. 1.0). This threat is compounded by the onset of climate change (McCaughie, 2021; Smith *et al.*, 2008). The experimental work contained within the research programme is a response to the predicted intense storm conditions generally (Sexton & Murphy, 2010; Traversetti *et al.*, 2018;) and specifically in Scotland (Holmes, 2015) with high rainfall and increased exposure to wind-driven rain (WDR) (Weeks, Sutton & Bassett, 2021 BRE), particularly in exposed western and northern regions (Fig. 1.1). The short intense spells of WDR are predicted to increase in the coming years and this exposes masonry buildings to a greater degree of vulnerability. In this thesis the functionality of buildings where the joints between stones are exposed is questioned, and the effectiveness of complete cover tested.

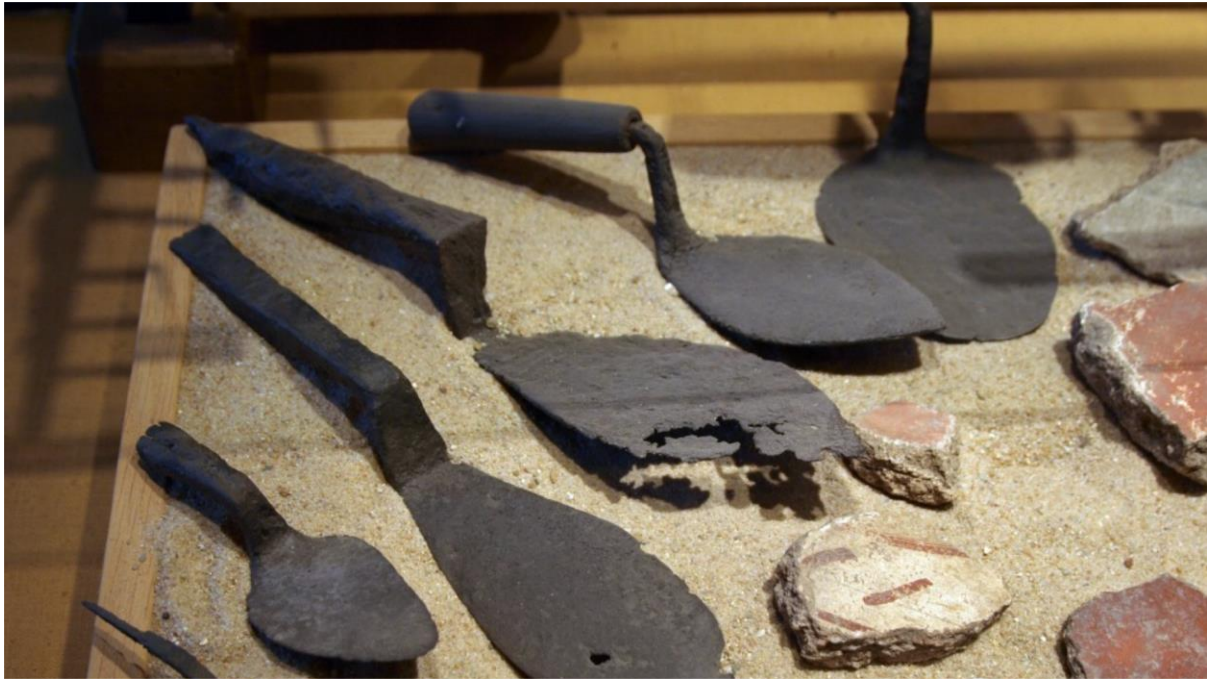
Figure 1.2. Roman trowels for building and finishing. Note the fragments of fresco to the right Andreas Franzkowiak, Halstenbek Germany. License: CC-BY-SA-3.0

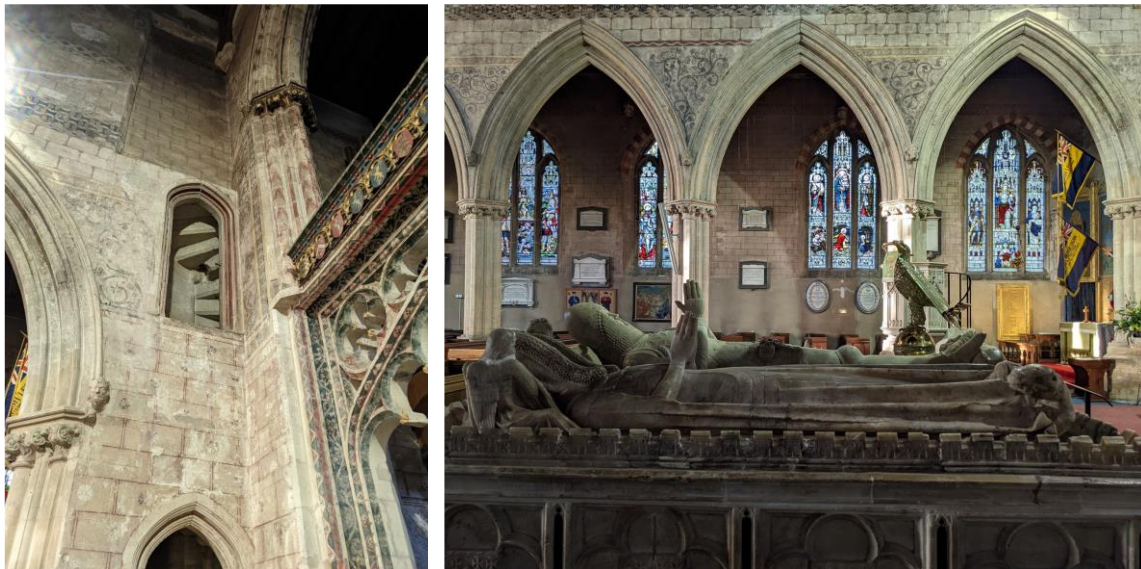
Figure 1.4. St Mary's Church, Berkeley, Gloucestershire, plastered walls with polychromatic illustrations of ashlar. Image credit Imogen Gower.

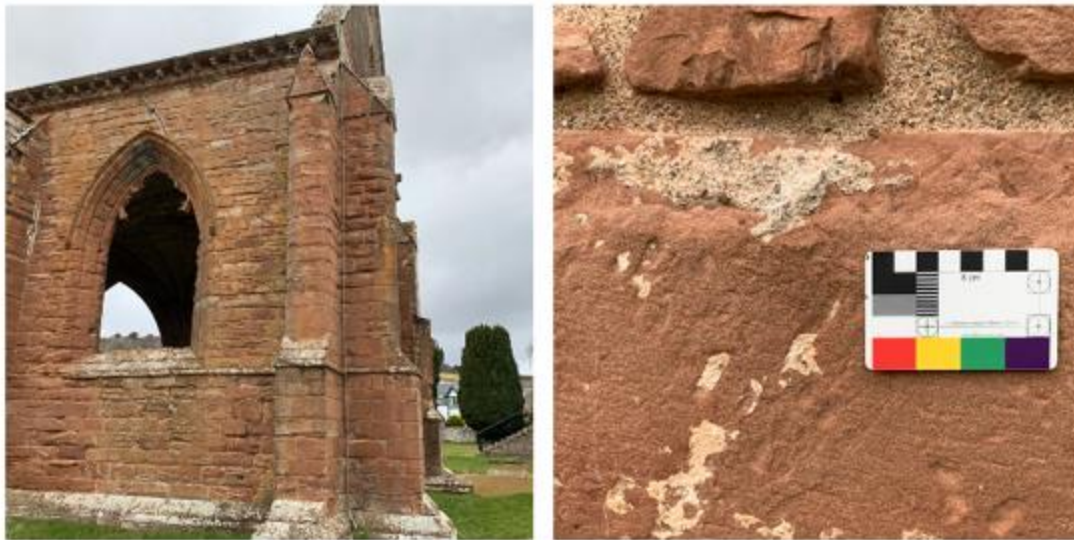
Figure 1.5. Fortrose Cathedral c. fourteenth century. Large, soft local sandstone blocks showing remnants of harl/plaster.

This statement indicates that square cut stone is not necessarily intended for display: it was square by convenience, soft enough to cut regularly and place accurately. Understanding those inherent qualities required it to be finished, much as poor quality low-fired common bricks are understood to be serviceable for building, but unfit for adverse climates and visually unacceptable to people of quality and rank (Hudson, 2015). At Fortrose Cathedral, soft local sandstone, regarded and conserved as ashlar, reveals clear evidence of harl/plaster (Fig. 1.5).

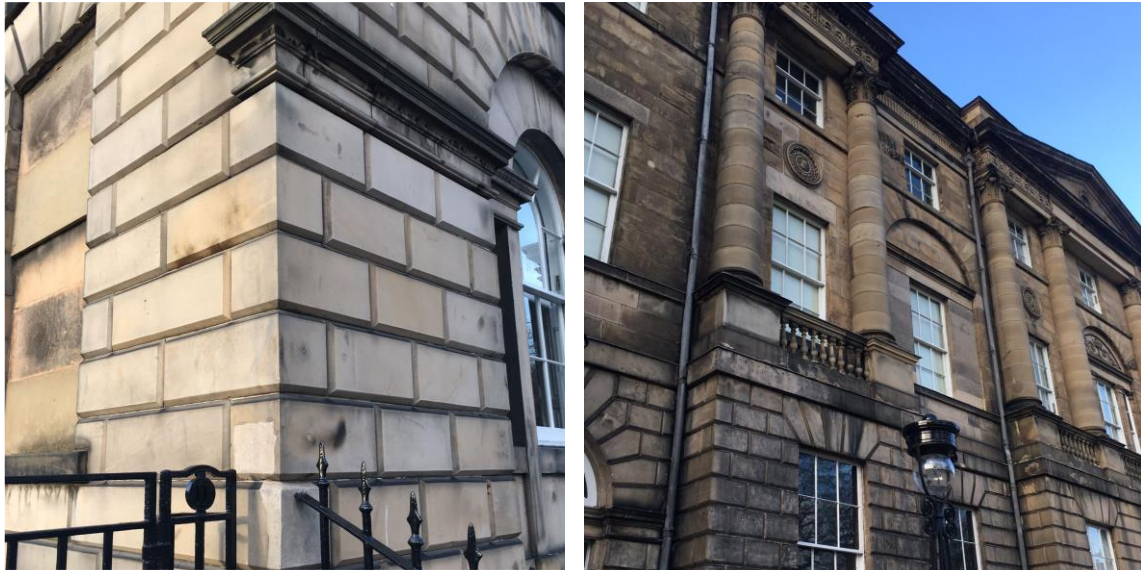
Figure1.6. Edinburgh bare ashlar stone.

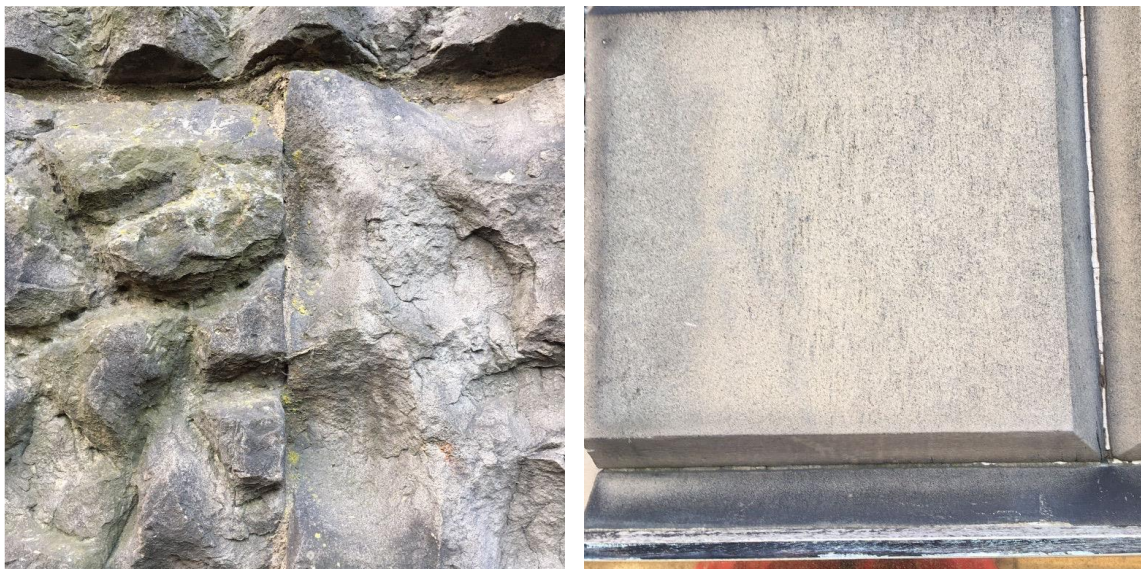
Figure 1.7. Edinburgh bare ashlar with rustic finishes retaining fine joints.

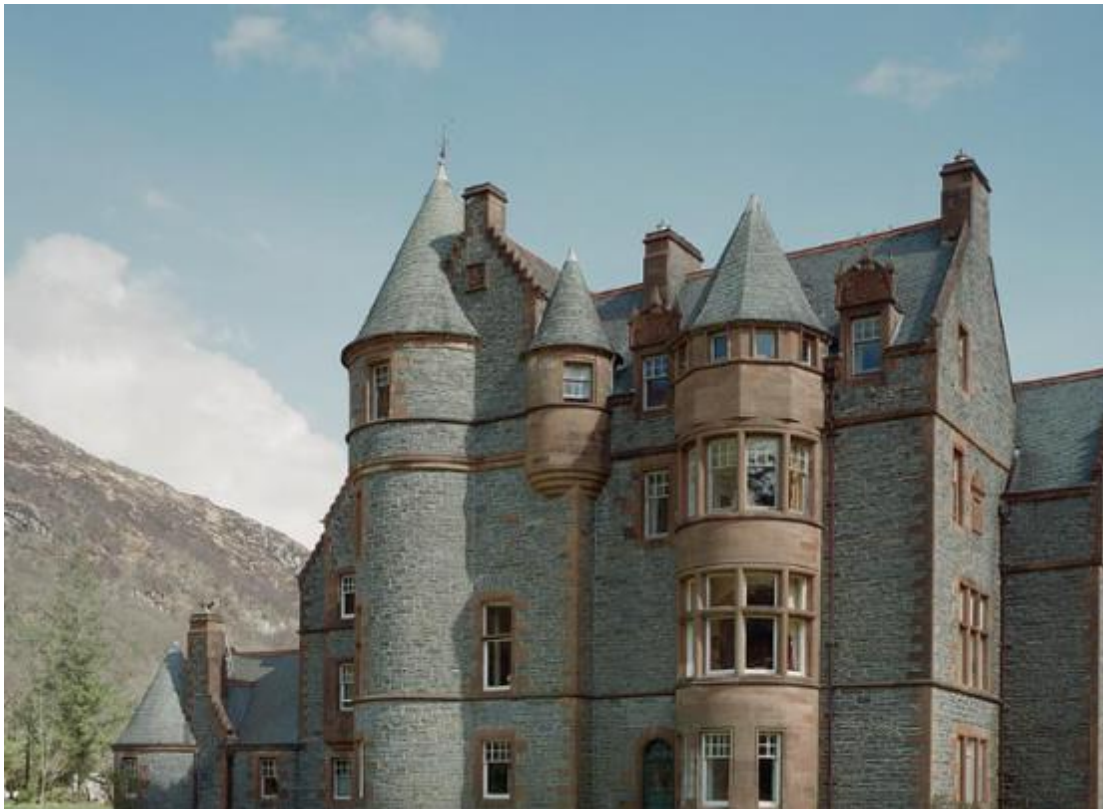
Figure 1.9. Kinlochmoidart House. Full Scots Baronial, vertical, asymmetric but with all the technological advances of the period. Imported red sandstone. Split and sawn whinstone.

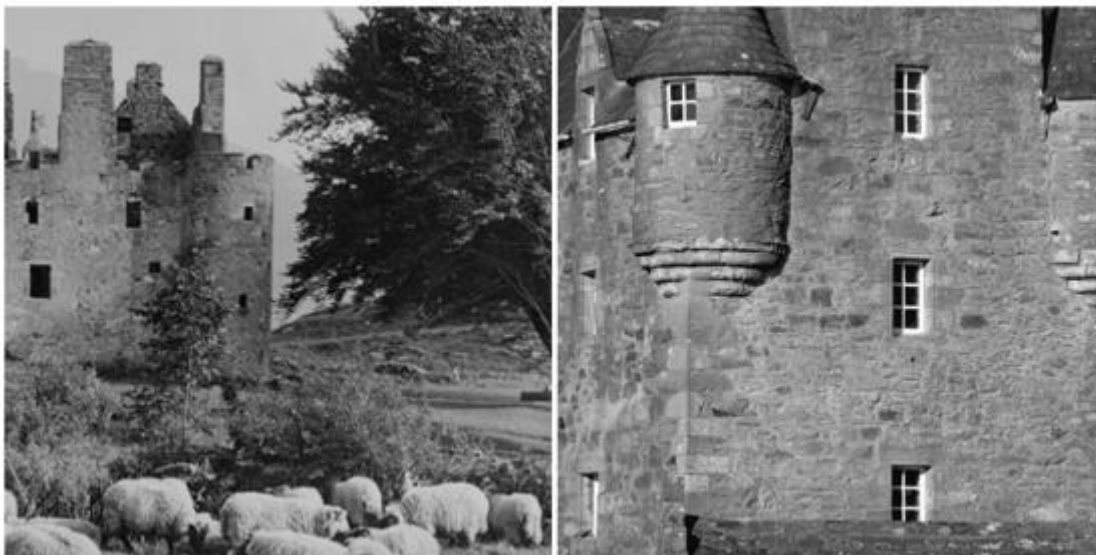
Figure 1.10. Dunderave, left, ruinous but with extant harl; right, remodelled and naturalistic, the high points of the stone grinning through (Image credit HES Canmore)

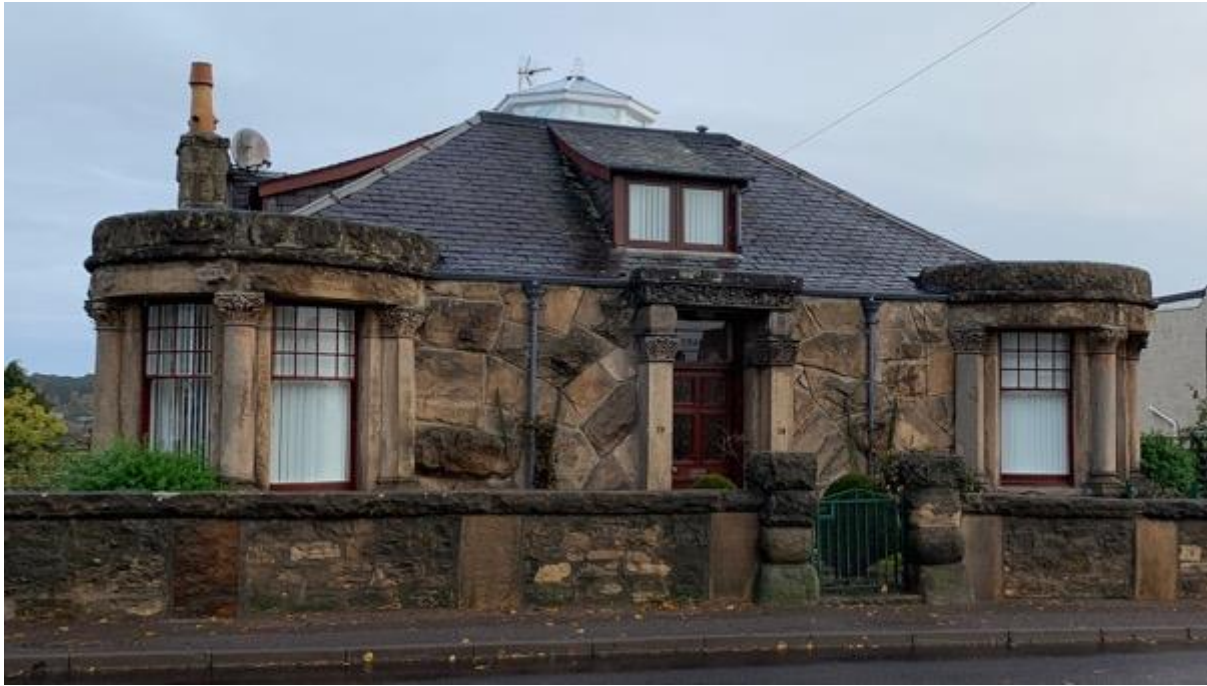
Figure 1.11. Complex rubble masonry and poor detailing; the legacy of Scots Baronial.

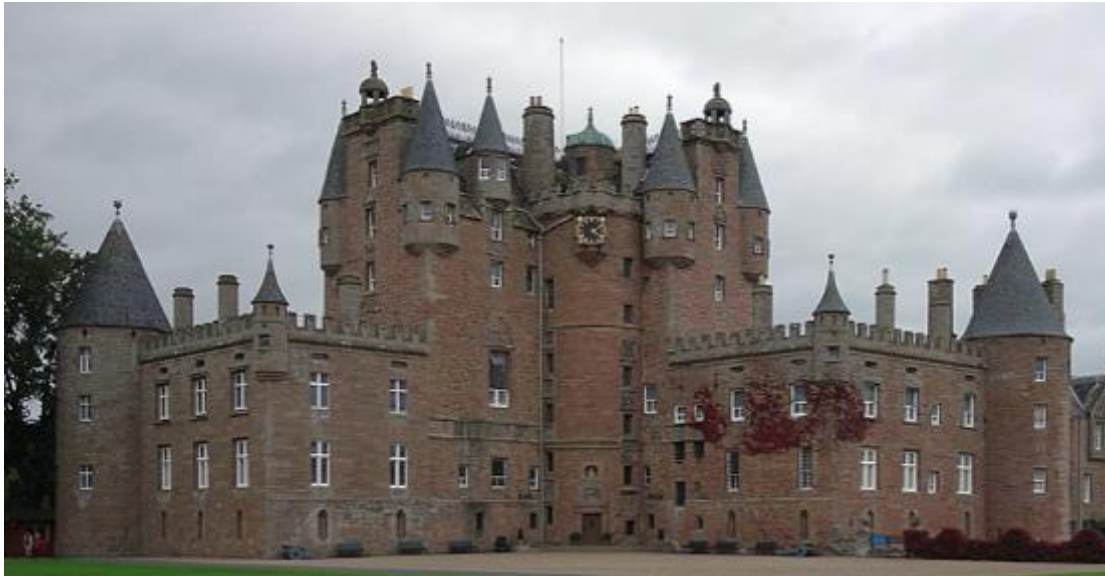
Figure 1.13. Glamis, today. The central towers remain, stripped of harl and the additions built with sawn, coursed rubble.

MacInnes also links the bare masonry of the Scots Baronial with national identity. The development of Scots Baronial architecture in general, and the changing attitudes towards bare stone (rubblemania) is, MacInnes argues, best seen at Glamis Castle. The L-shaped tower remains harled (Fig 1.12). In 1677, the combined tower block was added to on each side, making the vertical central component the central focus, and the combined complex symmetrical and harled (Stewart, 2016). It was castellated c.1770 and extended again in the early nineteenth century. These additions were constructed without harl. With references to the past and conversely to modernity with its plate glass windows and walls wholly denuded of harl, Glamis shows the quintessential evolution of the Scots Baronial style that by the mid to late nineteenth century was so invested in Scottish architecture taste and shows how bare stone was now commonplace (MacInnes, 1996) (Fig. 1.13).

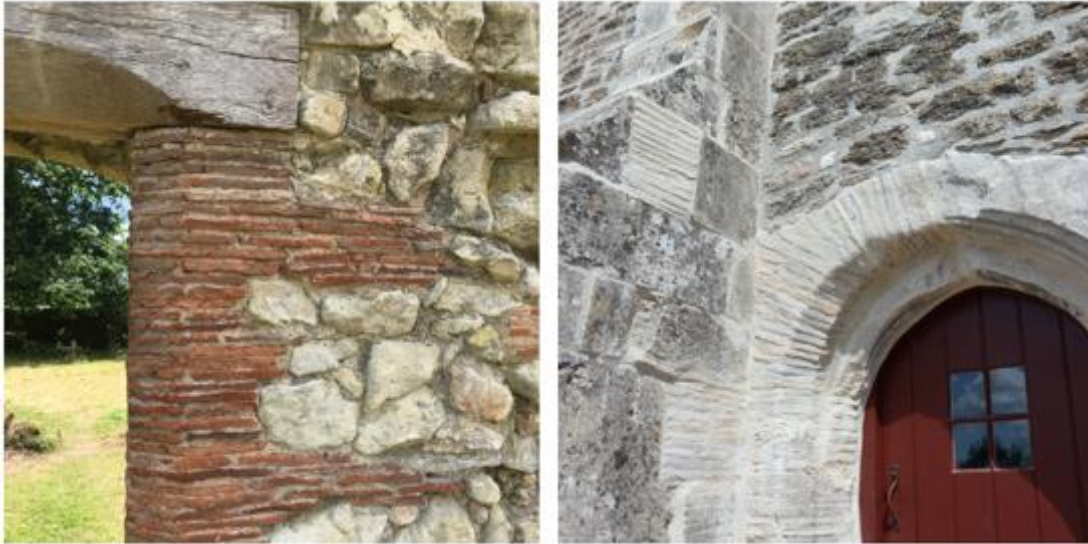
Figure 1.14 The SPAB tile repair technique in soft handmade tiles and stone tiles.  
Image credit the SPAB.

The embodiment of 'conserve as found', and 'honest repair' is the SPAB tile repair technique (Powys 1929), where slips of terracotta or stone are inserted into decayed masonry to support the structure. Sometimes the repairs are isolated, while on others they can be extensive, replacing large areas of masonry, following the contours of the weathered wall plane and respecting the decorative detailing (Fig. 1.14). The tiles are bedded in lime mortar and because the terracotta and stone tile and mortar are 'soft', they are deemed to be subservient to and distinguishable from the original masonry and are therefore regarded as 'honest'.

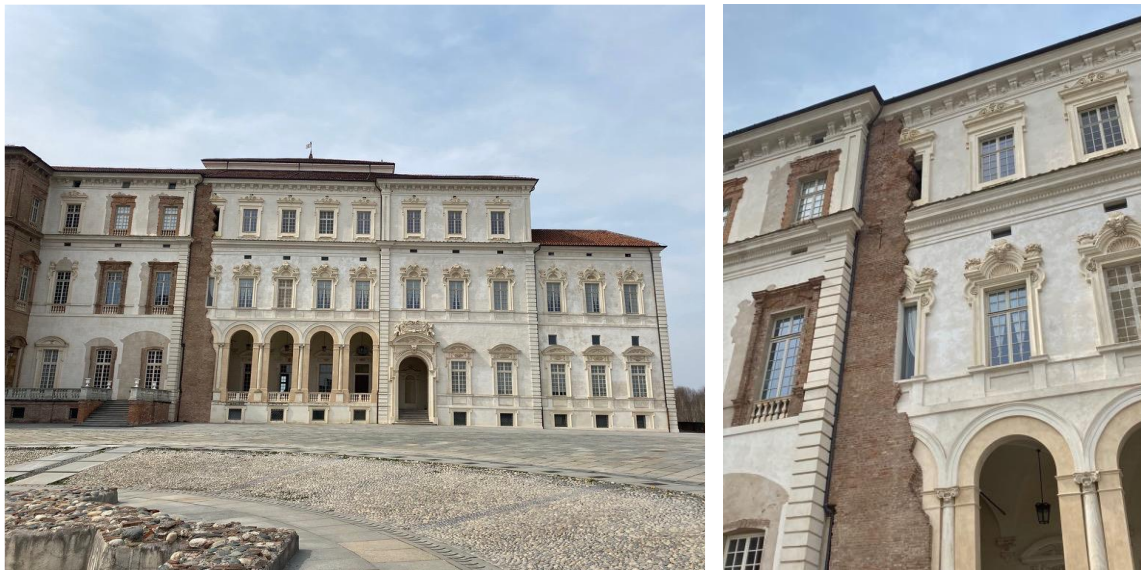
Figure 1.15. The Palace of Venaria c.1675 UNESCO WHS employing 'honest repairs'.

A measure of how significant and influential the SPAB principles of 'honest repair' and 'conserve as found' have been the impact on the conservation works undertaken on UNESCO World Heritage Sites. The Palace of Venaria c.1675, Turin was included on the Heritage List in 1997. Structural repairs were needed to stabilise the intersection between two parts of the complex and was addressed by a bare brick buttress, woven into the fabric of the plastered walls. The distinction is clear (Fig. 1.15). The research demonstrates that 'conserve as found' and 'honest repair' are prejudicial to the understanding of the intended presentation of architecture and has lasting significance to conservation of the monument and is unsustainable in a climate-changed future.

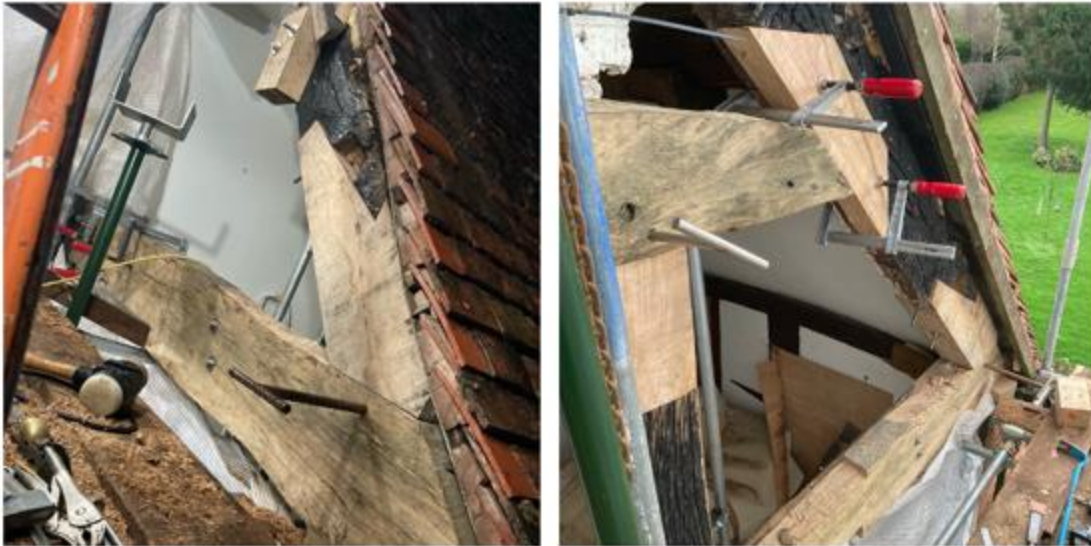
Figure 1.16. Honest repairs to timber roof trusses. In this example the repairs are clear but protected by the roof covering.

'Conserve as found' and 'honest repairs' are logical when, for example, damaged rafters are repaired by cutting away the decayed area and splicing in new timber. There is a clear distinction between the new and the old, and the repair will be

covered by the roof (Fig. 1.15). This research argues that it is when those conservation strategies are applied to masonry, and the repair itself becomes the distinguishing feature, that a difficulty arises. It legitimises a bare stone narrative, failing to address stone decay and water penetration, and presents an altered history.

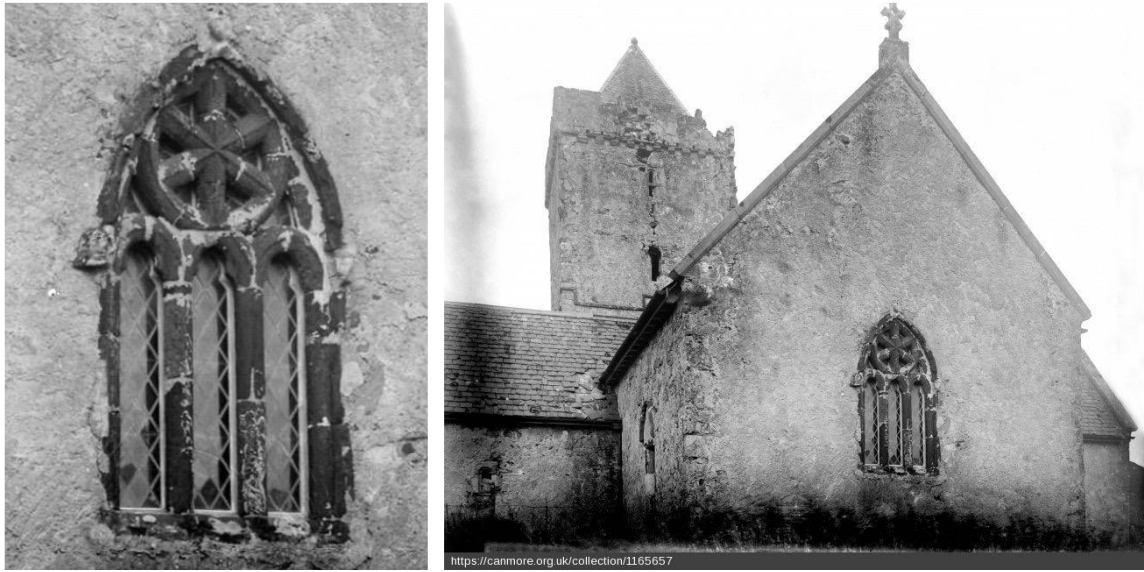
Figure 2.1. St Clement's, lancet window with extant plaster/limewash (<https://canmore.org.uk/file/image/1165657>).

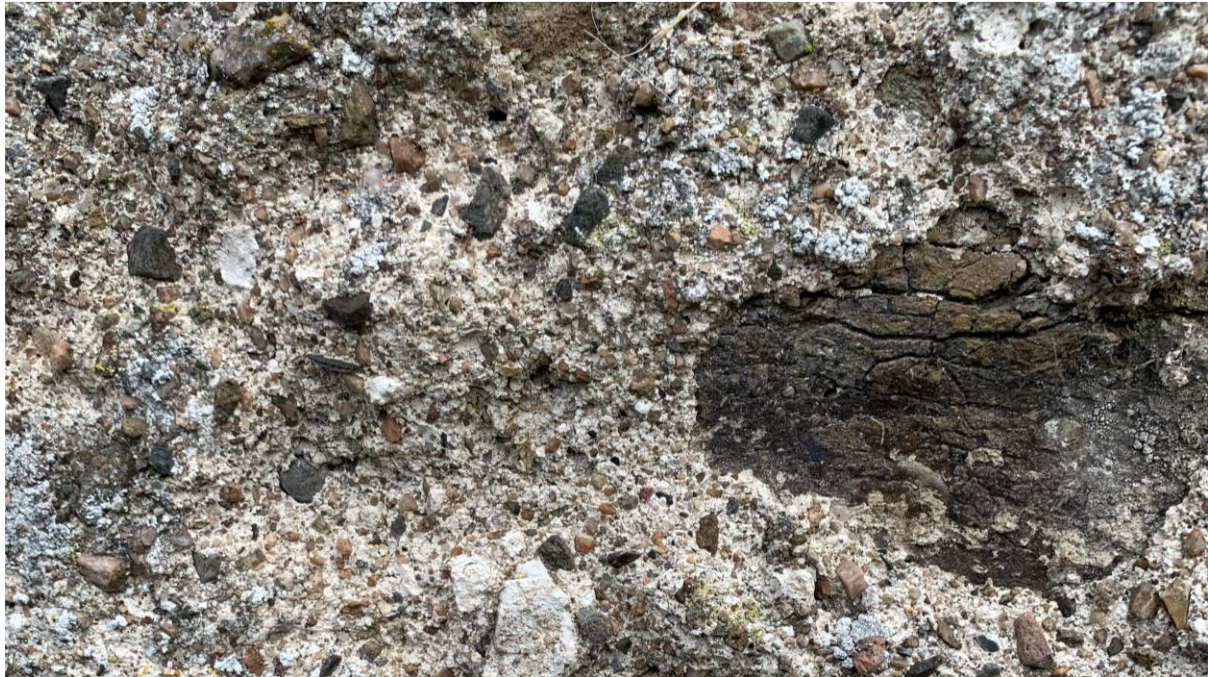
Figure 2.4. Grading away  $\text{CaCO}_3 / \text{Ca(OH)}_2$  exposing angular and sub-angular lithic aggregates embedded in the mortar.

The primary means of assessing external lime finishes was on-site, *in situ* visual assessment. Where fully cured, dissolution of carbonated  $\text{Ca}(\text{OH})_2$  is very slow, with erosion of the binder taking place from the lithic fragments that accumulatively make up the aggregate sample close to the exposed external face (Thacker, 2017) (Fig. 2.4). The weathering from larger sections of the aggregate is significant because the lithic clast ‘grins’ through the binder paste surface while leaving the underlying mortar intact. The colour of mortar is influenced by the sand/aggregate, but the lime remains white/cream depending on hydraulicity, aggregate binder ratio or the inclusion of pozzolana. Gradual erosion of lime binder is at odds with mortar made utilising

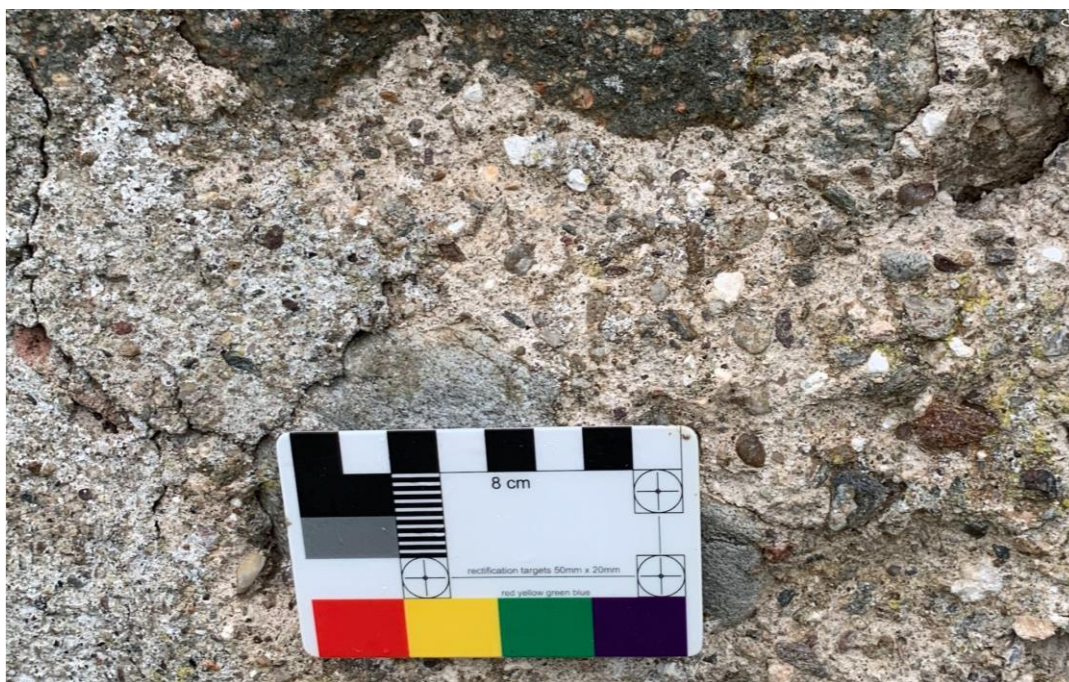
Figure 2.5. Lime inclusions, commonly in mortars mixed 'hot'.

The 'hot mixed' method of producing mortar where  $\text{CaO}$  is combined with sand and aggregates has been recognised as the most likely method used to produce historic mortar (Copsey, 2019). During the slaking process, most of the  $\text{CaO}$  is combined with the sand and aggregates, but not all the quicklime is completely integrated within the mix because of a lack of reactivity due to under- or over-burning  $\text{CaCO}_3$  during calcining. These particles appear as white/cream nodules of varying sizes and are indicative of lime mortar, irrespective of whether the mortar is high calcium or hydraulic (Fig. 2.5).

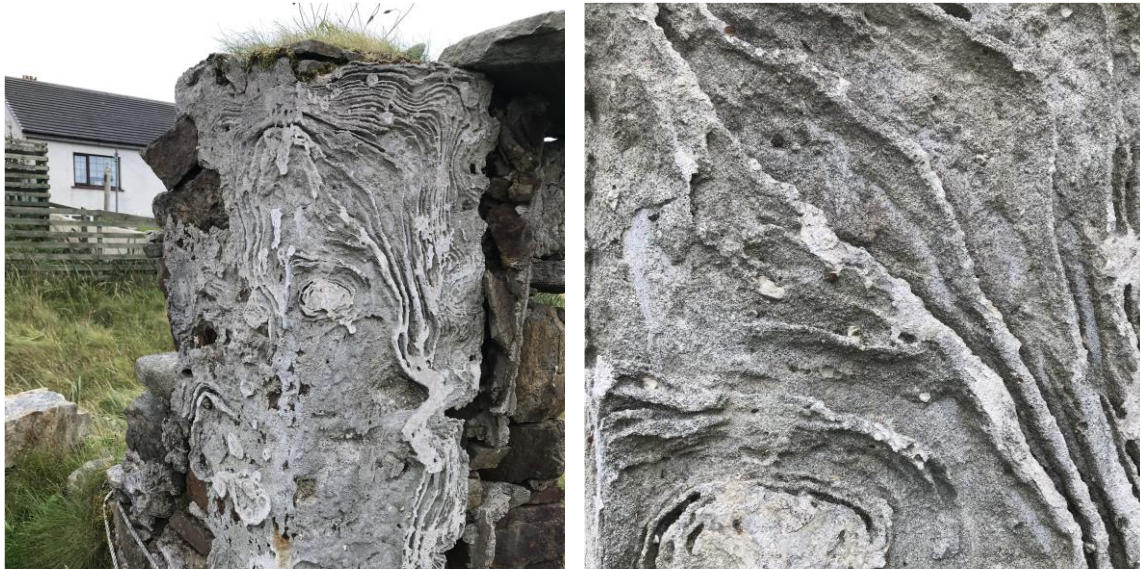
Liesegang patterning (Fig. 2.7) is the result of differential weathering in exposed environments (Rodrigues, 2016; Cazalla *et al.*, 2000) between carbonated and uncarbonated  $\text{Ca}(\text{OH})_3$ . The phenomenon occurs in lime mortar and is visually striking, exhibiting spirals and swirls in plaster. The recognition of this patterning helped identification of external lime finishes during the survey.

Figure 2.7. Liesegang patterning, Leverburgh, Harris.

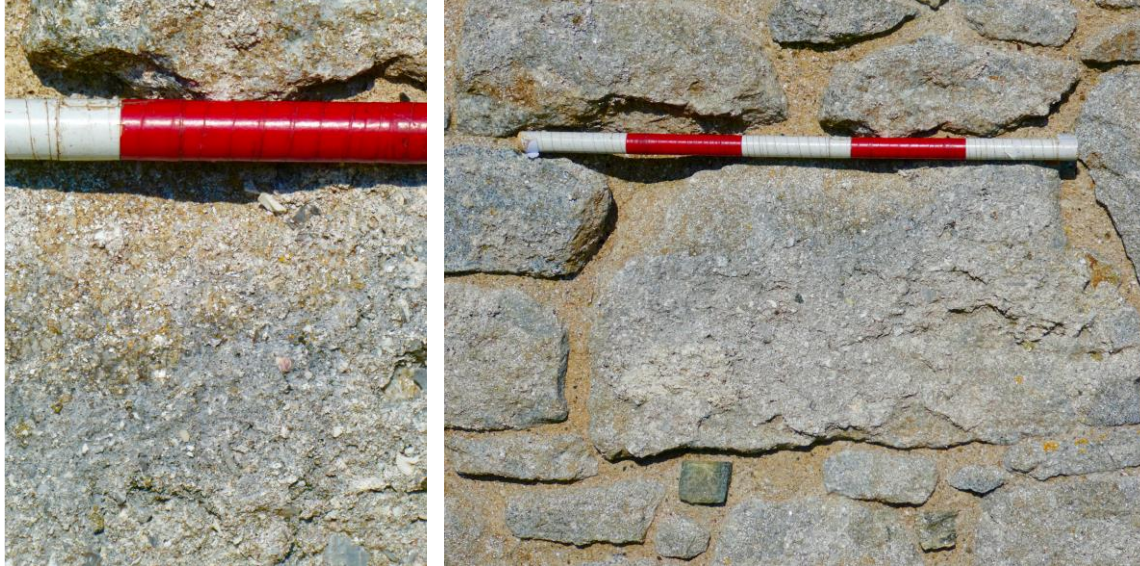
Where bare stone was the principal feature the colonisation of masonry with biological growth – lichens and algae (Gadd & Dyer, 2017) made identification of lime surfaces difficult. In the example below: St Clement's, Rodel (Fig. 2.8), the surface of

the biological growth and the harl blend. Given the restrictions in sampling mortar or teasing away microbiological growth, learning to tell the difference was a product of multiple observations on each elevation.

Figure 2.8. Left: Detail of 16<sup>th</sup> century marine harl at Rodel, Harris. Right: The same harl in context with the stone, demonstrating the importance of close scrutiny to identify the difference between stone and harl when the wall is completely covered in biological growth.

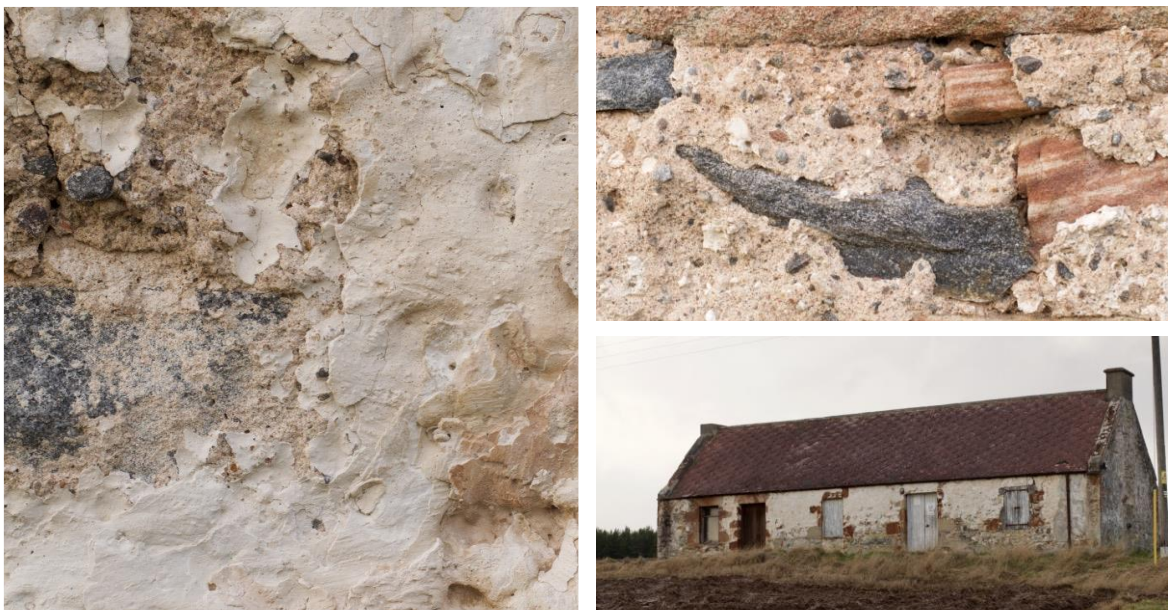
Tulloch Cottage, c.1860, is an unlisted semi-derelict cottage at Munloch, Ross Shire, and a good example of the many random entries within the study. Its location on the Black Isle skyline and obvious bright tonal values, visible from the adjacent road, raised the potential that the building – even in an abandoned state – would reveal evidence of limewash (Fig. 2.9). In sheltered areas – under eaves for example, multi layering often revealed many years of limewashing which was not evident when looking at the wall generally (Fig. 2.10).

Figure 2.9. Tulloch Cottage, Munloch, Ross Shire. Left: multilayering limewash. Right: an exposed area where harl and limewash had graded away.

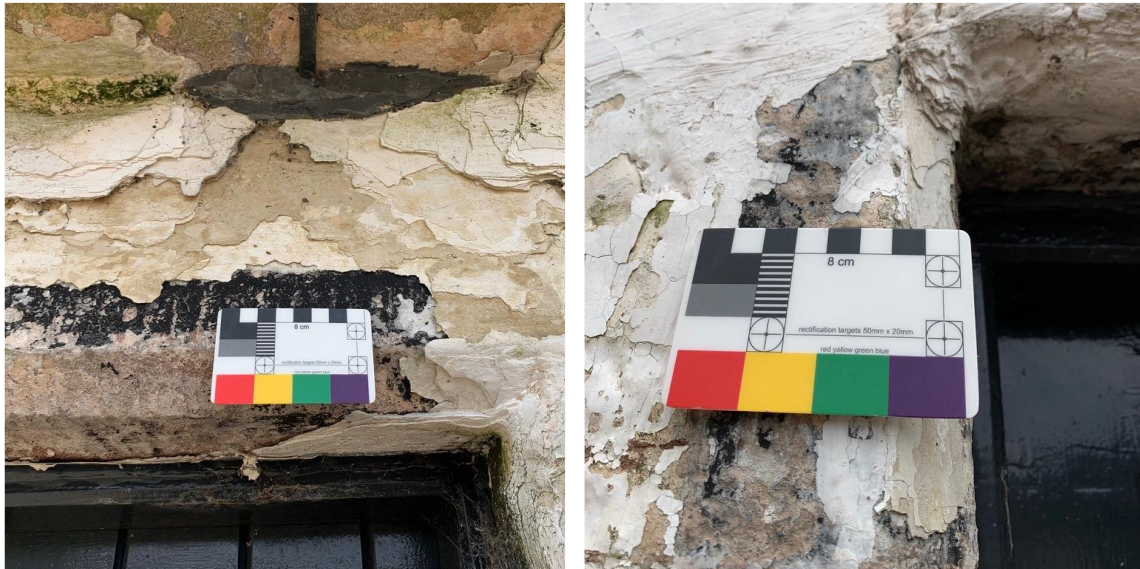
Figure 2.10. Exfoliating multi-layered limewash in sheltered areas.

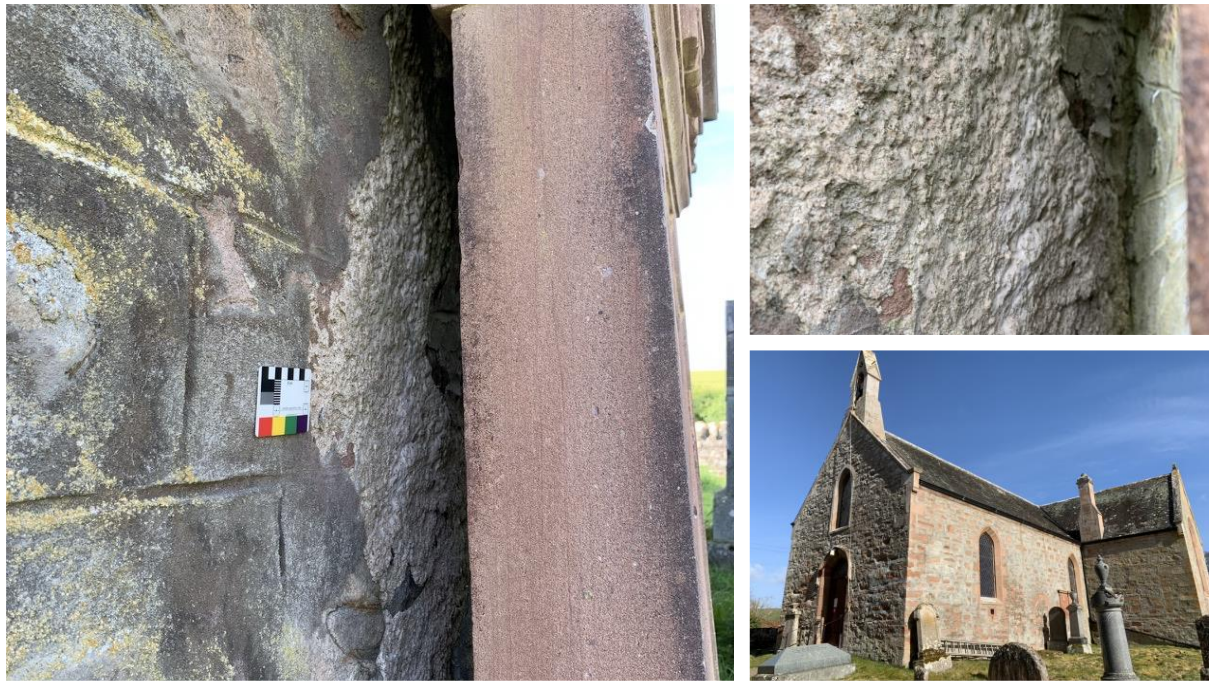
Figure 2.11. Killearnan Parish Church, Ross shire. Outwardly a bare stone Victorian church; evidence from behind grave markers suggested a harled surface.

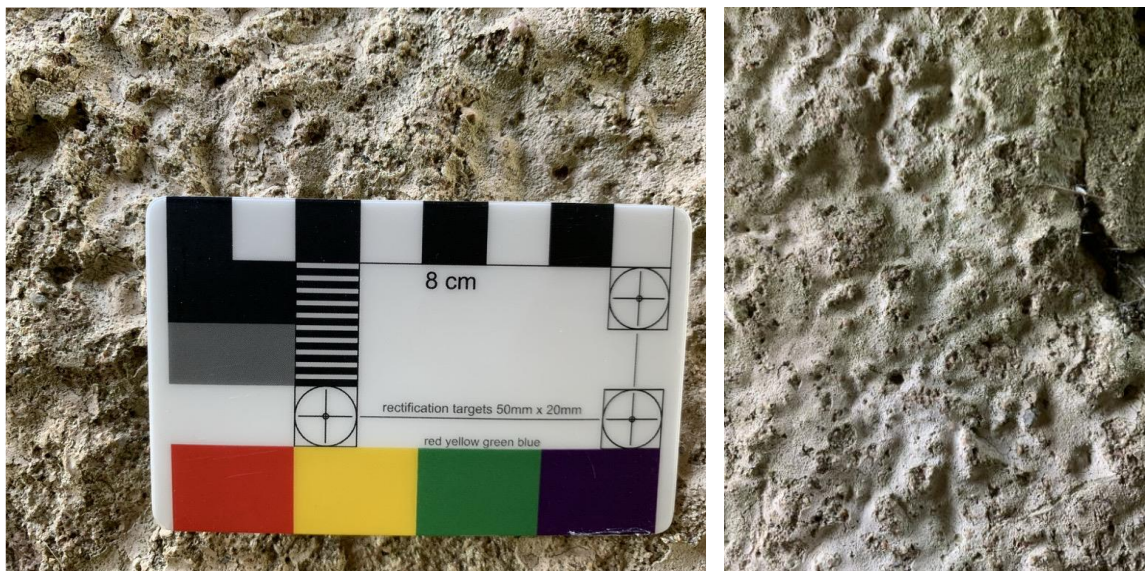
The preparedness to go beyond initial observations and locate hidden evidence was a common theme throughout the survey, further enforced by discoveries at Killearnan Parish Church, Ross shire (Fig. 2.11). In this instance an otherwise bare stone Victorian church was transformed by the discovery of harl and limewash found behind two grave markers, c.1858 (Fig. 2.12). Thus, the stones provide the *terminus post quem* for the earliest date the church was stripped. The listing designation (<http://portal.historicenvironment.scot/designation/LB7972>) indicates that later alterations to the church were made by the Inverness architects Ross and MacBeth, c. 1887, and it may have been that the harl and limewash were stripped then. Alexander Ross is the same architect who cleaned the walls at St. Clement's Rodel, and Ross was in favour of stripping what he considered inappropriate surface treatments. Other critical areas at different sites included loft spaces where former exposed gables were protected by later additions, basements, overhanging eaves and rhone pipes.

Figure 2.12. Killearnan Parish Church, Ross Shire, harl with limewash.

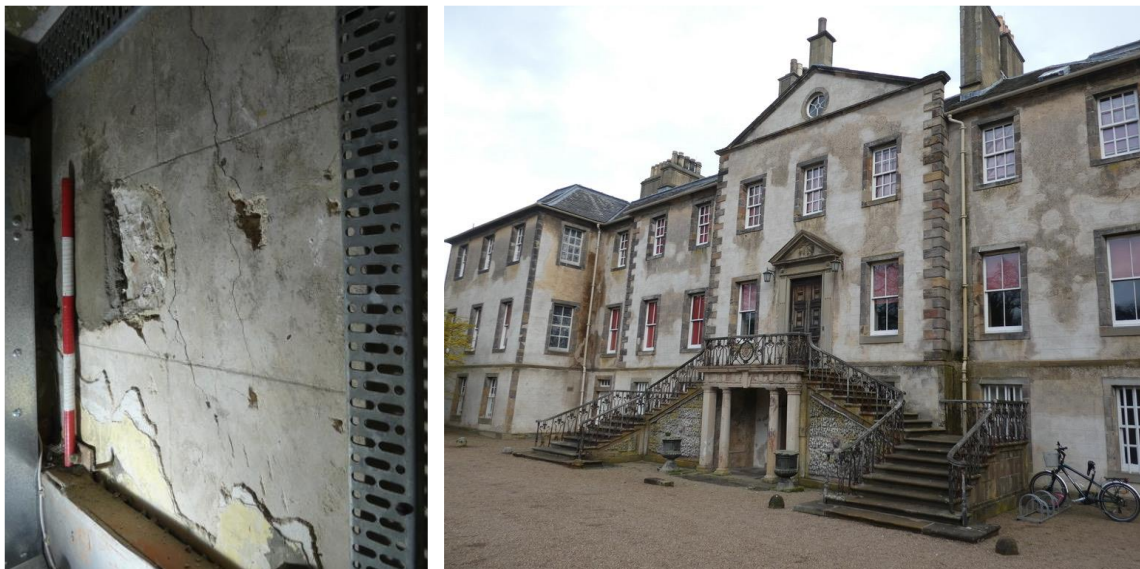
Newhailes House, c.1686 and extended c.1720, Musselburgh, East Lothian (Listed Building LB10911) (National Trust for Scotland) (Fig. 2.13). The external plaster of c.1686 remains within the basement below Adam's extension of c.1720. The extension of 1720 provided a *terminus post quem* for any alterations to the work of 1686.

Figure 2.13. Newhailes House, Musselburgh, East Lothian. Fully plastered and lined out 'ashlar' Left the basement area where the work of James Smith c.1686 was enclosed within the later work of William Adam c.1721.

In the Newhailes example the ruled plastered surface is bonded accurately: the perpendicular joints remain constant, and the horizontals correspond with rusticated quoins. In this it is possible to recognise an aspiration for perfection. In the example below (Fig.2.14) the coursing of the basalt masonry work outwardly corresponds with the quoin blocks and inband-outband rybat tails of the margins (Pride, 1996 p.65). However, there are discrepancies and in some areas the coursing of the basalt does not relate to that of the details. The perpendicular bonding characteristics of the basalt work is also sub-standard: in some areas there is no bonding, even when

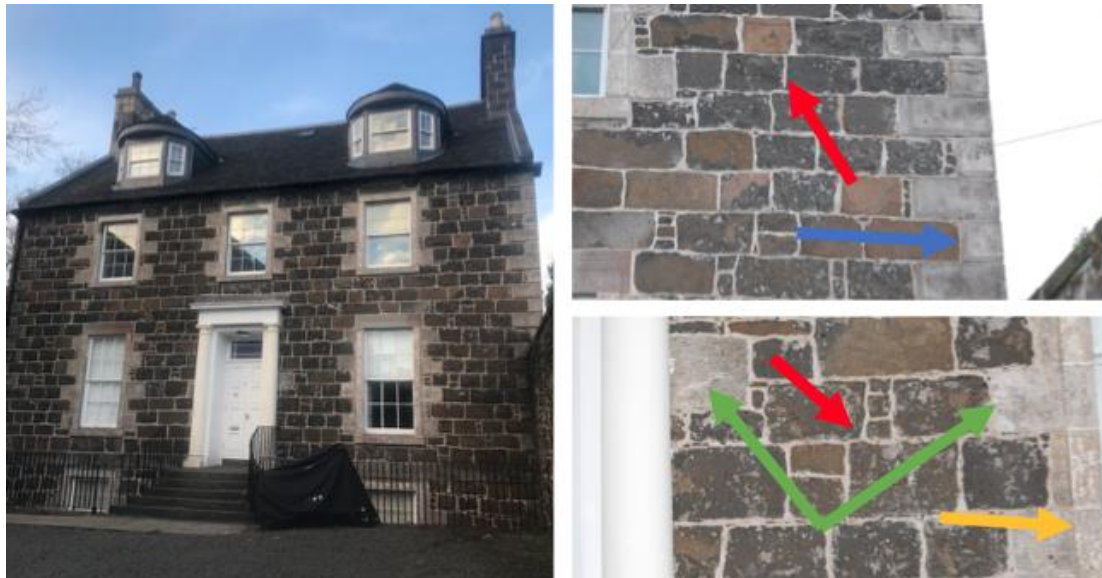
pinnings act as closers (Pride, 1996 p.25). When compared with the exactitude of the ruled plaster at Newhailes, there is little to suggest that the current bare stone presentation is a credible representation of 'Taste' (Babcock, 1935), and 'Politeness' (Klein, 2002).

Figure 2.14. Dalglish Court, Top of Town Stirling. Irregular bonding characteristics (red arrows) in the roughwork. Raised margins (yellow arrow) with inband-outband rybats (green arrows) at the windows and raised rusticated quoins (blue arrows).

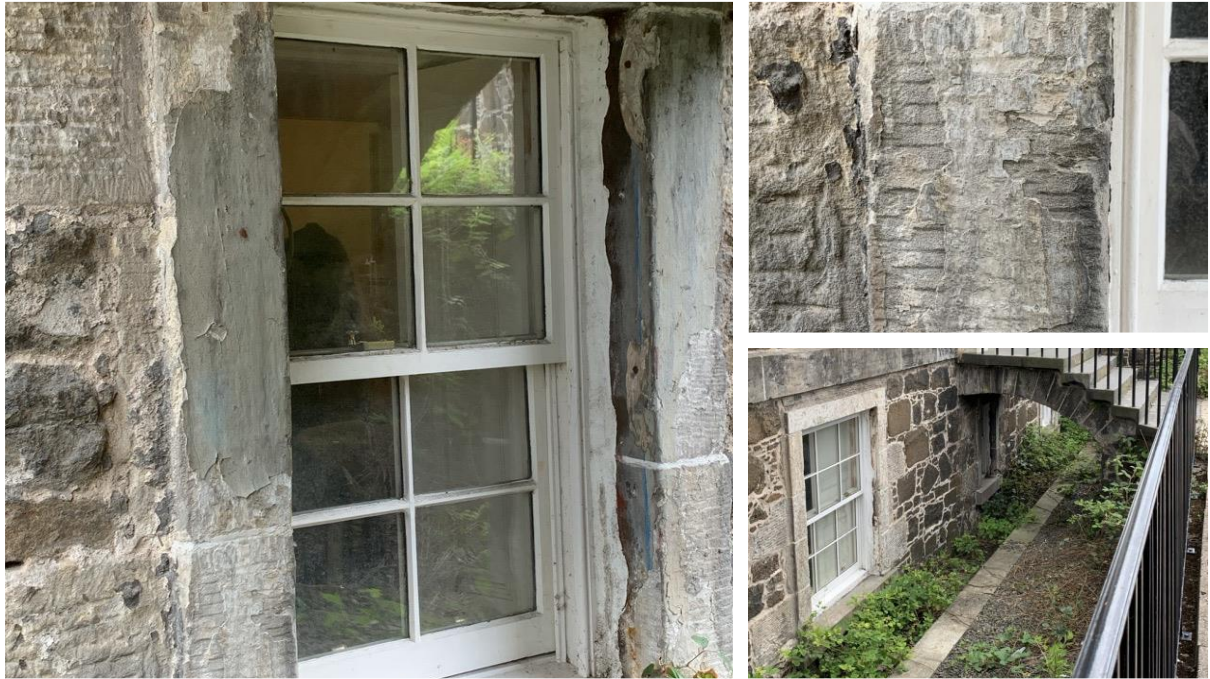
It was important to consider the totality of evidence. In the Dalglish Court example, traces of harl were found adhering to the broached inband-outband tails. Harl traces were also found adhering to the basalt over the whole elevation. Moreover, the front door is accessed by a stone stair and platform. Below this, the basement is difficult to access. The central basement window retains multiple coats of limewash, overlain with several coats of oil paint (Fig. 2.15). These coats had been applied to a droved surface on the raised margin.

Figure 2.15. Dalgleish Court. Discreet below ground level area, retaining harl and limewash.

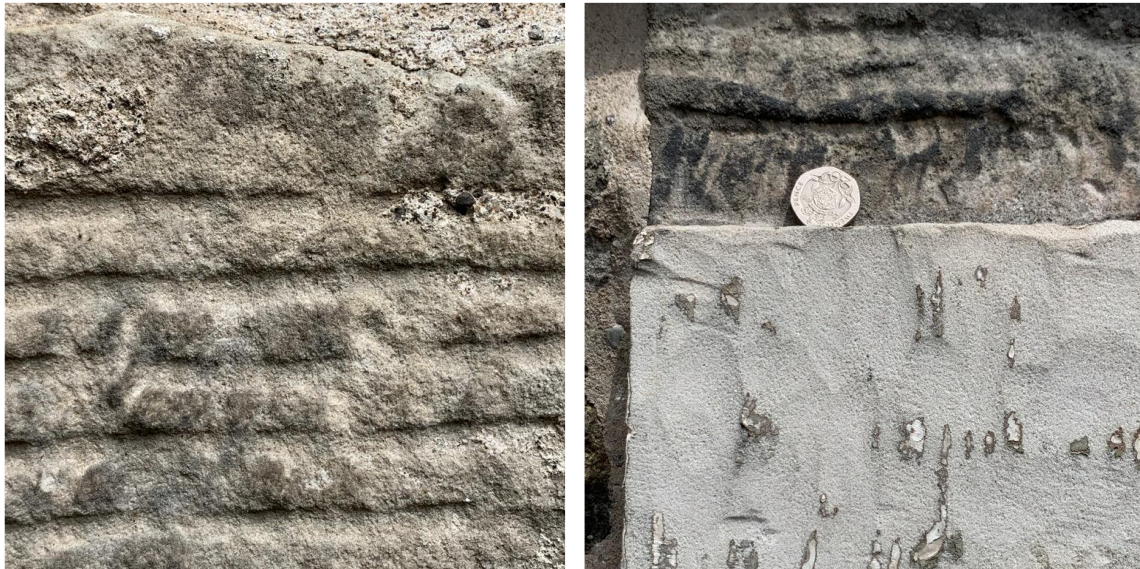
The margins at all other windows have been abraded with an angle grinder, yet traces of limewash remain embedded in pockets (Fig. 2.16). Given the accumulated

Figure 2.16. Dalgleish Court. Left: broached masonry with extant harl. Right: raised margin, cleaned with an angle grinder yet still retaining traces of limewash.
