**Cultural and physical factors in the history and  
development of traditional external wall  
coatings in Scotland**

Timothy John Meek  
MA

Thesis submitted for the degree of Doctor of Philosophy

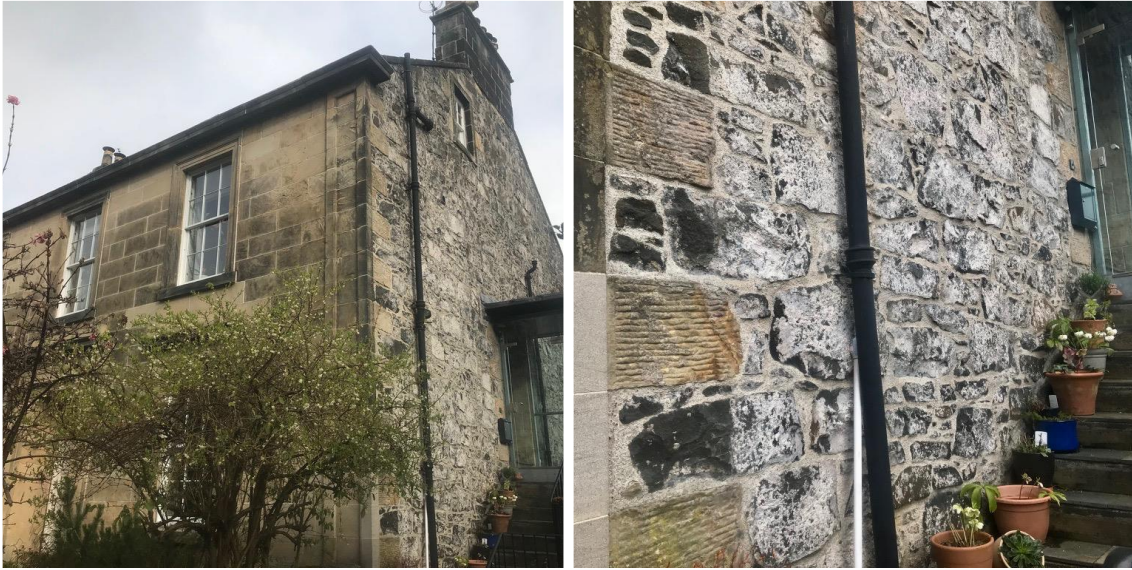
In Figure (Fig. 2.27), Irvine Place, Stirling, the front ashlar elevation is regularly coursed, with exact perpendicular joints in the range ~1mm--~3mm. The windows and quoins have raised margins. This was contrasted by the side and rear elevations where the bulk of the wall was constructed from basalt. The inband-outband tails on the side and rear elevations all retain traces of harl in the broaching marks on the face of the tails. Similarly, the basalt has a residual film of lime mortar. The process of removing the harl and the subsequent pointing of the basalt rough work in lime mortar was executed by contractors on behalf of the current owners in 2017 (pers. comm., owner Mary Taylor). The early aesthetic had been one of a hierarchy of finishes: expensive ashlar on the outward face, complemented and contrasted by a harled surface applied to inexpensive rubble work on the sides and rear.

Figure 2.17. Irvine Place, Stirling. Ashlar front, basalt gable and rear elevations with harl extant on the surface of both masonry components.

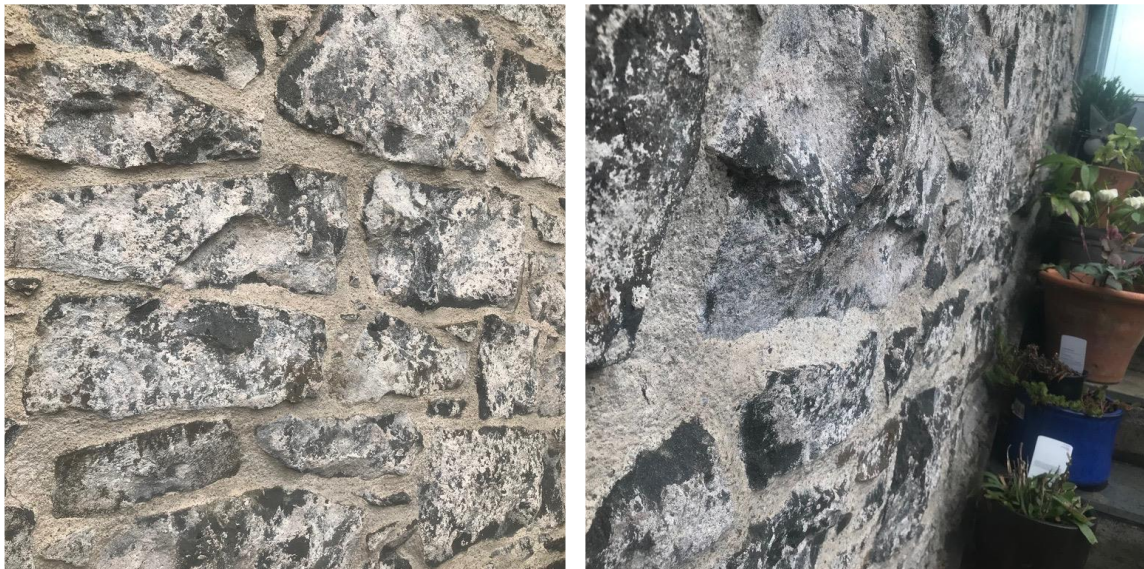
Figure 2.18. Irvine Place, Stirling. The crudely squared basalt, with open ledges.

Within the survey the type and style of the stone was seen in context. The on-site evidence demonstrates the difficulty in working the stone by hand (Fig. 34). It is too hard to work with a broaching iron; instead it is crudely squared using a mason's

walling hammer, the percussive action of the hammer removing spalls of the stone much as flint might be knapped. The resultant block is sufficiently square to enable placement in the wall but insufficient to leave a wall face with a flat, vertical, outward plane. The face edge of blocks undercuts the plane of the wall, resulting in ledges and hollows at the intersection of each placed stone (Fig. 2.18). At the interval between stone and mortared joint the potential for water penetration is great because of the differential in the porosity of the stone (Hall & Hamilton, 2015) and mortar (Stefanidou, 2010; Branco, *et al.*, 2021). By combining the on-site evidence, the presentation, science, and appreciating the requirements of taste and politeness, it was possible to overcome the epistemological constraint of the loss of finish. The gable and rear elevations were understood to have been harled.

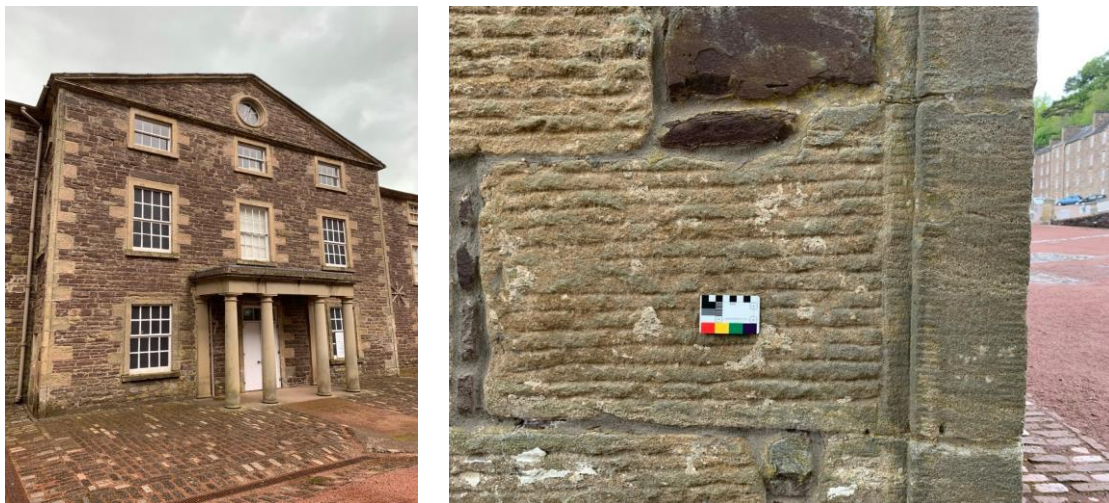
The inband-outband rybat tails have a less formal 'broached' surface, made with a chisel point, running raggedly along the complete length of the stone (Pride, 1996). The panel of masonry between raised details was filled with semi-coursed random length rubble with a hewn surface. On inspection traces of lime harl were found on the inband-outband tails woven into the rubble work on most buildings. It was concluded that broaching was a functional practice to reduce the depth of the 'tail' while maintaining the raised, droved face of the margin. The coarse texture left by the

process of broaching created a 'key' for harl. Harl was observed located in the broached track (Fig. 2.20). No traces of limewash were located on any raised margin droved surfaces within the New Lanark complex, so in this instance the aesthetic appears to have been one of harled surface framed by bare stone raised quoin. The greater survival of harl on the inband-outband rybat can be attributed to the quality of the stone used for the margin; the softer, dark red-brown surface having sloughed away, taking with it any surviving evidence.

Figure 2.20. New Lanark. Left: raised margin at the quoins and windows in the structural inband-outband. Softer red sandstone roughwork fills the space between. Right: raised margin with droved surface contrasted with broached tail. The tail retaining substantial traces of harl.

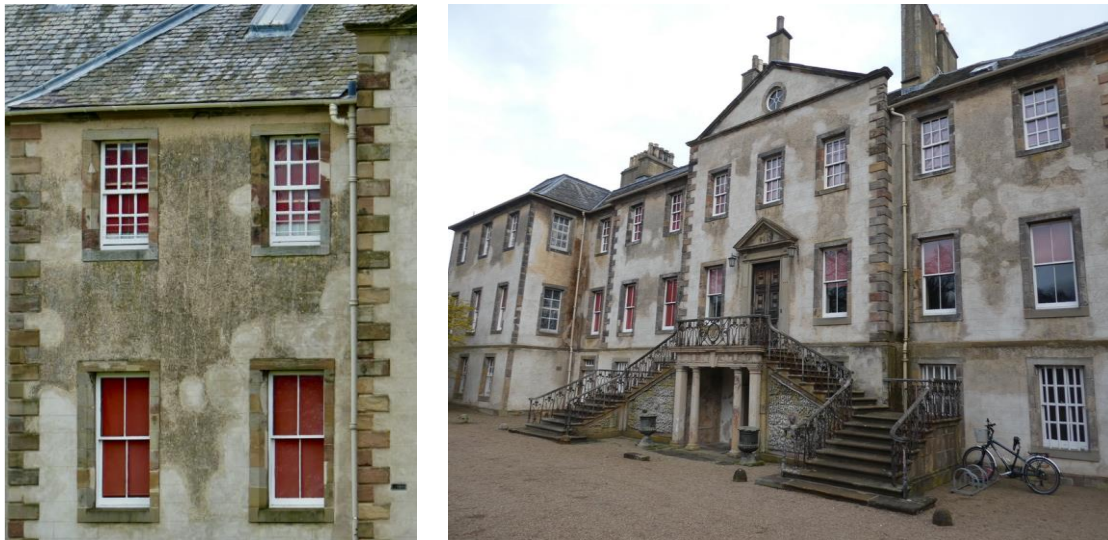
By comparing buildings where only fragments remained (in this case New Lanark) with other sites where finishes survived more completely, a more complex and nuanced understanding of the vestigial remains was possible. At Newhailes House, the surviving lime plaster covered the rubble work and inband-outband rybat tails, demonstrating that the finish was contained within raised details and providing some indication of the intended presentation at New Lanark. The Newhailes details fall into two categories: the raised margins similar to those found at New Lanark and raised rusticated quoins.

The ruled plaster terminated approximately 3mm–4mm below the level of the droved surface of the raised margin. A small shadow was cast by the margin onto the plaster. The upper surface of the raised rusticated quoins was greater still than the upper surface of the margins and cast a deeper shadow onto the plastered surface. The intention was that the margin and raised, rusticated quoins should be seen distinctly (Fig. 2.21). Because they are raised, the plaster is contained within the details so is protected from wind-driven rain and provides a nuanced aesthetic of light and shade: functionality and presentation combined. Throughout the survey, all margins raised above the plane/surface of the harl.

Figure 2.21. Newhails House, Raised margins and raised rusticated quoins.

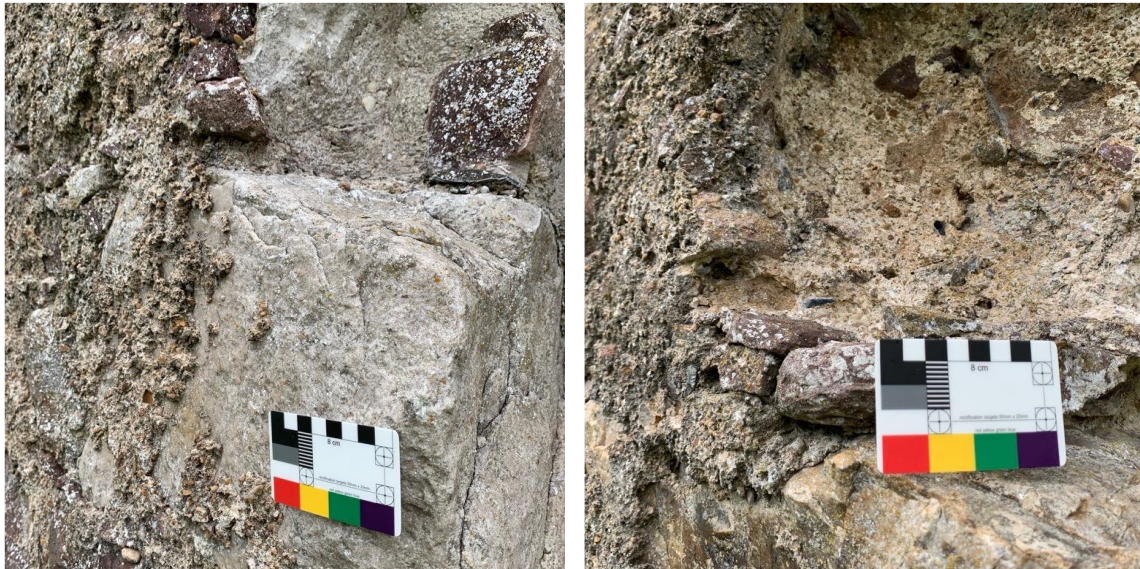
Throughout the survey a trend emerged at early sites: a visible relationship between the building mortar and the harling coats. The two are contiguous and integrated (Meek & Adderley, 2019; Addyman and Meek, 2019; Meek 2020; Meek, 2022) (Fig. 2.23), indicating that the finish had been applied during construction. The relationship between finish, bedding and core is explored in detail in Chapter 3, where thin section petrographic analysis explains the relationship of building and wall coating mortars, and what impact the process had for the survival of relict mortars. The consequence of this survey outcome adds a new dimension to dating finish, where there is a known date for the construction of the monument. Identifying a visual relationship between the two confirms a date for external coating with that of building. Dating mortars utilising radiocarbon analysis has gained increasing importance but is reliant on calcining  $\text{CaCO}_2$  with timber or charcoal (Thacker, 2020). Moreover, the process is time consuming and expensive and beyond the scope of small projects with budgetary constraints.

Figure 2.23. Left: Ardvreck Castle. Right: Calda House, Sutherland. Harl contiguous with the bedding mortar.

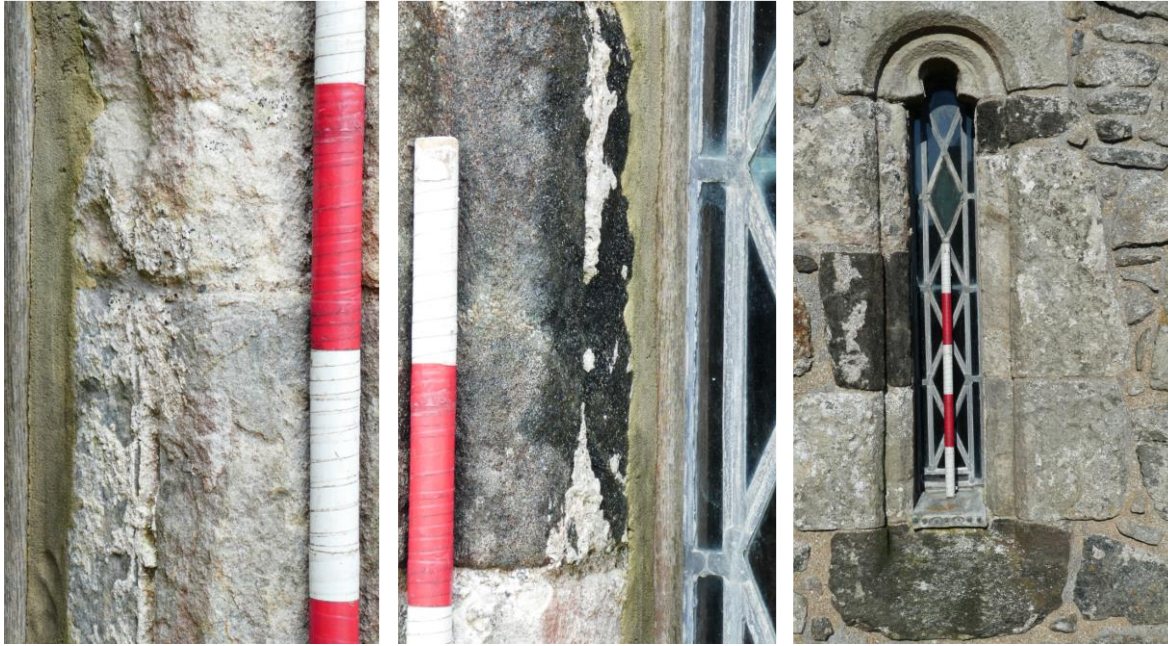
Figure 2.24. St Clement's Rodel. Fine plaster and limewash folding around the decorative components into the glazed area.

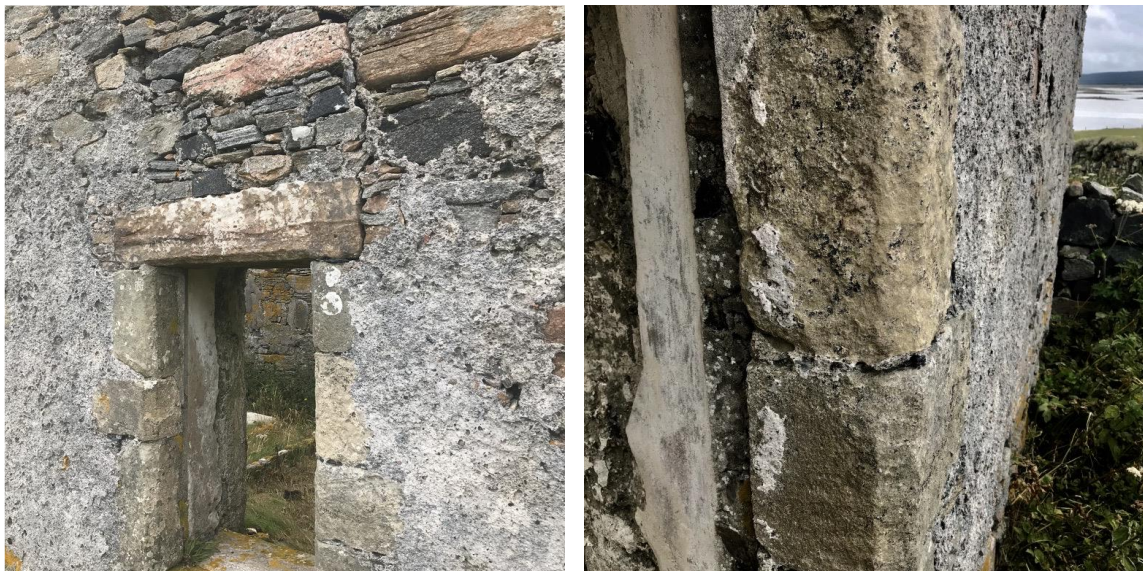
The chamfered margin in the early eighteenth century appears to be an anachronism, once used in the Scottish tower house. In this context the harl remained a thick, coarse coating on the wall face, 'feathering out' at the intersection of the general wall plane and chamfer. In several examples, such as Old Vallay House (Fig. 2.25); Harbour Building, Portsoy (Fig. 2.26); Brodie Castle and Coxtan Tower, Moray Shire; Craigievar Castle, Aberdeenshire; and Howan, Egilsay, Orkney (Addyman & Meek, 2019) harl again transformed to finer plaster with subsequent overlying limewash, taken into the window frame. The evidence suggests that this was a conscious act to maintain the angular form of the opening while ensuring the functionality of a covered, seamless surface at a vulnerable junction.

Figure 2.25. Old Vallay House, Uist. Harl approaching the chamfered margin. This then folded around the detail as a finer plaster, as evidenced by the remains in the more sheltered window opening.

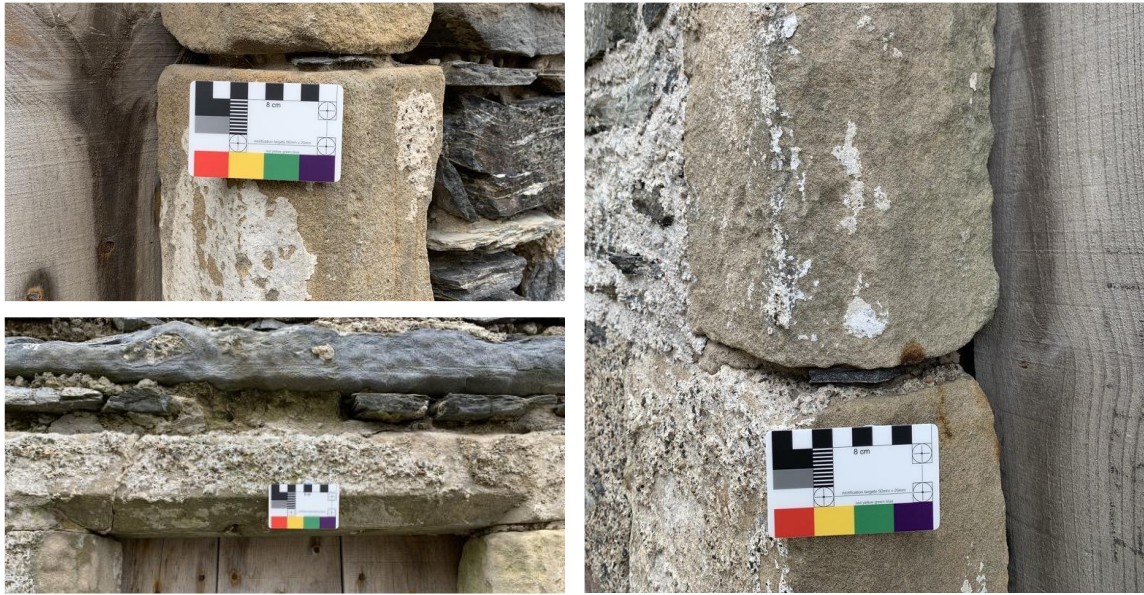
Figure 2.26. Harbour building Portsoy. Harl approaching the chamfer then folding around as fine plaster and limewash.

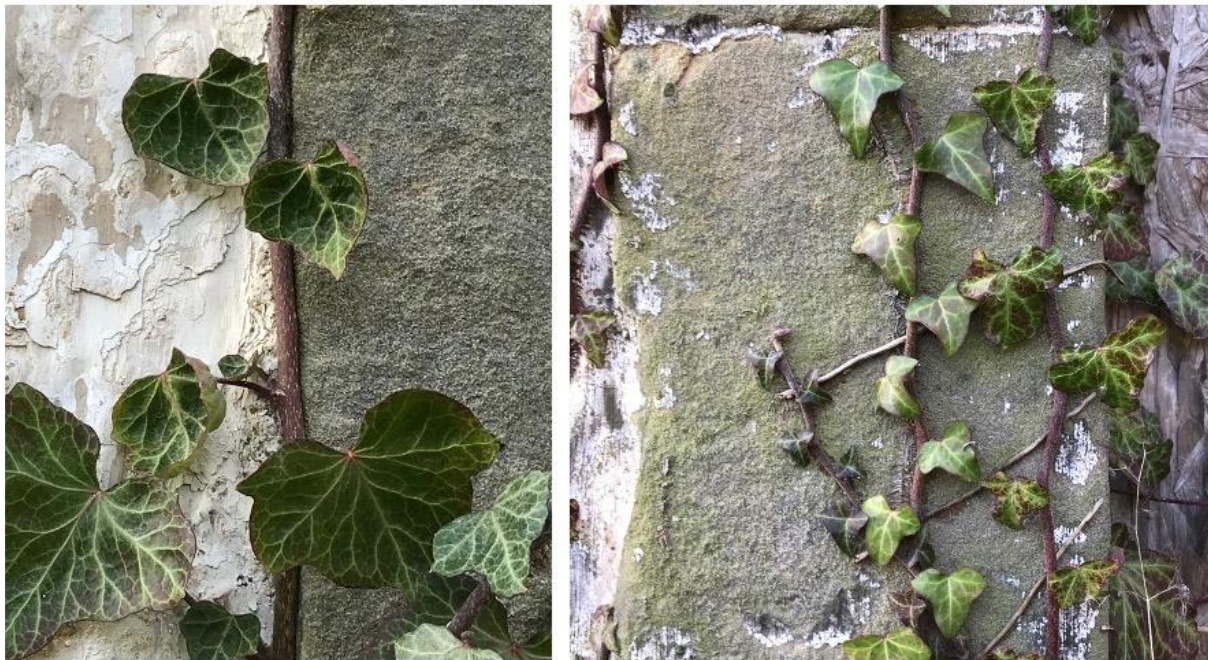
Figure 2.27. The Old School House, Charlestown, Fife. Multi-layers of limewash on the harl with traces still clinging to the raised margins.

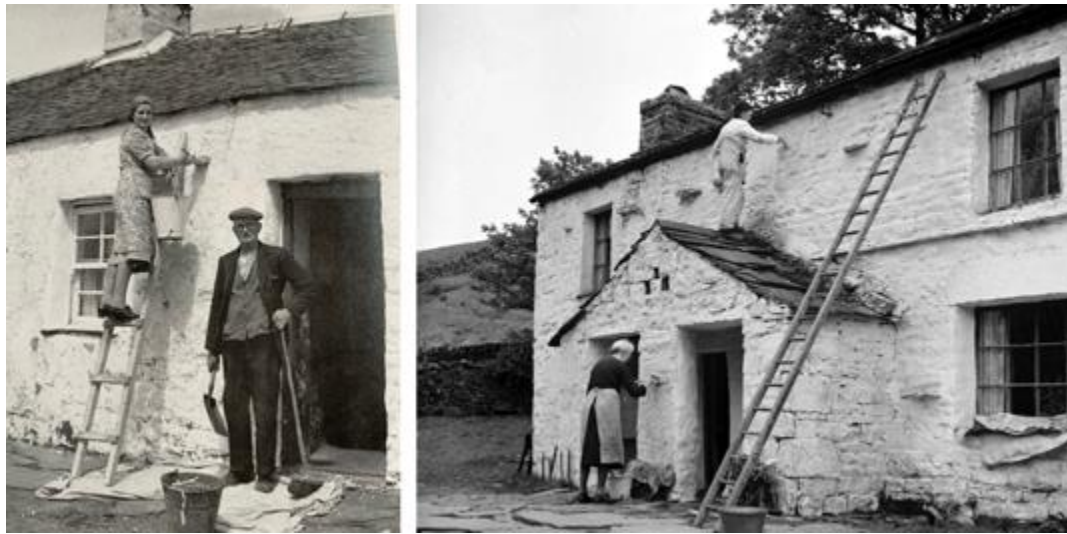
The paucity of physical evidence was not matched by the desktop study. Early photographic images primarily record daily life, but on occasion it was possible to recognise the practice of limewashing (Fig. 2.29). Recordings of slum clearances in places like Leith, for example, provided a more widespread and underlying sense of what has been lost. Examples of early photographers would be Thomas Annan's images of Glasgow (National Library of Scotland, 2019), Thomas Keith's images of Edinburgh (Hannavy, 1981), Alasdair Alpin MacGregor's of the Highlands and Islands (Kidd, 1992) and, more generally throughout Scotland, Erskine Beveridge (Ferguson, 2009). By comparing the physical evidence with photographic material it was clear that the practice of applying limewash in key isolated areas that required constant maintenance was widespread, particularly at street level and around doors and windows (Fig. 2.30). This strategic limewashing was likely to have been practised from an earlier period, as the Vermeer painting of c.1658 suggests (Fig. 2.31). An illustration of the early accidental recording of limewash is the world's first photograph of a human taken by Daguerre in 1839 (Metropolitan Museum of Art, 2004), depicting

Figure 2.29. Photographic record of limewashing. Left: Alasdair Alpin MacGregor, courtesy of National Museum of Scotland. Right: courtesy of North Yorkshire County Record Office Online Shop, Emily Ward.

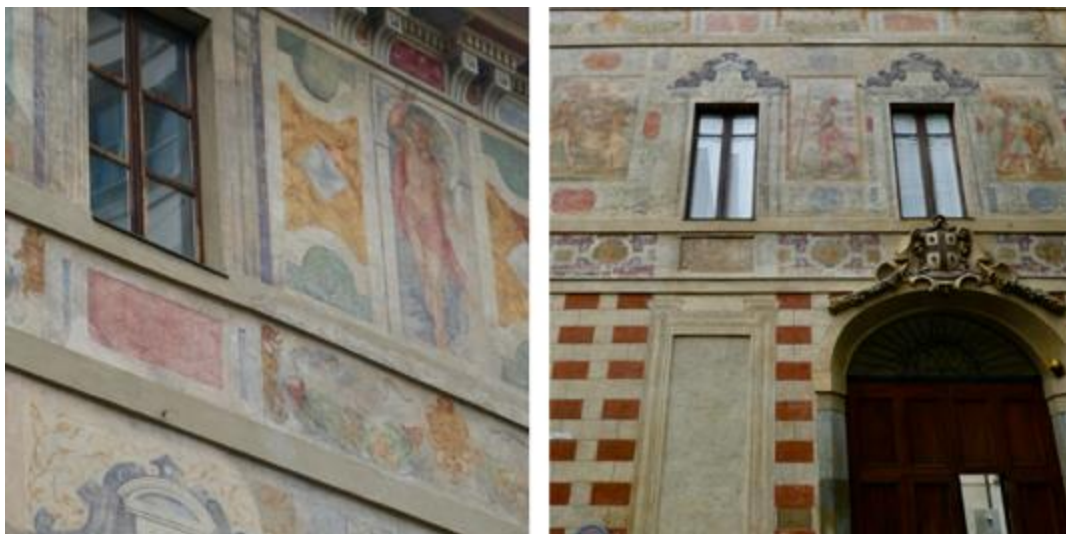
All evidence of the use of colour was scarce, so locating documentary evidence was highly valued. This extract describes 'marbling', 'colouring', and the imposition of ordered regular 'ashlar' joints onto the plaster applied to the rubble masonry of the Netherbow, Edinburgh, which was decorated for the arrival of Anne of Denmark on her marriage to James VI, c.1590. While the building was demolished c.1764 this indicates a willingness to create formal finishes on informal roughwork. No complete Renaissance external finish survives in the UK (although internal polychromatic schemes, including 'ashlar' work, are not uncommon, for example St Mary's Church, Berkely, Gloucestershire), but the example in Figure 2.33 (Fig 2.33). gives a sense of what it may have looked like. As the chapter demonstrates, the process of making

Figure 2.33. 'Marbling, ashlar and colouring', the conserved Palazzoo Scaglia di Verrua, Quadrilatero Romano, Turin, Italy.

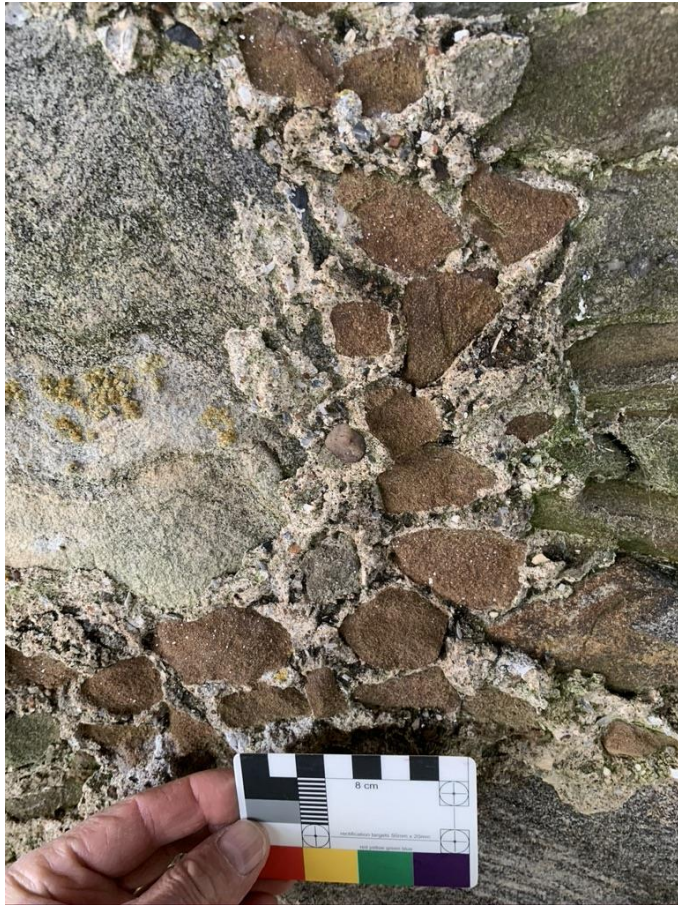
The refinement in wall preparation was commensurate with a noticeable thinning of harl. At Fairburn Tower (stair tower) the masonry was made up with regularised blocks at the quoins and more rounded boulders in the mass of the wall. At the rounded intersection of the stones the hollow was made up with cherry-cocks/gallets. To maintain bond on the course above, spacing was maintained by pinnings and cherry-cocks. At The Stables, Cromarty, the process is more developed, facilitating a flatter wall plane (Meek, 2020, pp. 4–7). In its ultimate form, the cherry-cock/gallet was to become a decorative component in the nineteenth-century as complete finishes gave way to the preference for pointing bare stone (Meek, 2022).

Figure 2.34. Fairburn Tower, Inverness Shire. Seventeenth-century packing out of wall surface. Closely packed wall face.

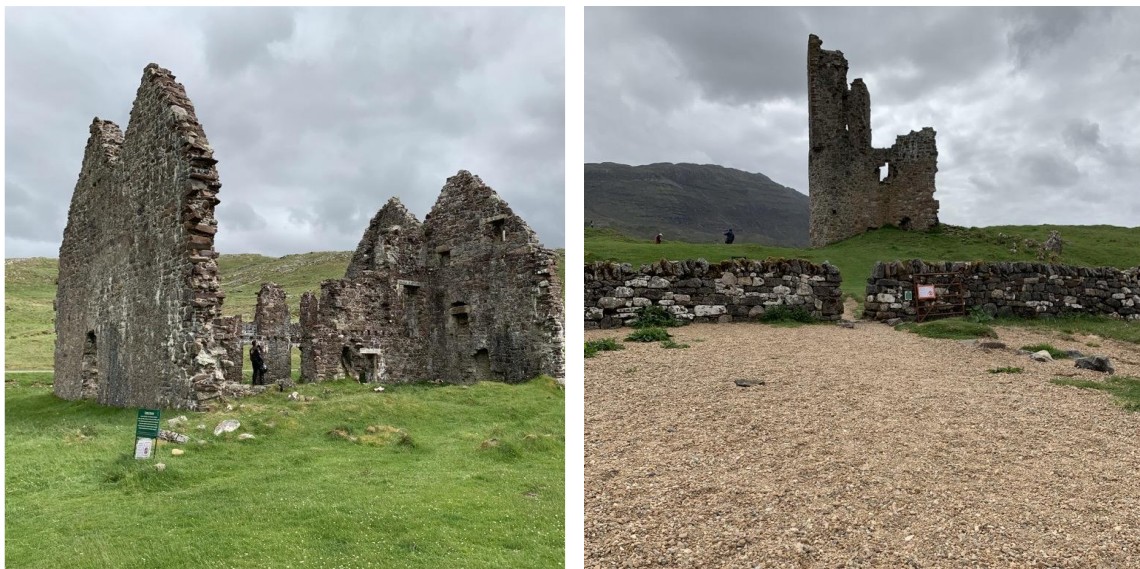
Figure 2.36. Left: Calda House. Right: Ardvreck Castle, Sutherland.

(<https://canmore.org.uk/site/4660/ardvreck-castle>) and its successor, Calda House (SM6533) c.1725 (<https://canmore.org.uk/site/4661/calda-house>) (Fig. 2.36), the former being an example of a late Medieval tower house and the latter the first symmetrical house noted in the Highlands and known as 'the White House'. What distinguished the two buildings is wall thickness: Ardvreck Castle in the range ~900 mm in window areas and between ~1.3 m--2 m elsewhere (Fig.53); Calda House in the range ~850--650 mm generally (Fig. 54), diminishing to ~250 mm--300 mm under windows and in the area of external flues. The construction of Calda marks the introduction of Palladianism into the Highlands, with narrower walls and multiple larger windows.

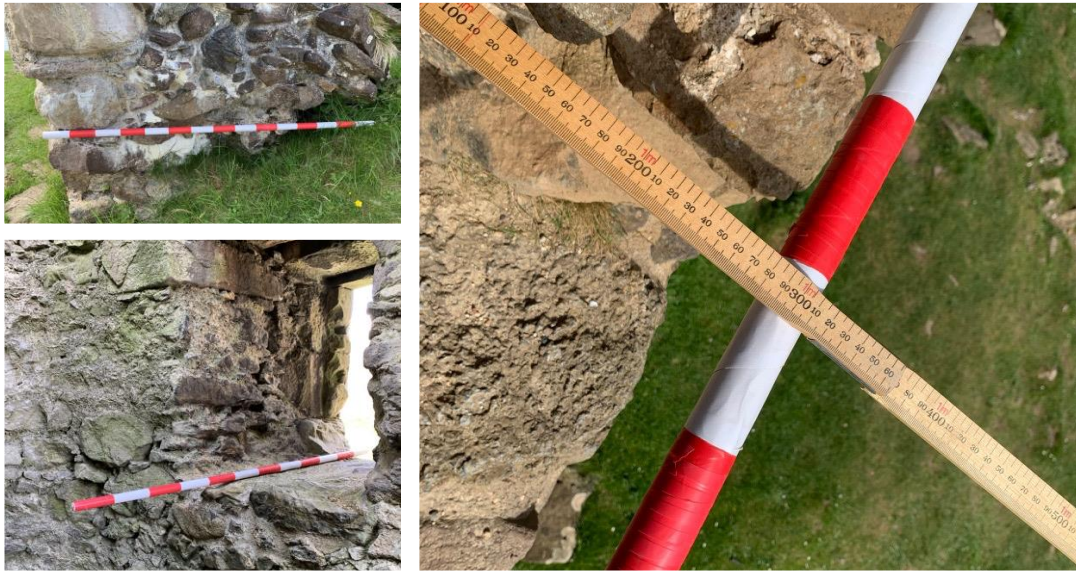
Figure 2.37. Wall widths at Ardvreck Castle.

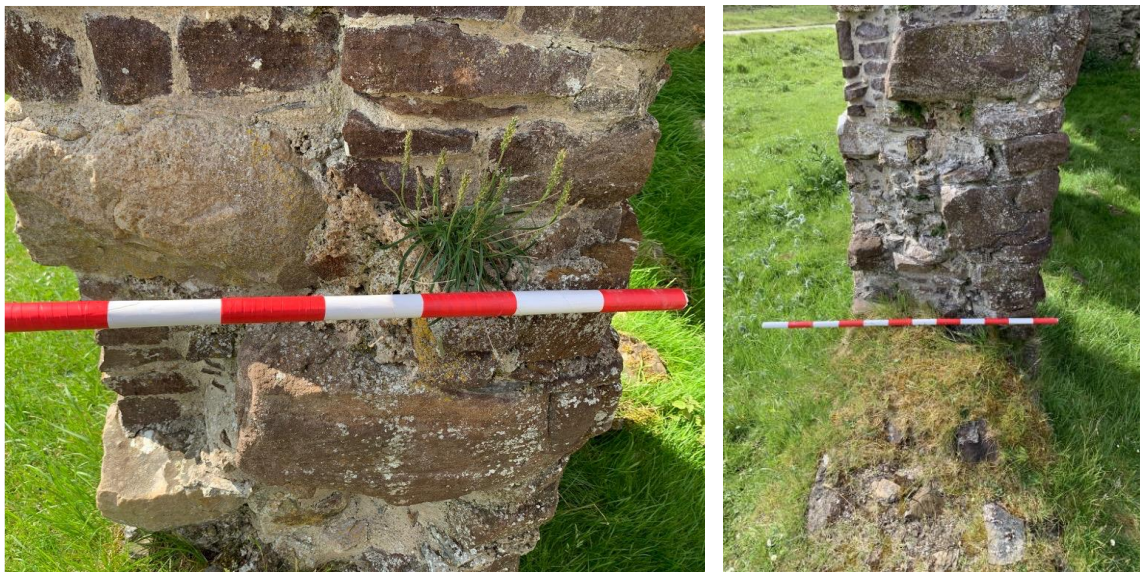
Figure 2.38. Wall widths at Calda House.

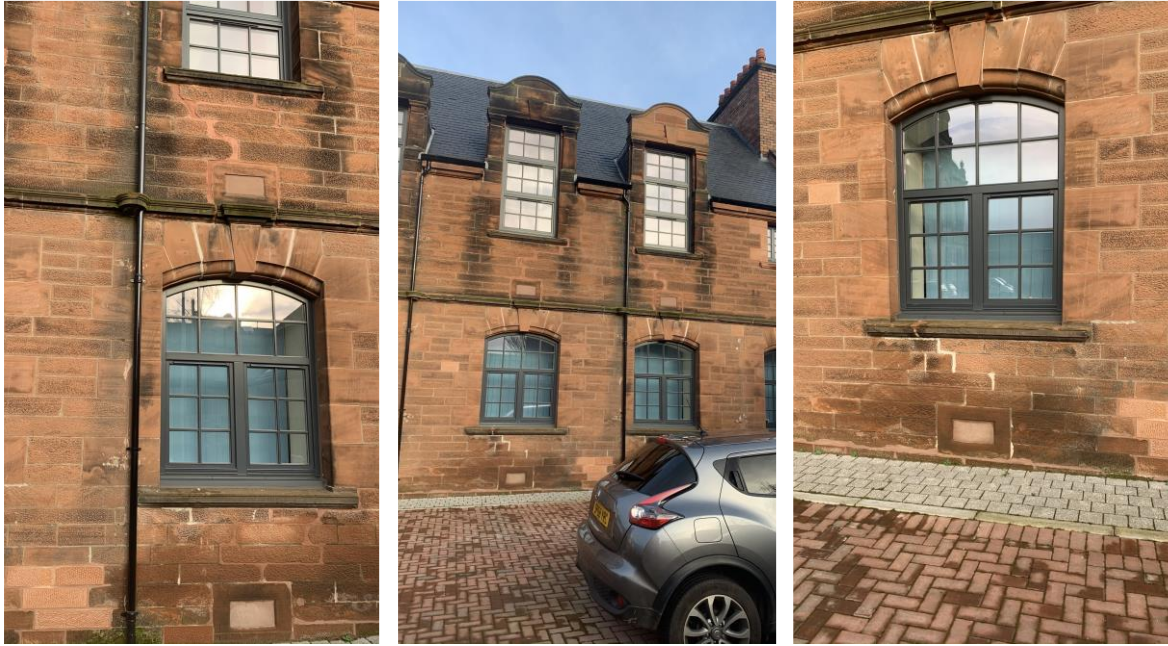
Figure 2.42. Structural issues in and around windows, Perth c.1900.

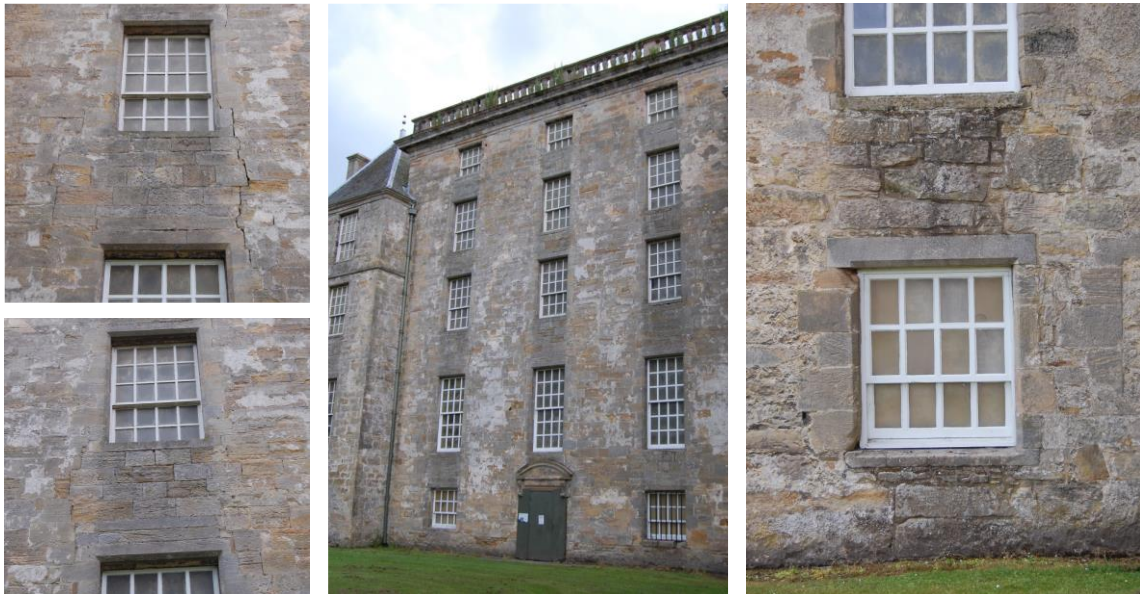
Figure 2.47. Kinniel House, Bo'ness, c.1553. Altered in the seventeenth-century to accommodate newly fashionable sliding sash windows.

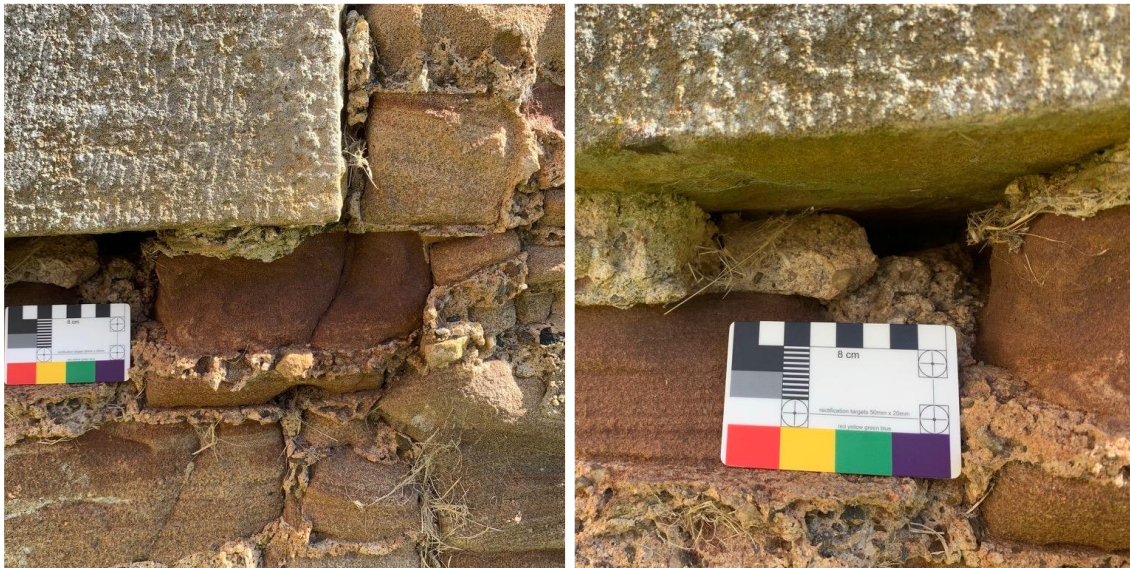
Figure 2.48. Support during the process of levelling sills.

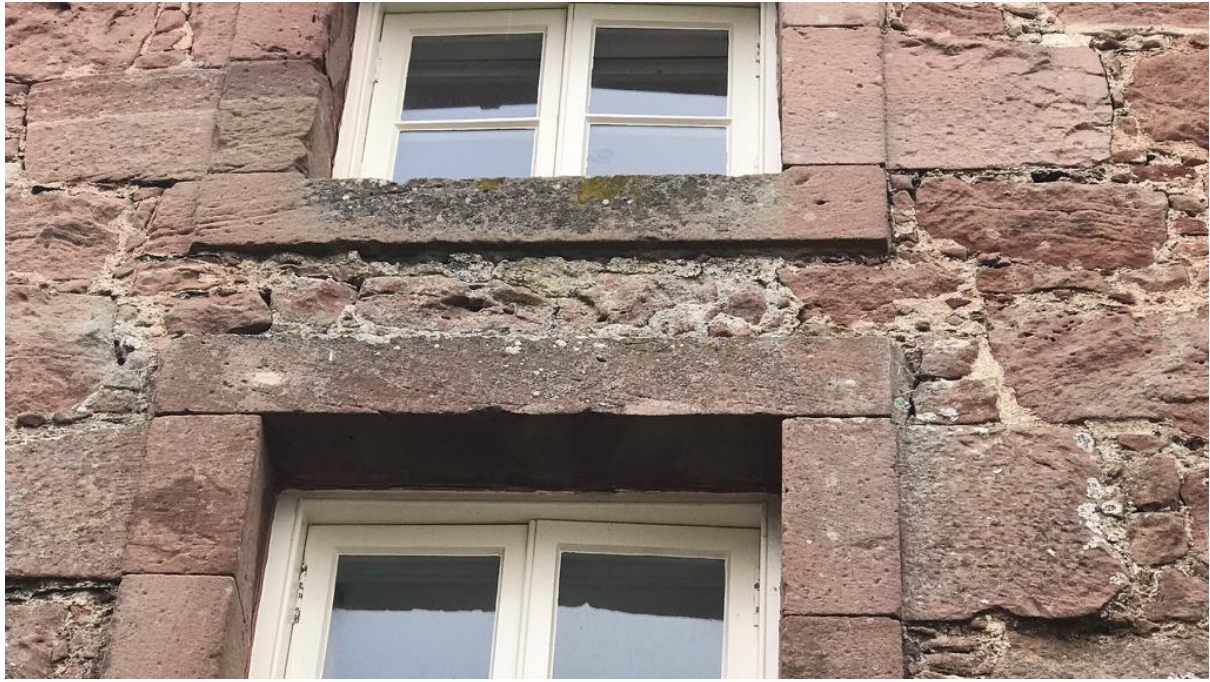
Figure 2.49. Retrospective under sill packing.

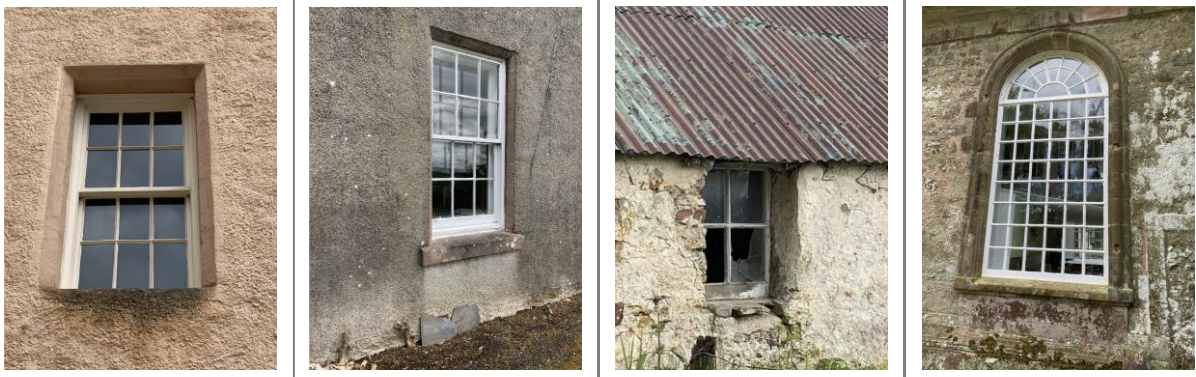
Figure 2.50. Rainwater discharge from glass onto the area below the window: an area of diminished thickness.

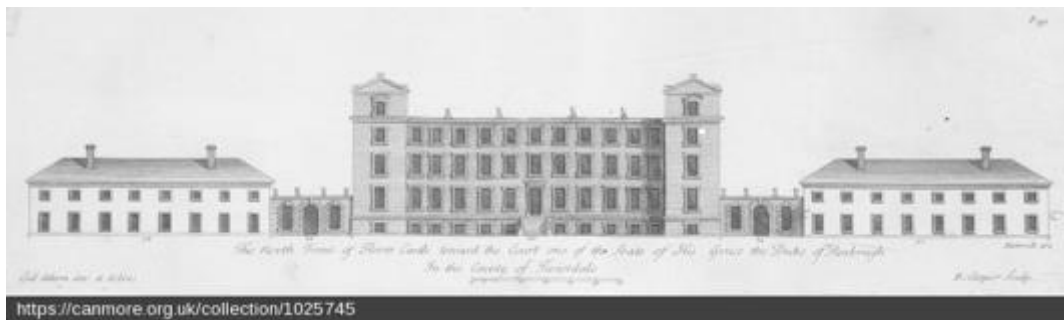
Figure 2.55. Floors Castle, Adam’s scheme.

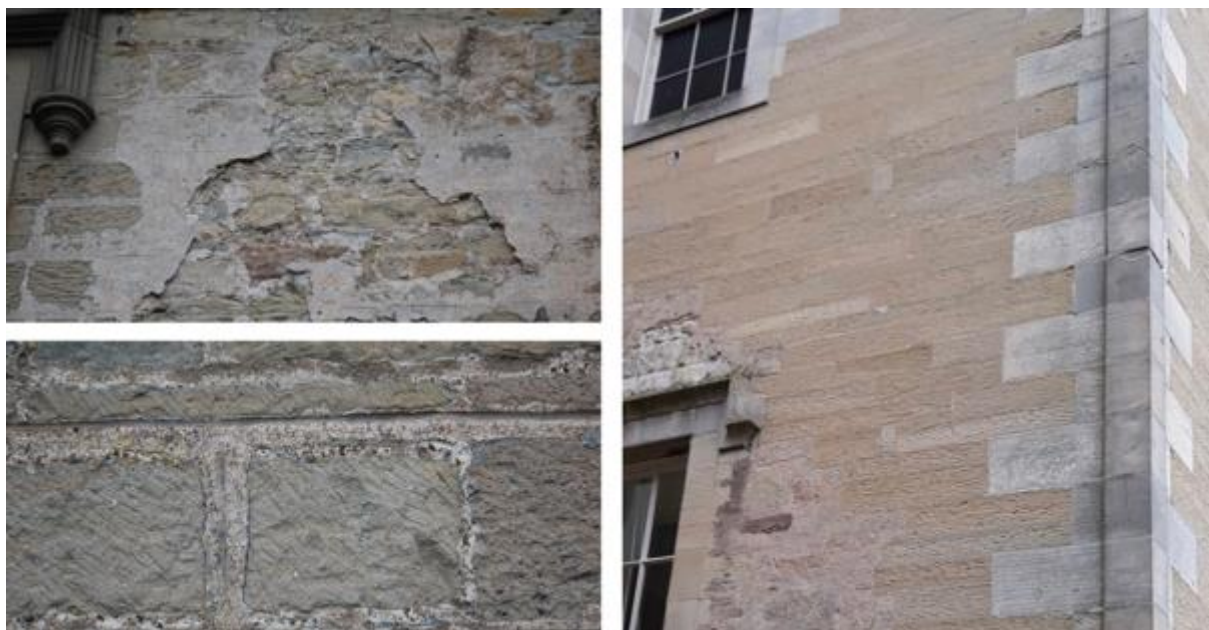
Figure 2.57. Top left: Adam's worn flush plaster applied to informal roughwork. Bottom left: Playfair's squared, coursed sandstone blocks with slaistered pointing. Right: Bryce's squared coursed, rustic ashlar blocks tying into Adam's informal roughwork.

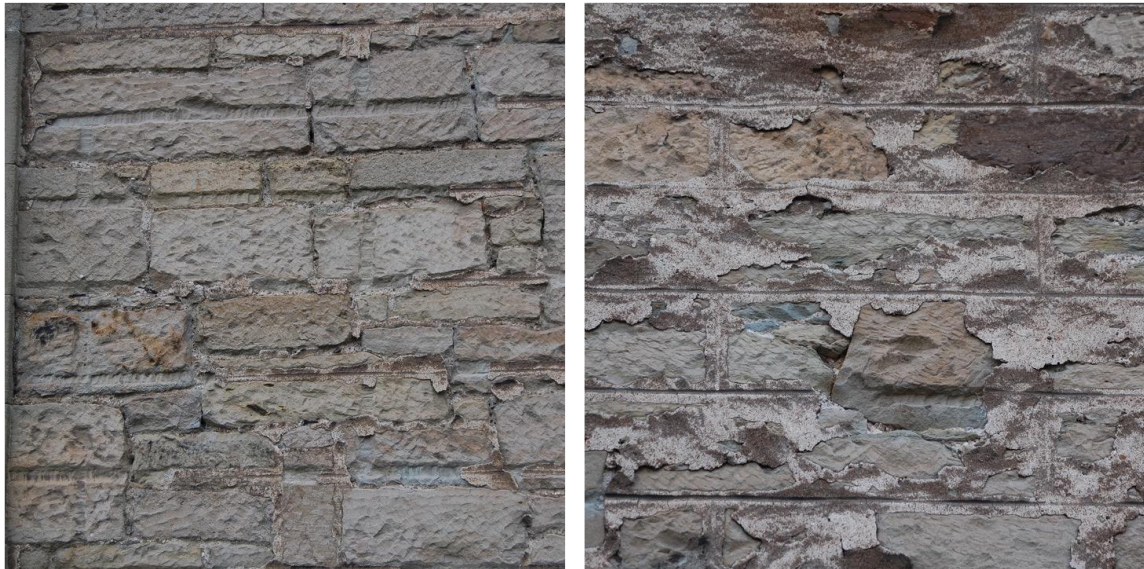
Figure 2.58. Adam's perpendicular and horizontal chasing of the wall surface, subsequently overlain with a thin, single coat, undulating plaster.

Accurate lines were facilitated by chasing out the underlying rough work (Fig. 2.58), a process already established in Europe in common brickwork (Fig. 2.59). The chasing out executed by Adam was narrow and deep. The chasing does not respect the natural joint lines of the rough work, often cutting through the central face of the stone. The process of chasing out the underlying masonry was the only example found within the study. Despite enquiries to the National Trust for Scotland (pers comm. Brian Dixon, Head of Buildings Conservation, NTS), The Scottish Lime Centre Trust (pers comm. Roz Artis Young, Director SLCT), Addyman Archaeology (pers comm. Tom Addyman. Partner. Simpson & Brown Architects and Addyman Archaeology), no other example is known in Scotland. Its use by Adam was thought to relate to extending the time needed to produce accurate ruling out, a deeper mortar contained within the chase remaining workable longer than the thin plaster.

Stylistically Adam portrayed the monumental scale of Floors with long blocks scribed into the mortar. The 'ashlar' plaster was ruled in the range ~837mm—~1408mm in length. The horizontal joint line intervals ~198mm.

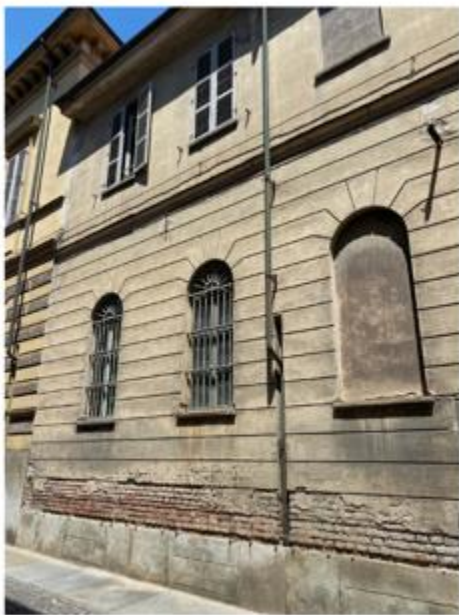
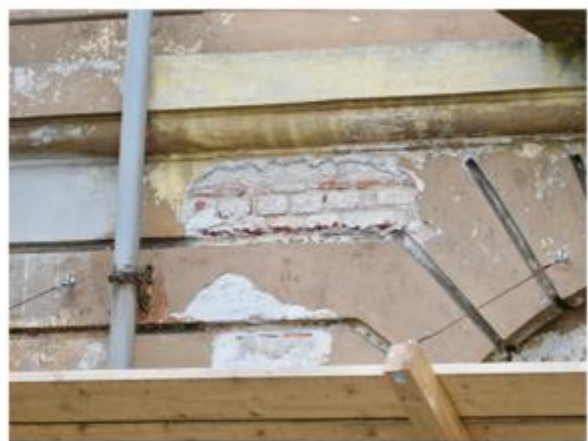
Figure 2.59. Horizontal chasing in common brickwork to form 'rusticated ashlar' in (left): Asti, Italy and (right): Turin, Italy. (Asti image credit Darren Mclean).

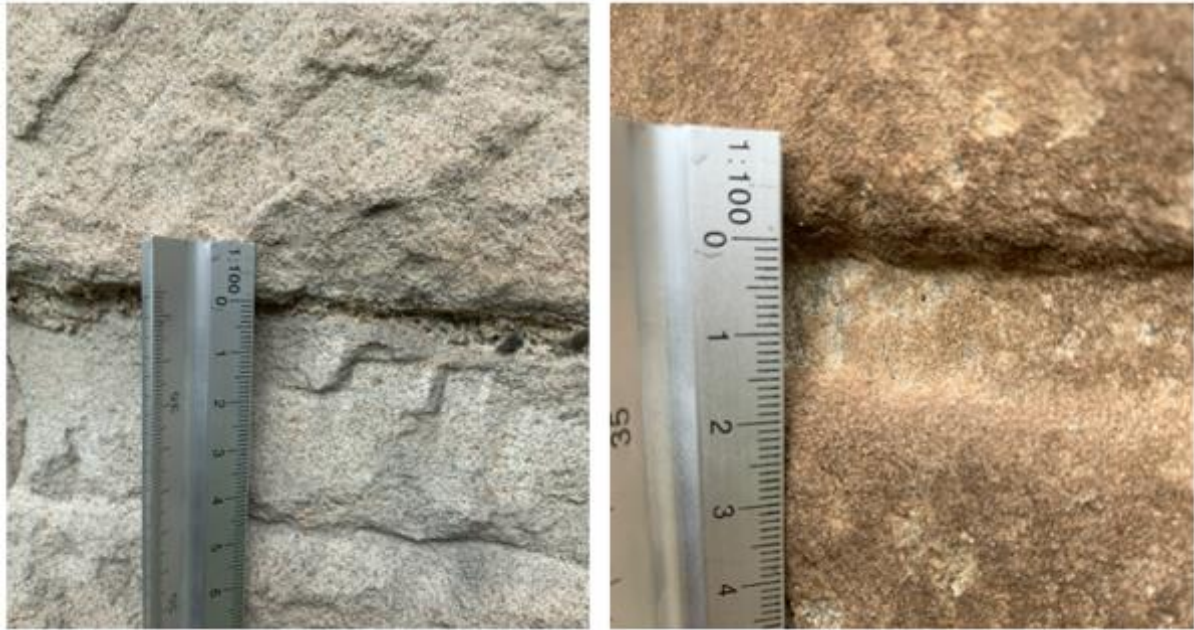
Figure 2.60. Left: the width of Playfair. Right: the chase width of Adam.

The work of William Playfair at Floors Castle (c.1837-1840) differs from Adam. Firstly, the underlying masonry is coursed, squared and droved rather than broached or stugged. Like Adam, Playfair also initiated a programme of chasing out the underlying masonry but this work, unlike that of Adam, is wide and shallow (Fig. 2.60). There were also differences in the monumentality of the ruled 'blocks'. Playfair considerably reduced the length to ~600mm--~800mm. The crucial difference was in the extent of the mortar covering the masonry. Playfair slaister pointed and ruled out the 'joint' lines, leaving the high points of the squared blocks exposed. This may represent a misreading of over 120 years of wear in Adam's work or a deliberate action to express the underlying masonry commensurate with the increasing trend towards displaying stone (Fig. 2.61).

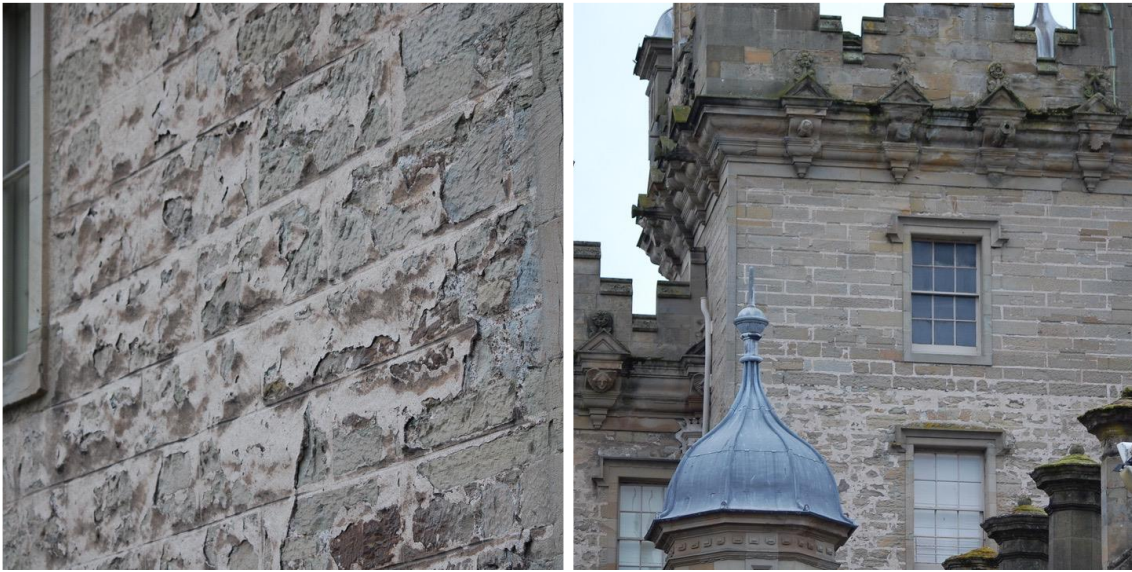
Figure 2.61. Left: decayed fully ruled out plaster, Adam, c.1721. Right: top of the tower, Playfair's work of c.1837. Evenly coursed, pointed and ruled out. Lower tower, Adam's work c.1723. Randomly coursed with fading plaster. This relationship corresponds with Playfair's watercolour scheme in Figure 2.55.

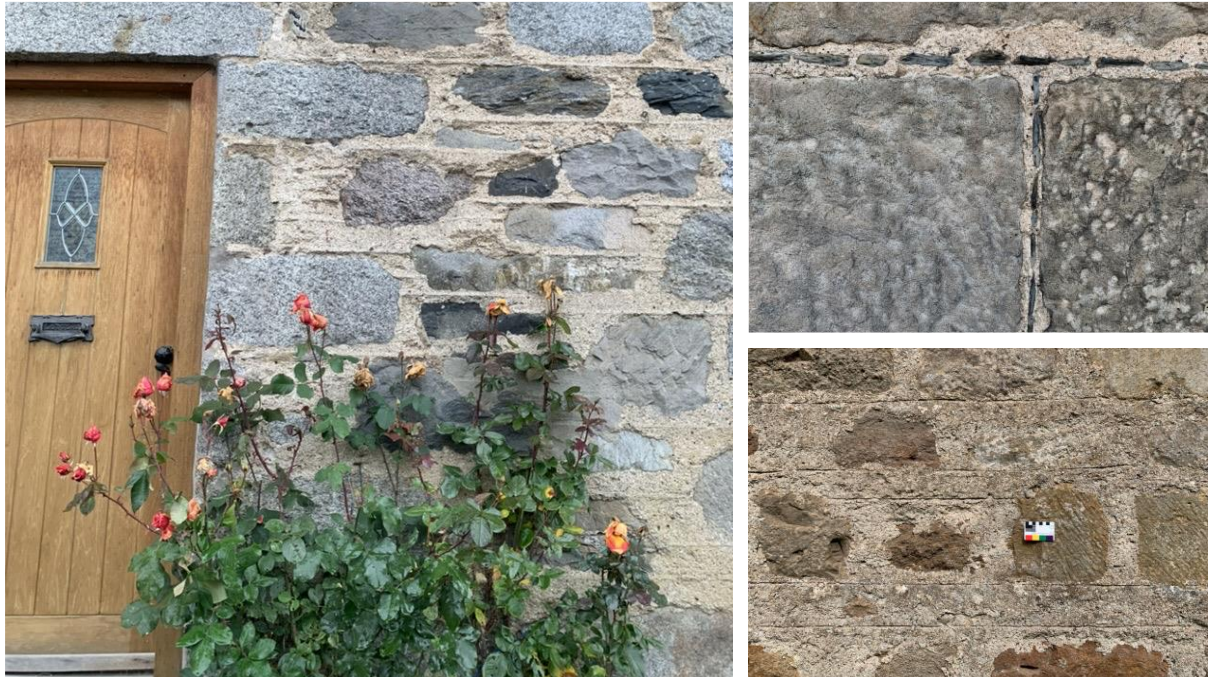
Figure 2.63. Formal, ruled out pointing styles.

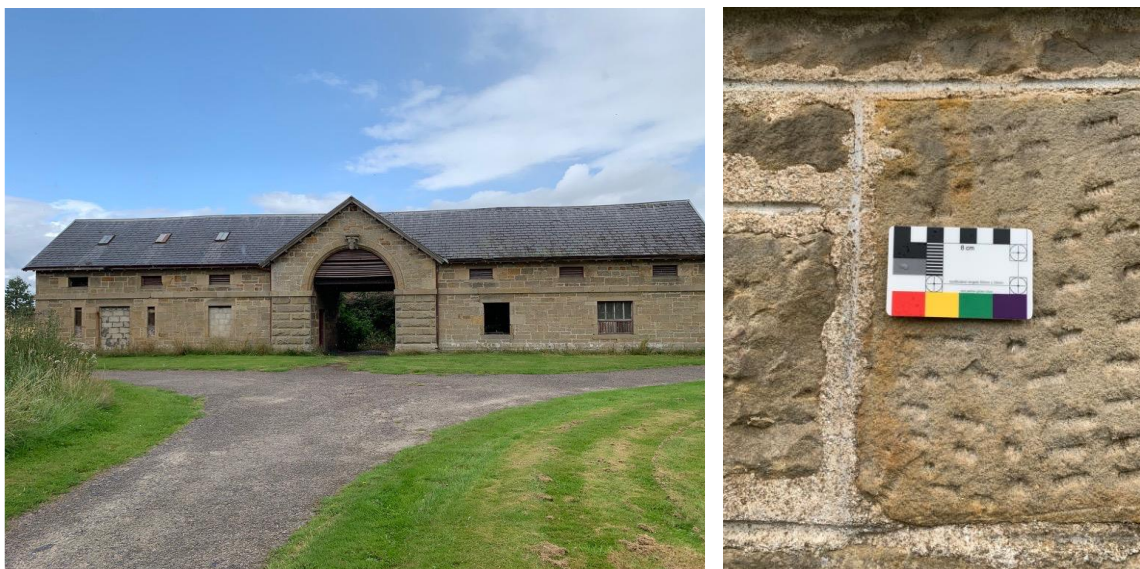
Figure 2.64. Lindores, Morayshire. The formal front (facing the house) with squared rusticated ashlar, lined out and white lined pointing.
