**Cultural and physical factors in the history and  
development of traditional external wall  
coatings in Scotland**

Timothy John Meek  
MA

Thesis submitted for the degree of Doctor of Philosophy

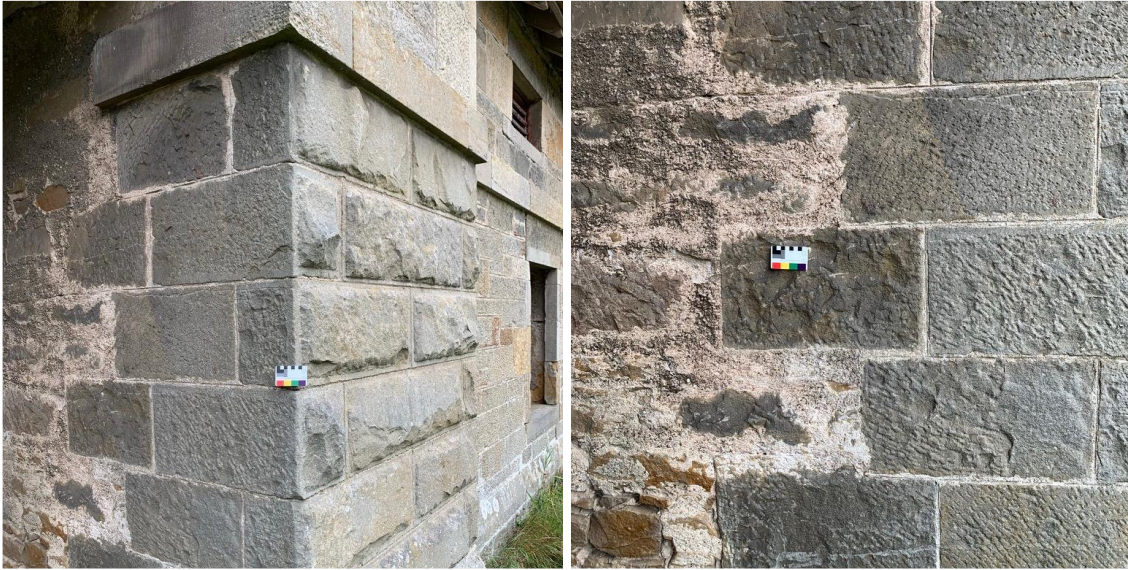
Figure 2.65. The junction where the main front elevation meets the worn harled side.

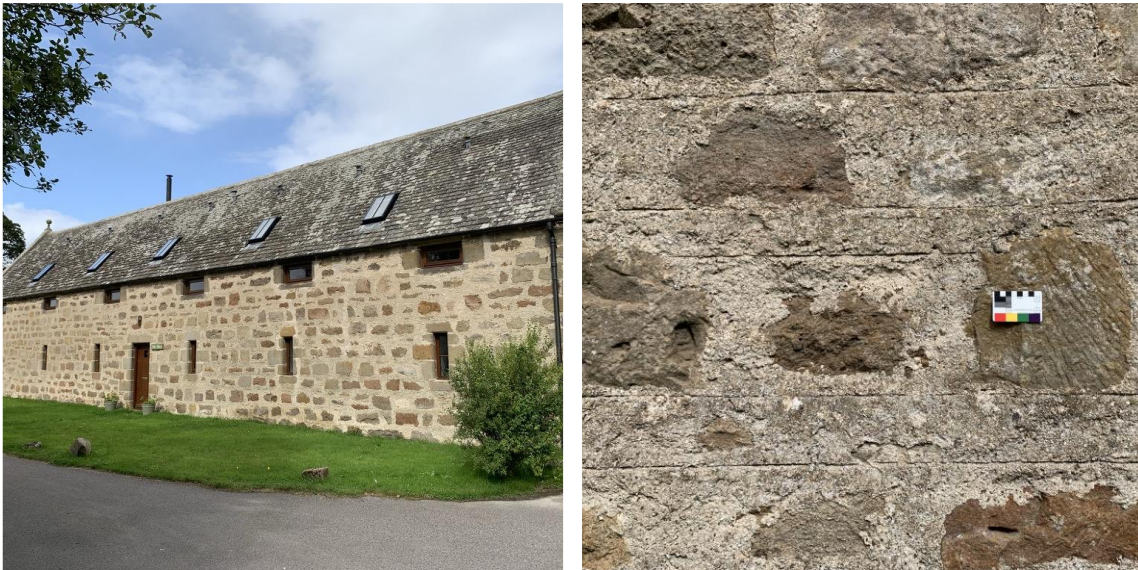
Figure 2.66. The Granary, sneck harled and ruled out.

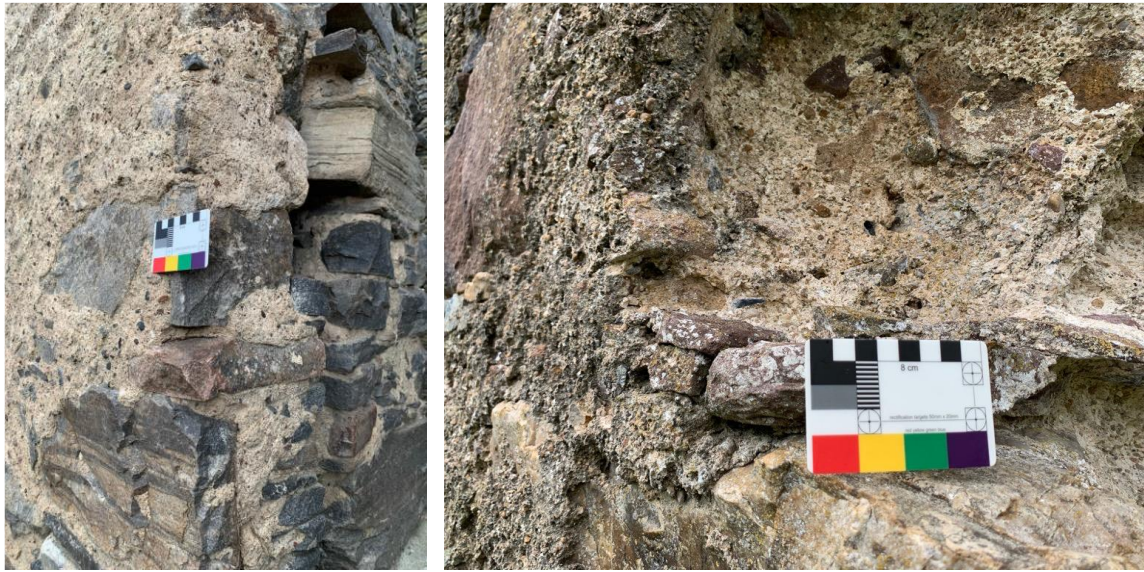
Figure 3.3. Ruthven Barracks. Core and bedding mortar spilling out to the surface as harl and exposed by stone robbing showing the finish during construction method.

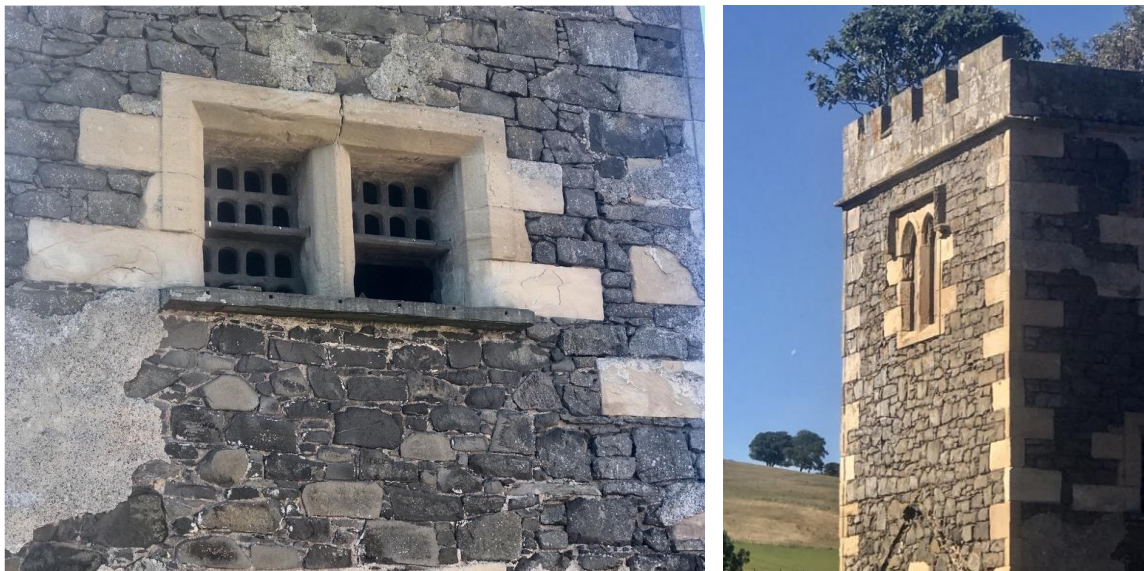
Figure 3.4. Grange of Lindores, c.1820, Newburgh, Fife. The isolated survival of post-construction application. Once the harl grades away, there is little surviving evidence of the former complete finish.

In contrast a different pattern of survival in finish was observed when the FDC was not employed. In general, fragmentary survivals of finish remained when post – construction applications (PCA) were made as can be seen at the Steadings, The Grange of Lindores, Newburgh, Fife (Fig. 3.4). The presence of detailed cherry – cocking/galleting also indicated a change in methodology from the FDC method to a PCA, for example, The Stables, Cromarty, Ross shire (Fig. 3.5). The difference between the two methods was clearest at the Ruthven Barracks (Fig. 3.6) The main block was constructed in c. 1721 while the stables were not completed until thirteen years later c.1734. During that time the FDC process was abandoned, and walls carefully built with cherry-cocks/gallets. No harl or internal plaster survives on the stable block, whereas on main barrack, relict samples are plentiful (Fig.3.4). The survivals on the main block take a singular form: the high point of the underlying stone peaks through surviving mortar which was connected to the joints.

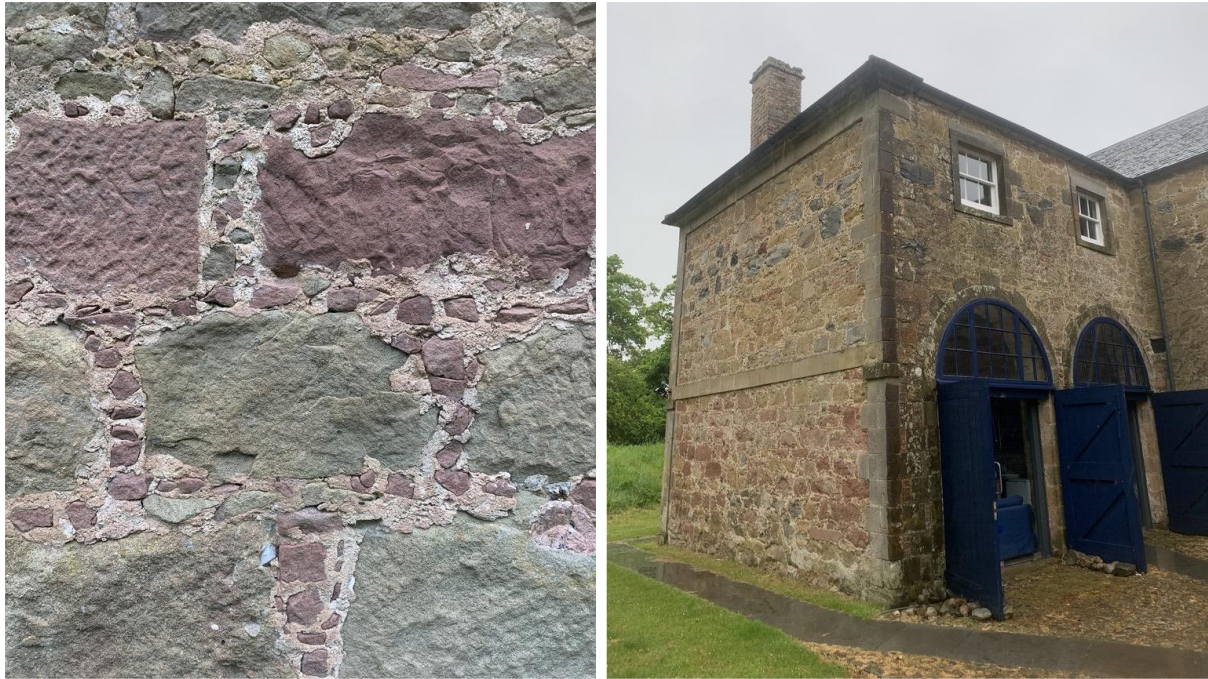
Figure 3.5. Cromarty House Stable Block c. 1785, Cromarty, Ross shire. In this example the joints between the stone survive well due to the cherry-cocking/galleting but the remains of the post-construction harl are scant.

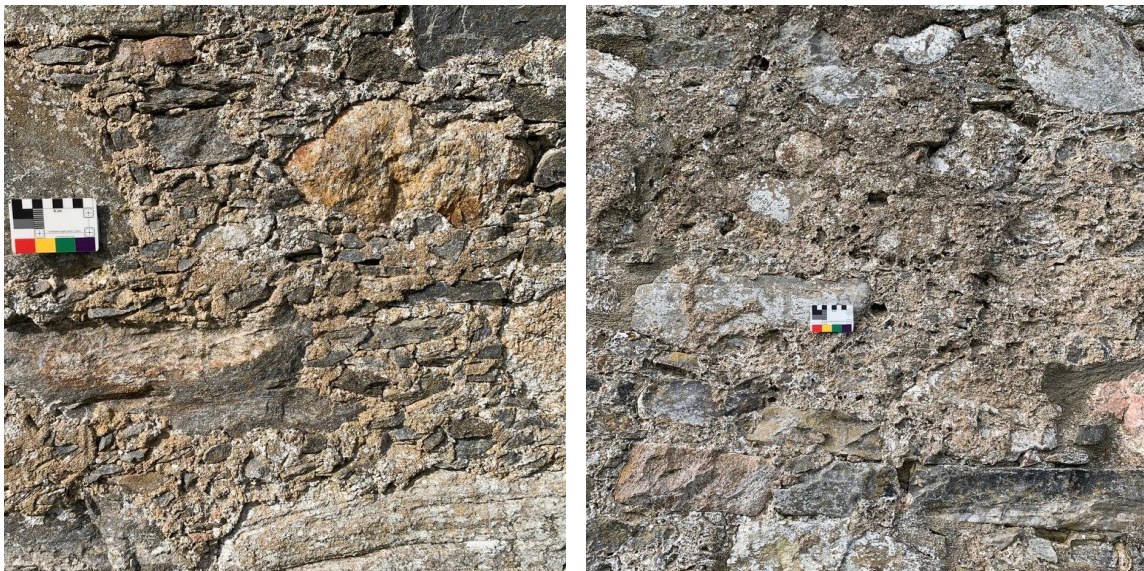
Figure 3.6. The Ruthven Barracks: Left, the Stable block, NE elevation with no remaining evidence of harl or plaster. Right, the Main Barrack block, NE elevation showing extensive harl remains contiguous with the joints, leaving the high points of the stone exposed.

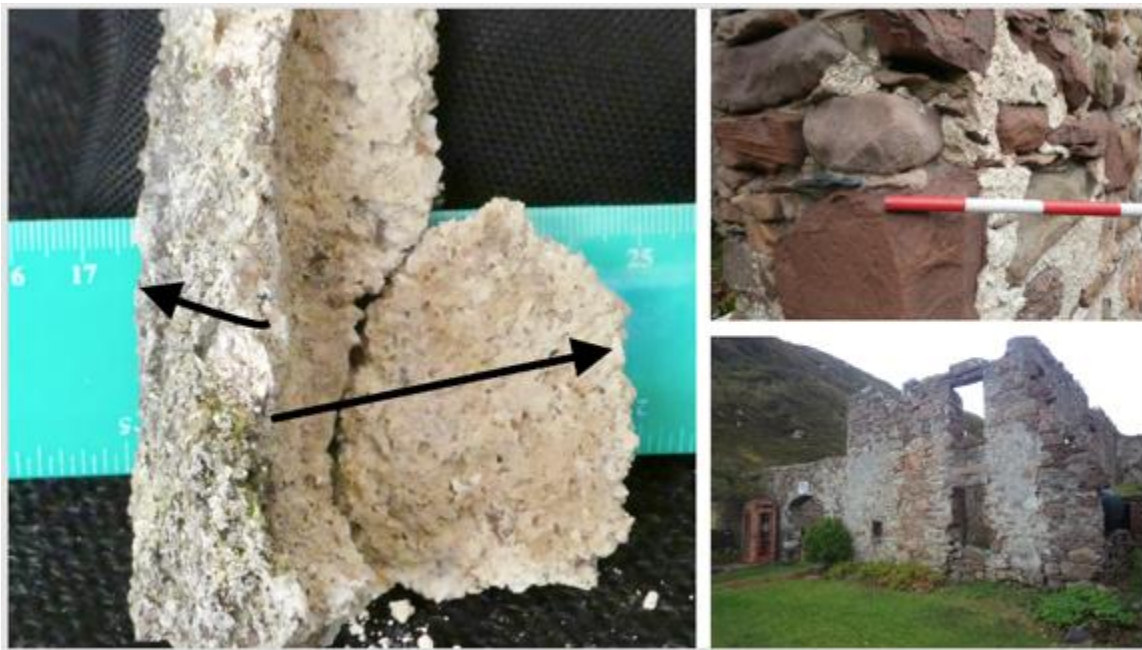
Figure 3.7. Fishing Station Tanera Mor. Harl and tail, right *in situ* harl.

During essential repairs at three sites, the eighteenth- century Fishing Station, Tanera Mor, Wester Ross (Fig. 3.7), nineteenth-century Lime Kiln, Port Ramsey, Lismore, Argyll and Bute (Fig. 3.8) and the pre-restoration recording at Fairburn Tower, Muir of Ord, Inverness shire (Fig. 3.9), a cross section of mortar within the joint, spilling out over the face of the stone, was removed intact illustrating the visual continuity of the material.

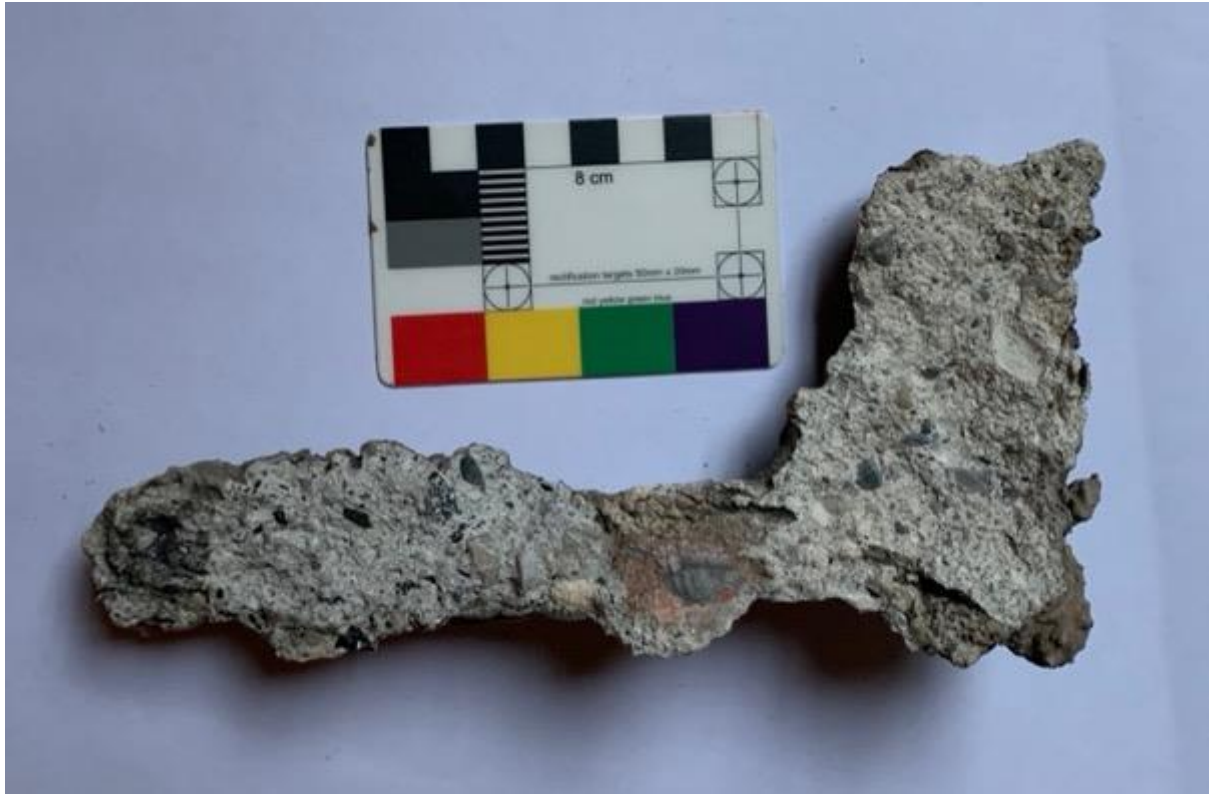
Figure 3.8. Bedding mortar (left) and harl (right) from the Lime Kiln at Port Ramsay, Lismore.

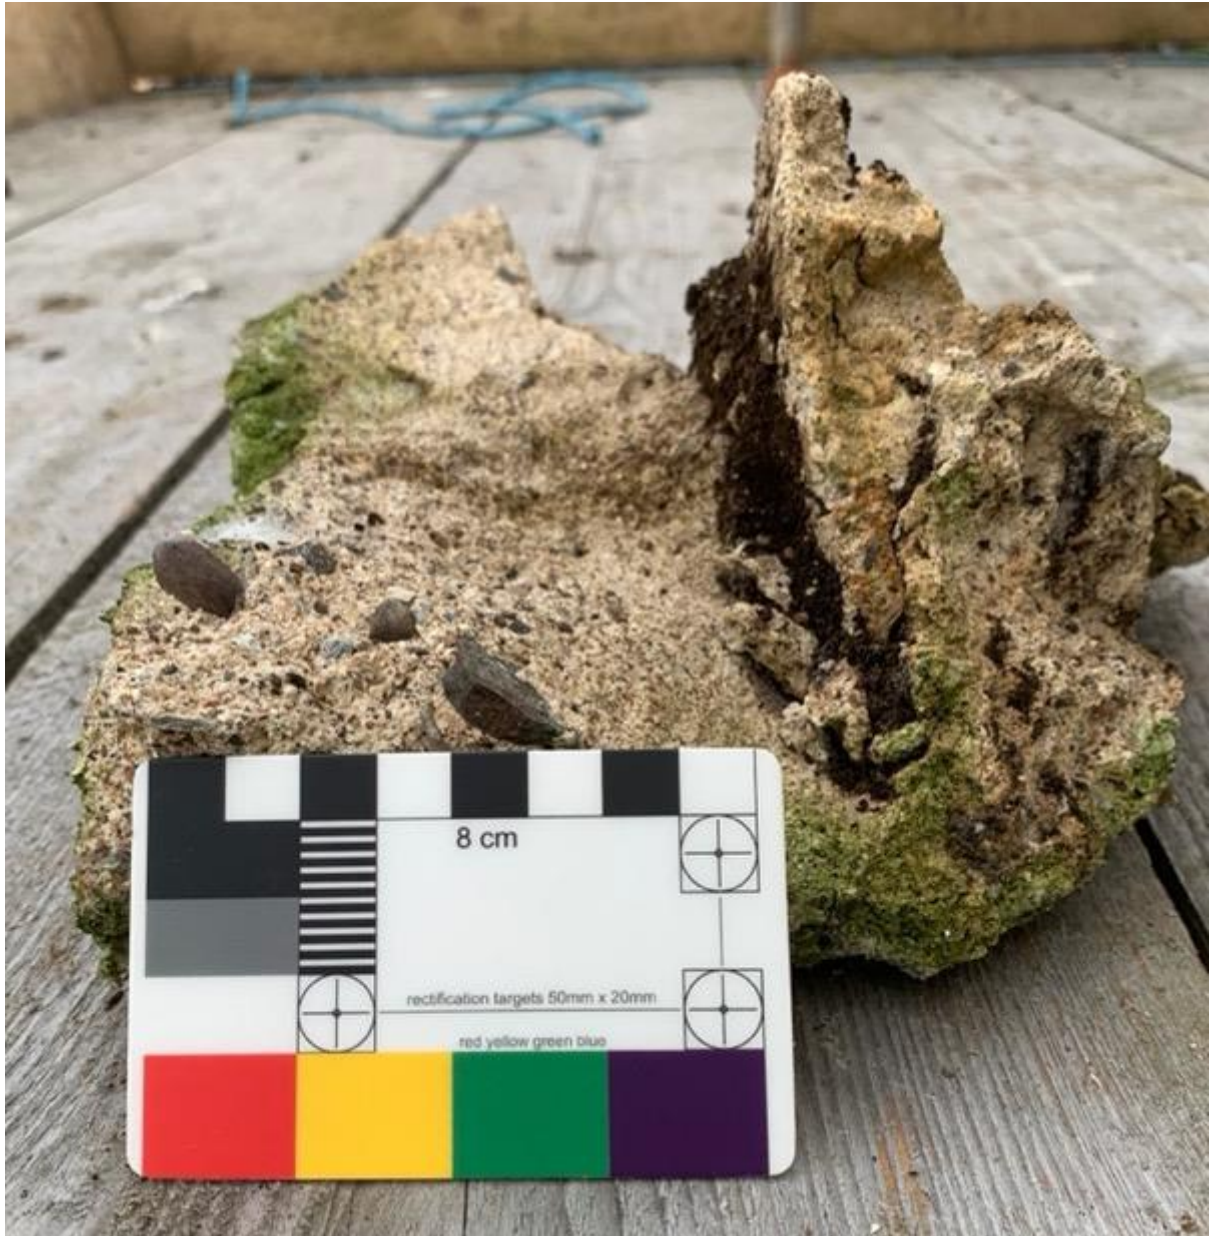
Figure 3.9. A section of harl (face down) and the ‘tail’ (standing upright) taken from a joint in the masonry from the Main Tower at Fairburn c. early sixteenth – century, Inverness shire.

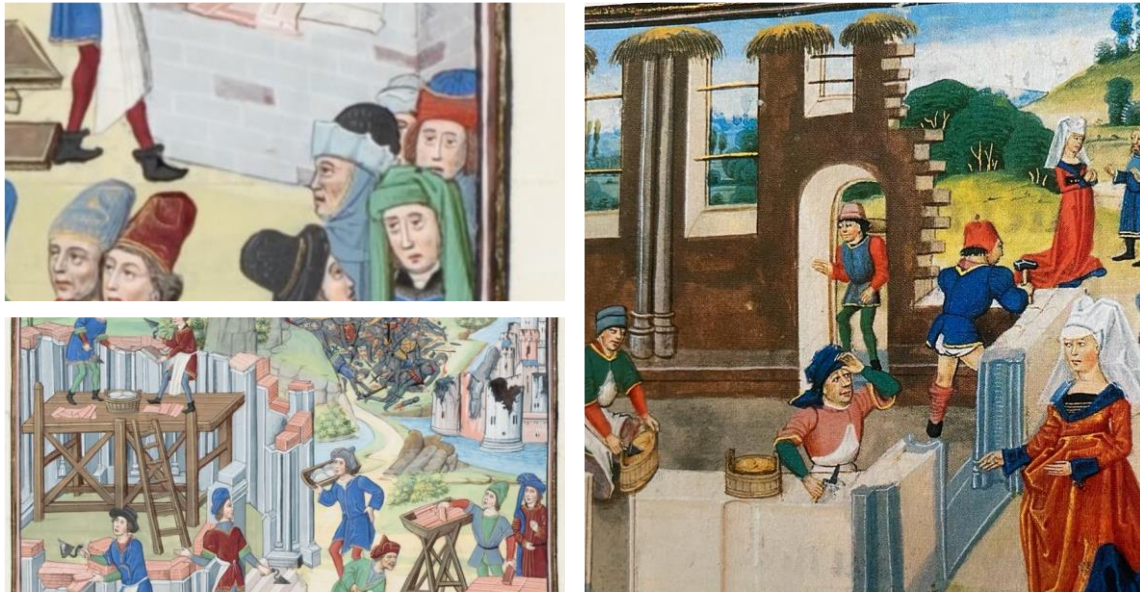
Figure 3.10. Illustrations from *Annales historiae illustrium principum Hannoniæ* c.1390 – 1396 showing the completion of building surfaces as work proceeds with wall head protection. Image credit Koninklijke Bibliotheek Royale, Belgium. [https://uurl.kbr.be/1894866\\_p345](https://uurl.kbr.be/1894866_p345)

Other sources provide compelling visual evidence of finishing walls during the building process. The Chronicles of Hainaut is an illustrated text produced c.1446 – 1450 of the *Annales historiae illustrium principum Hannoniæ* c.1390 – 1396 and shows the construction of a brick church with the internal – external plaster applied as work progressed (Fig.3.10). Significantly, the illumination also describes scaffolding situated internally. This is contrary to accepted practice today where the platform for the building envelope would be located outside and independent of the building. As the building gained stature and the floor joists set into the wall, the flooring became a temporary scaffold, so the construction took place ‘over arm’. In this scenario, the combined load of the materials, stone and mortar was located on a solid platform, the floor rather than a more unstable external scaffold. External scaffolds are depicted throughout Günther Binding’s ‘Medieval Building Techniques’ which is a catalogue of medieval illustrations of building practice and tools. The external scaffolds are insubstantial providing access rather than a platform for a significant load. Within this context it possible to see the bulk of construction and finishing masonry as work proceeds and perhaps the nuancing of wall finish from a lighter putlog scaffold (<https://scaffoldpole.com/putlog/>). The construction of the church of the Madelaine at Vezelay similarly illustrates the completed wall as building work took place. In this instance soft capping the wall heads add to the sense of the need to protect work through several seasons as Breadalbane makes clear (Harrison, 2017).

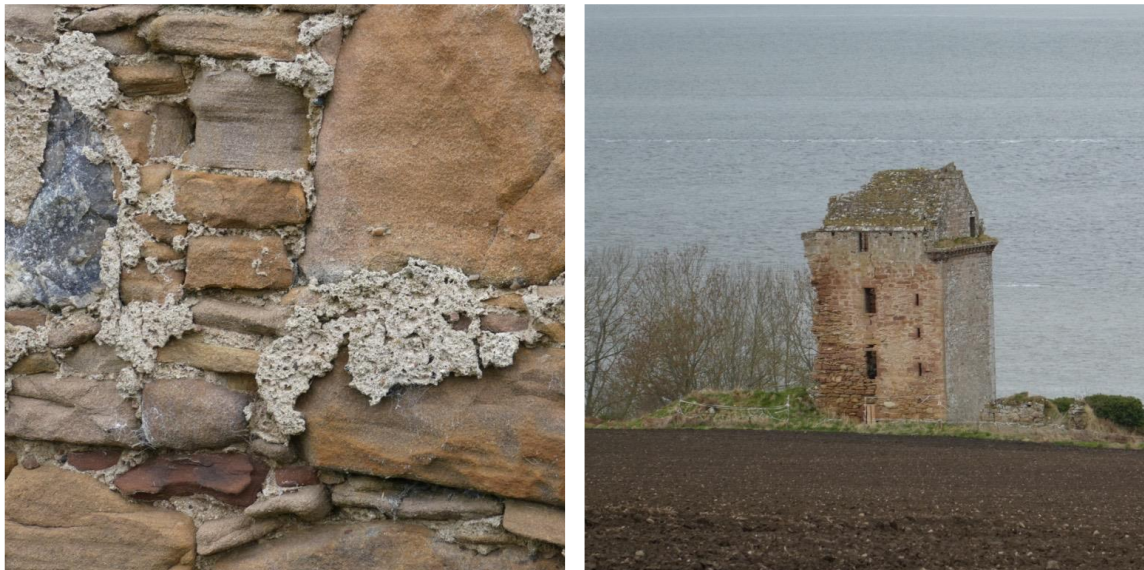
Figure 3.11. Castle Craig, c.1561 Ross shire. Mortar extruded from the joints surviving at the expense of the surrounding sandstone.

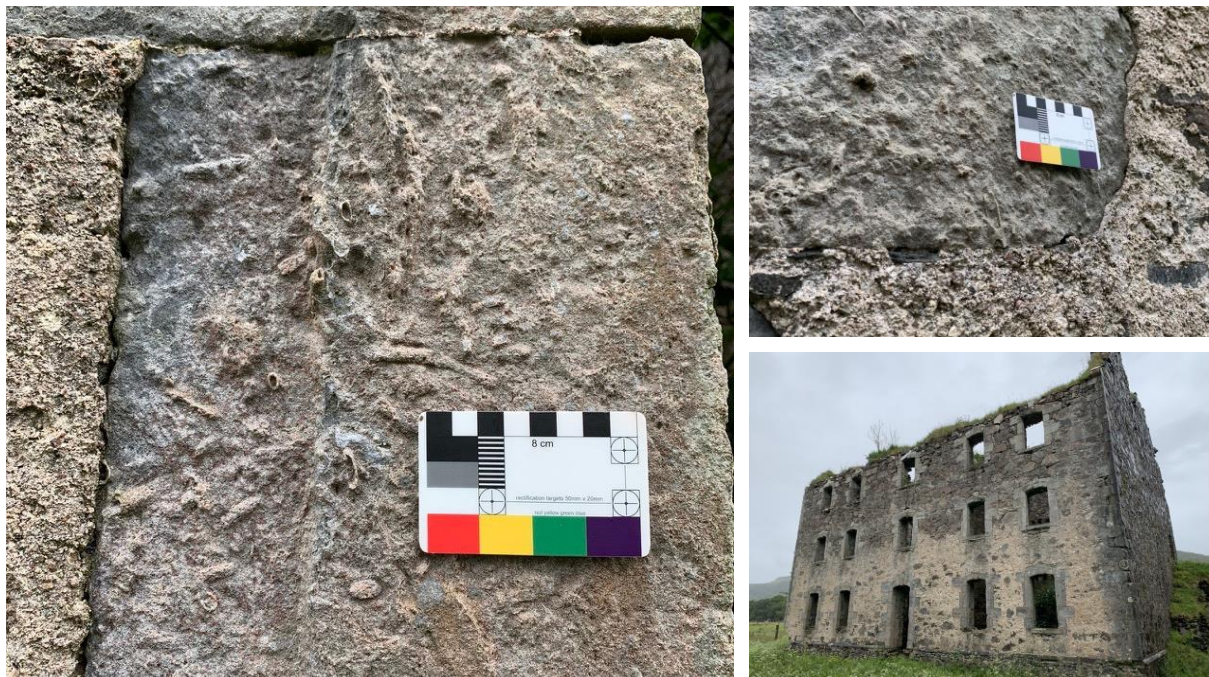
Figure 3.12. The Bernera Barracks, c.1723 Glenelg. Weathered limestone, decaying while the harl remains robust.

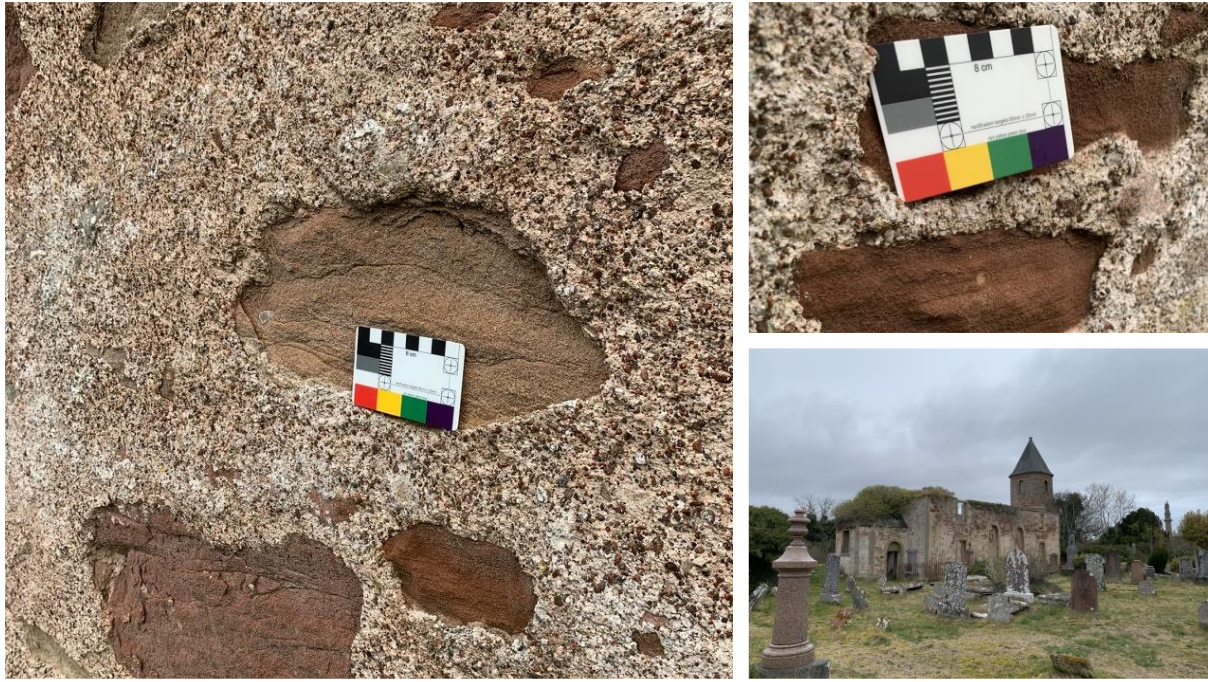
Figure 3.13. The Gaelic Chapel, c. 1783, Cromarty. FDC mortar surviving at the expense of the soft underlying sandstone.

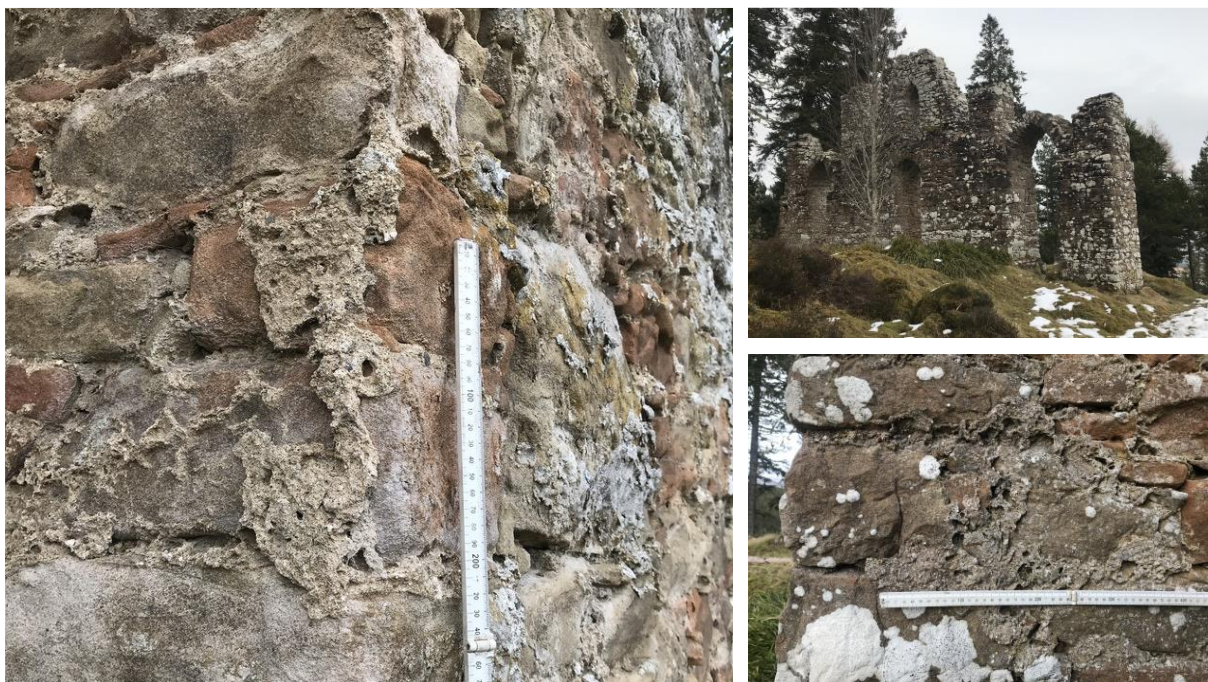
Figure 3.14. The Fryish Monument, c. 1782 Ross shire. Mortar extruded from the joints and remaining on the face of the sandstone, and where the sandstone can be seen weathering.

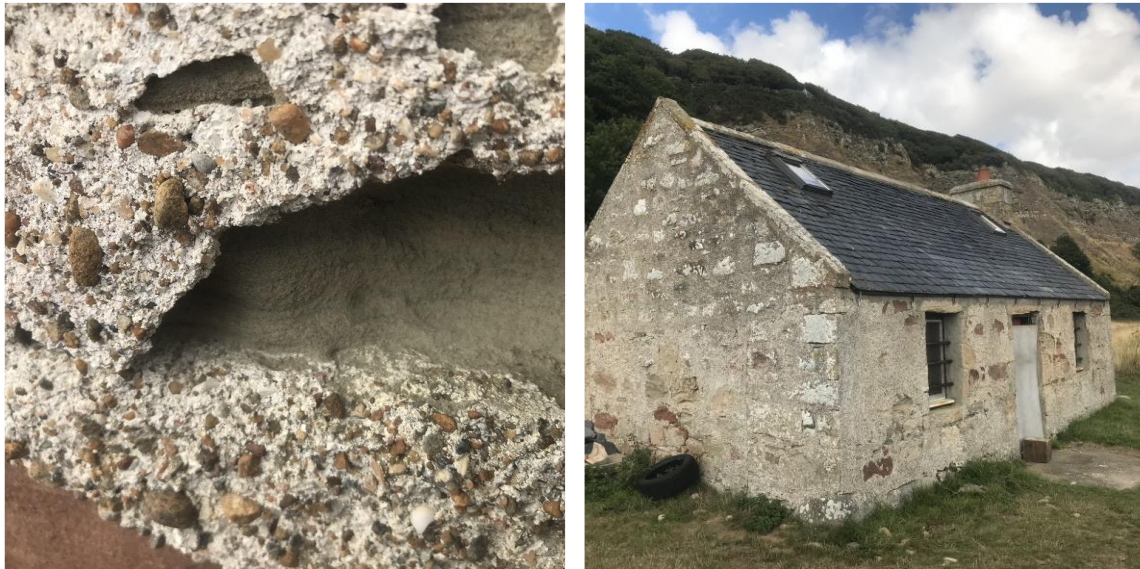
Figure 3.15. Geanies House salmon bothy, c. 1870, Fearn, Ross shire. Extreme weathering of sandstone while the weathered harl survives.

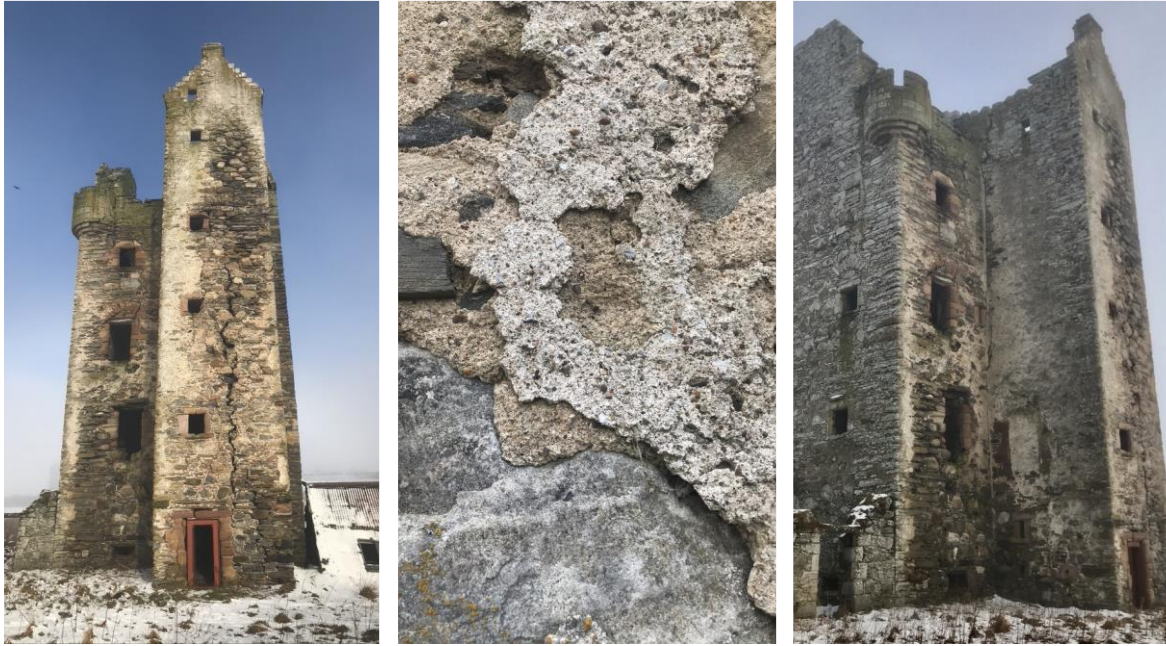
Figure 3.18. Fairburn tower, Inverness shire. Main and Stair towers. Centre the Main Tower FDC mortar overlain with 17<sup>th</sup> century Stair Tower harl.

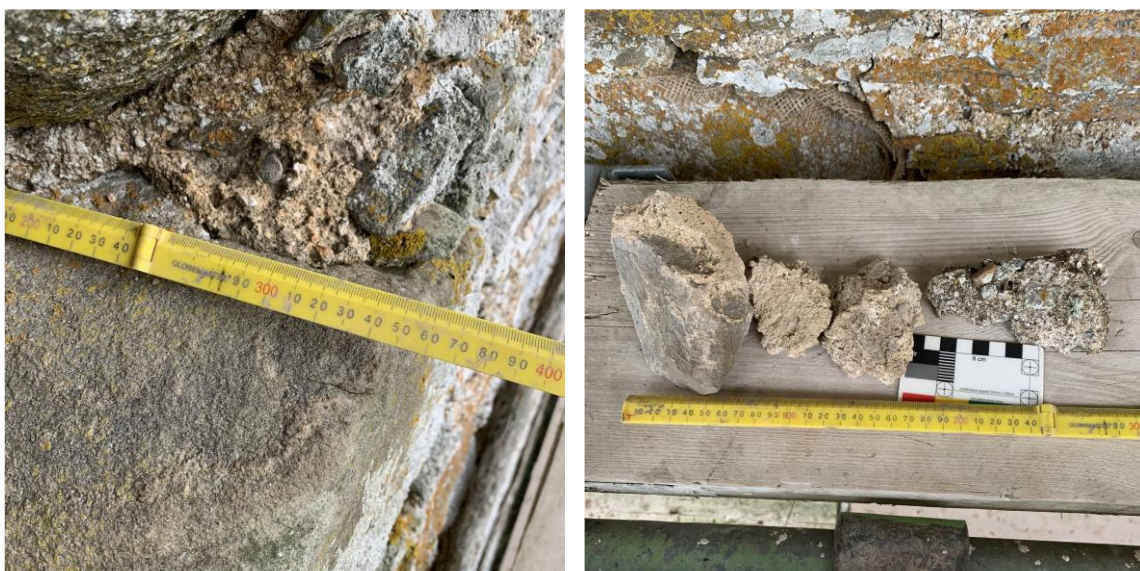
Figure 3.22. Sample FT006 ABC core, bedding and harl locations of mortar on the west elevation Main Tower.

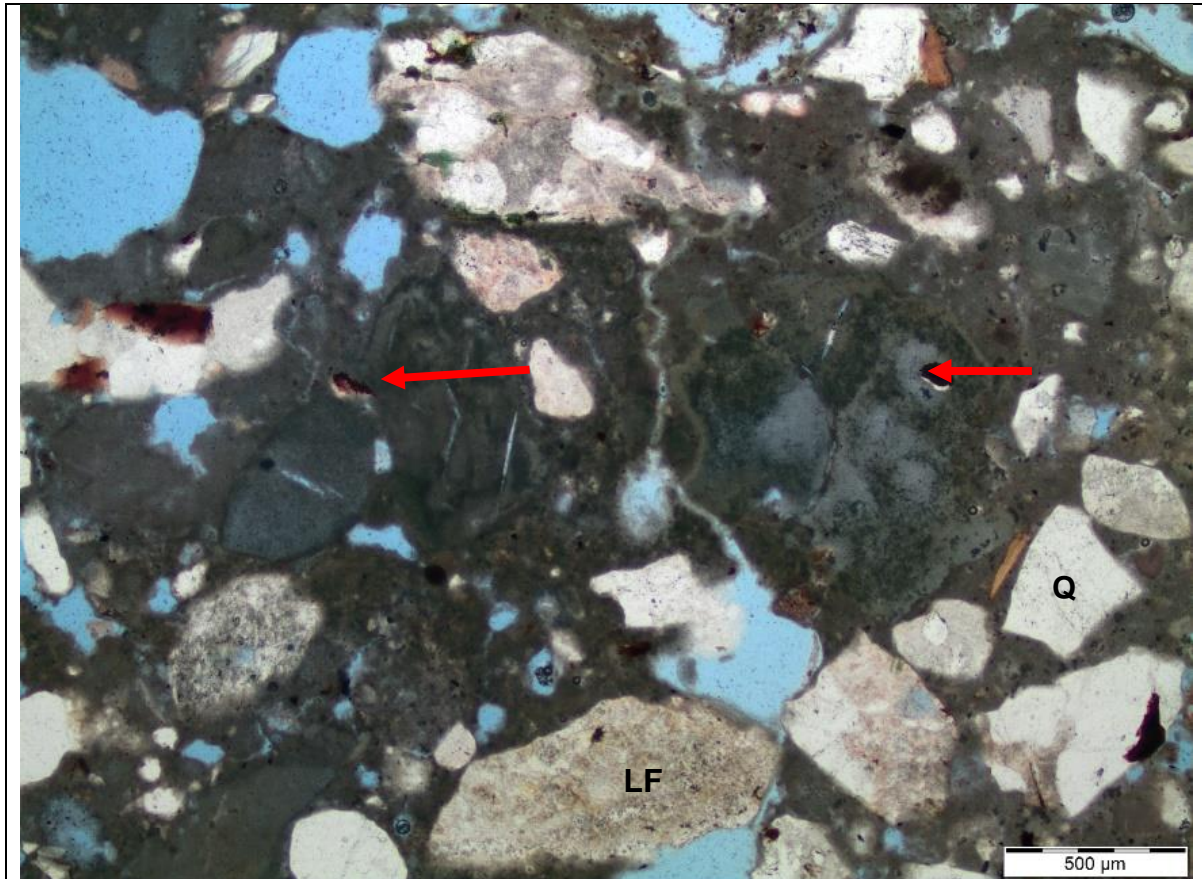
*RB004A Two lime inclusions (red arrows) show partial dissemination into the surrounding mortar binder. The aggregate is comprised of lithic fragments (LF) and quartz grains (Q).*

Sample RB004AB was removed from the main entrance on the east wall, facing the road to the left of doorway at ~500 mm as a harl and core samples.

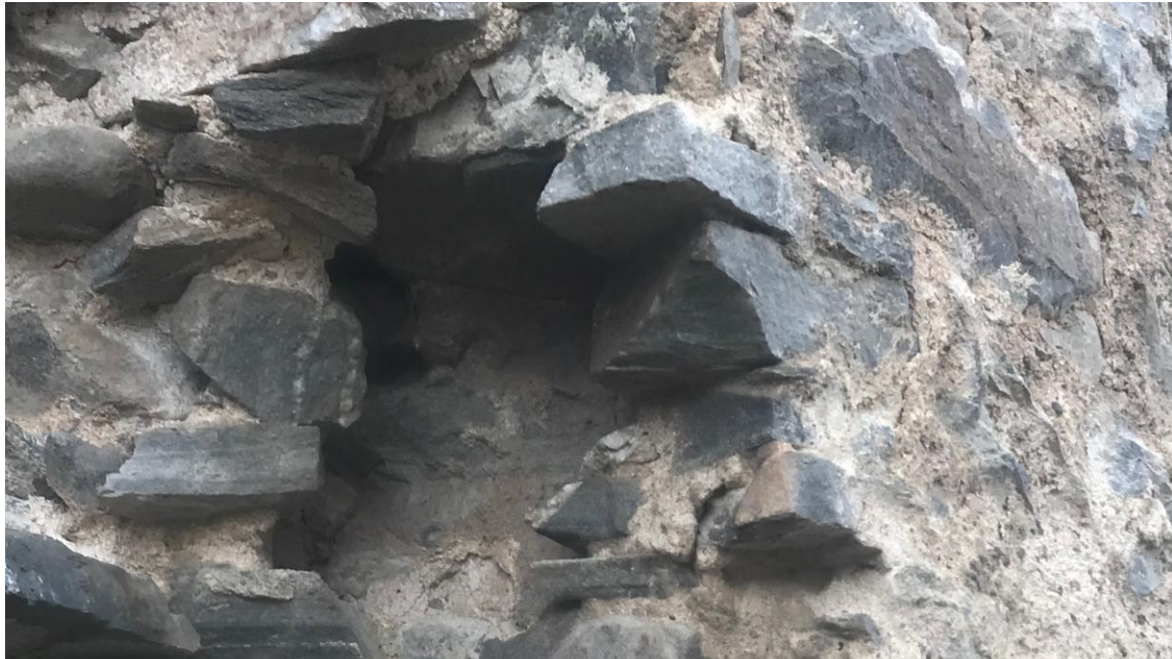
Figure 3.30. The location of sample RB003. The wall core has washed away the majority of the building mortar. In contrast, the wall face retains large areas of harl.

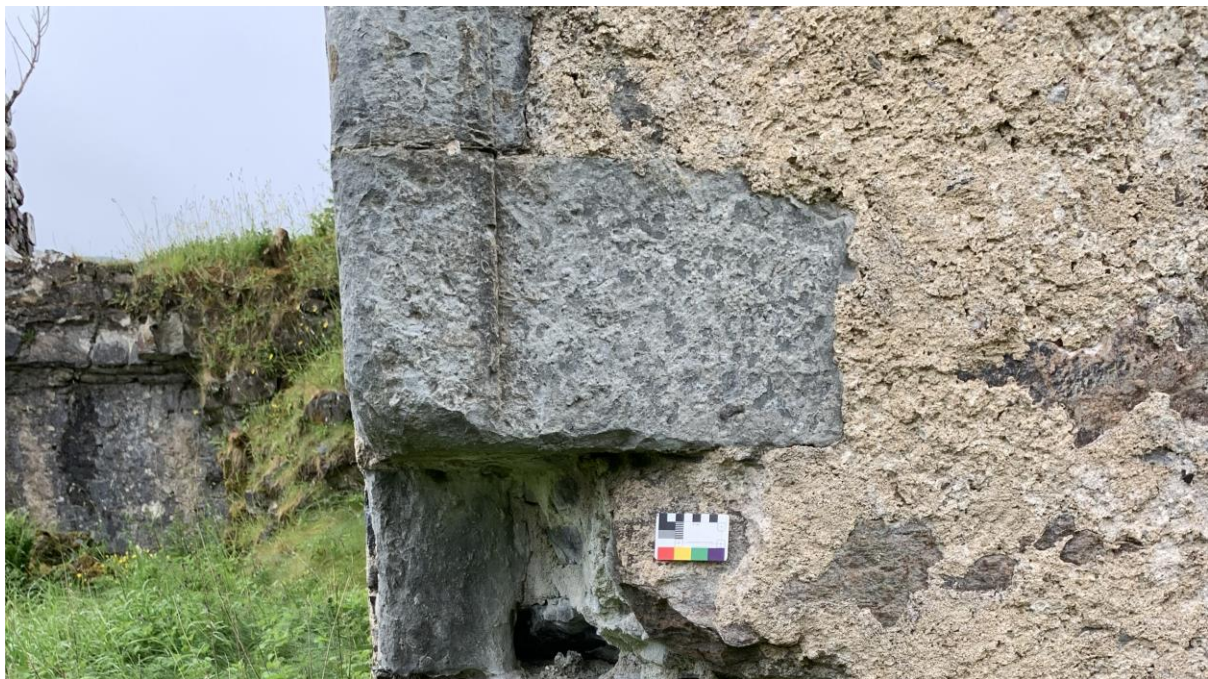
Figure 3.31. Stone robbing undercuts the wall and directs water into the core. Note the green/blue leaching of the limestone quoins.

Binder aggregate relationship between the samples showed consistency except for RB003A and RB003B where the volume of aggregates at the core (1: 2.1) were greater than the harl (1: 1.33) (Table 11). This anomaly is within the boundaries that can be found within the analysis of relict mortars (pers comm Callum Graham HES). Furthermore, the sample was taken from the more exposed south west elevation doorway where stone robbing has exposed the core which is now presented as an exposed complex series of ledges, hollows and troughs and more likely to trap moisture and hold it longer. In contrast the wall face remains vertical with an even distribution of water shedding (Fig. 3.30). In this scenario binder leeching is more likely from the core, particularly given that carbonation takes place at the wall face and migrates inwards to the wall core. This statement is supported when examining wall cores generally: for example, the Ruthven 'sister' Bernera Barracks, c.1733 (Addyman & Meek, 2019) where again stone robbing provides access to core. In this case the undercutting directs water into the core, the volume sufficient to carry dissolved limestone from the quoins (Fig. 3.31).

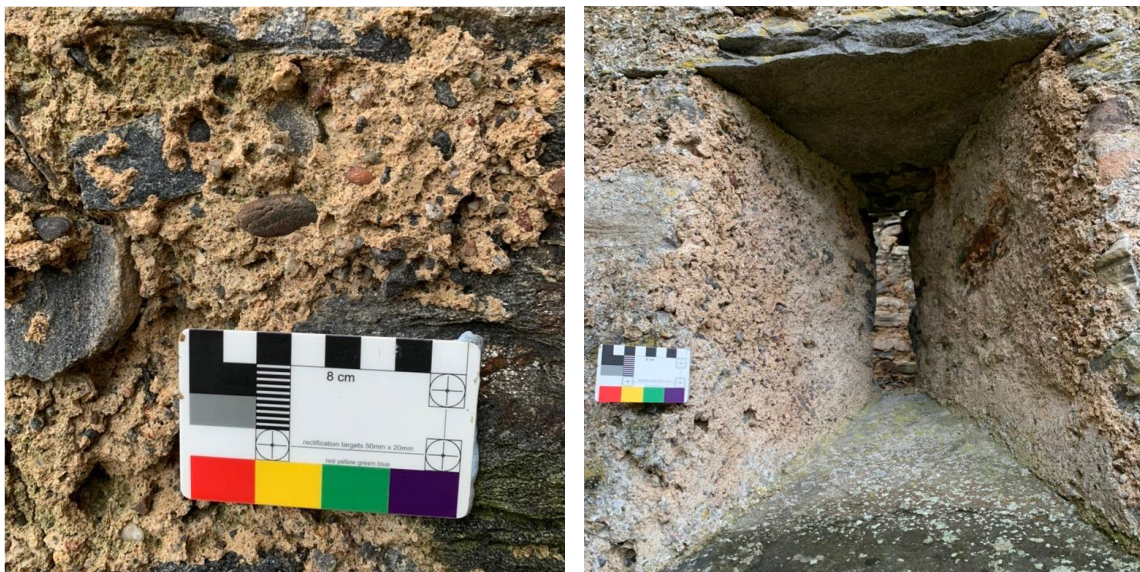
Figure 3.32. Left: shows the external wall face of the S.W. elevation and binder dissolution. Right: the S.W. elevation gun loop, the same mortar but in a sheltered location, retaining binder.

Onsite evidence indicates that exposure can alter the binder/aggregate ratios on the same elevation when comparing sheltered areas with exposed (Fig. 3.32) and between elevations. An outcome of the sampling was the care needed when taking a mortar section from an exposed area because the larger aggregates tend to drop off as the sample is removed because the binder had become insufficient to hold the larger particles in place. This also influences the analysis of size range of the aggregates, therefore, it can be expected that there can be a discrepancies between the core and harl mortars.

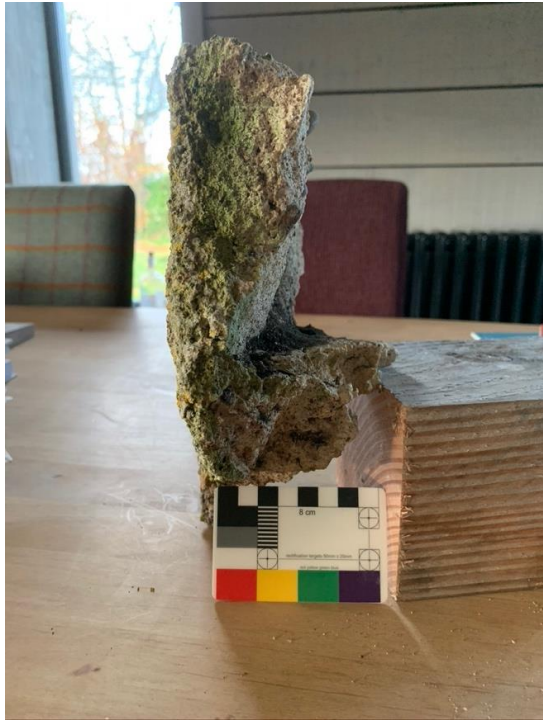
Figure 3.38. FT001. North elevation: harl with bedding tail.

All thin section samples are revealed under plain polarised light. Pore space is highlighted in blue. All areas of blue-grey represent binder that has absorbed some of the blue-dye resin. FT001 AB Removed as a large intact section of harl with bedding tail, removed from a structural crack at high level on the north elevation (Fig. 3.38) and (Fig 3.39).

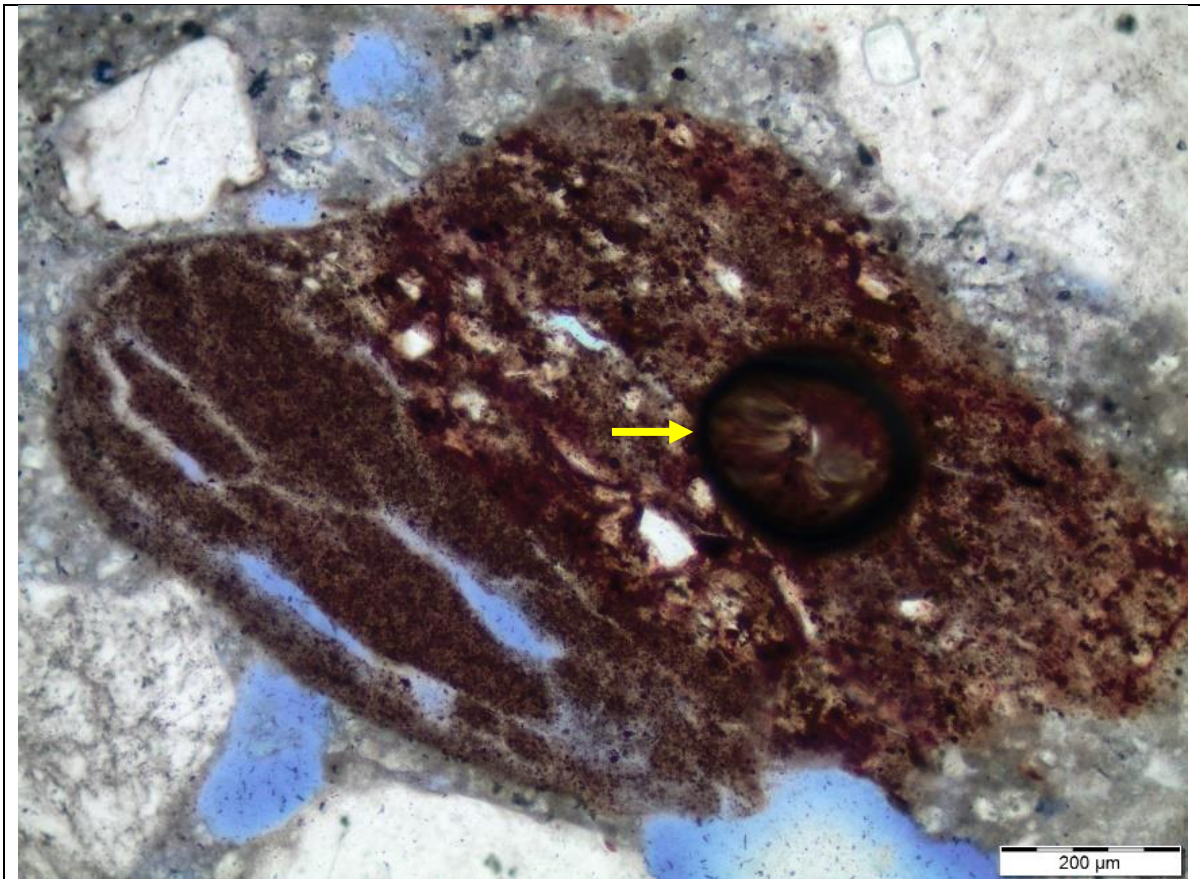
*FT002 A small under-burnt lime inclusion displaying the relic marl limestone texture indicates the use of the same impure marl limestone in the manufacture of the mortar. The black circle (yellow arrow) is an artefact of the glass thin section slide. Note the scale bar shows 200 $\mu$ m.*

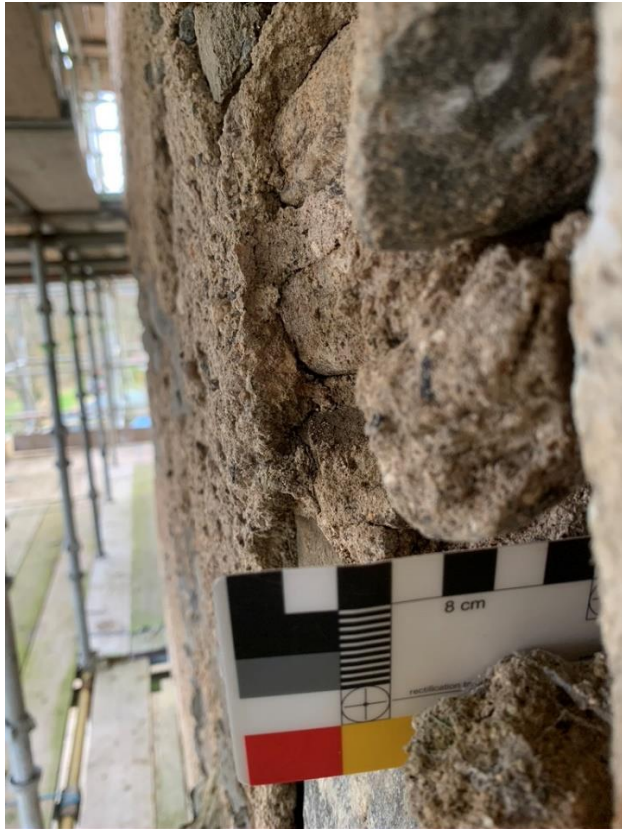
Figure 3.42. FT003 Main Tower, north elevation, sample removed from large structural crack.

FT003AB removed as a large section of harl and separate bedding tail, taken from a structural crack at high level on the north elevation (Fig. 3.42) made with Types 1 and 3 limestone (Fig. 3.43). While this is the only sample where Type 3 was found, it should be remembered that sampling is not all inclusive and given the visual similarities between this example and most others on the Main Tower, it is likely that other areas also contain Type 3.

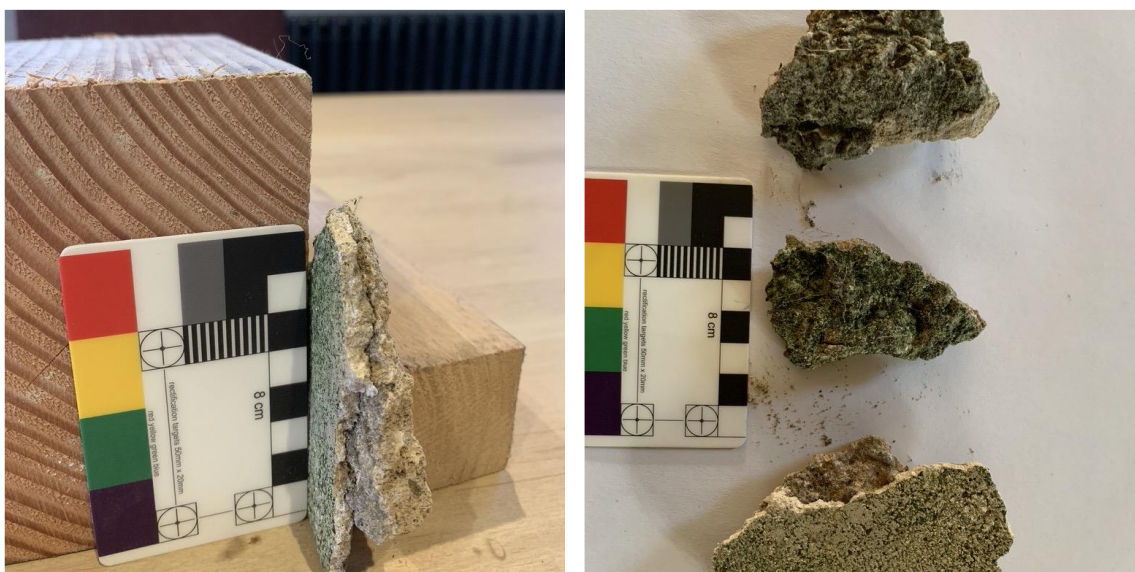
Figure 3.45. FT004ABC. Left: Detail of the line of separation between the 'polished' finished plaster and backing coat. Right: Core/bedding mortar, harled first coat plaster and 'polished' finish.

FT004ABC internal (Main Tower finished/bedding/core) was the only internal sample (Fig. 4.44). Samples B&C were mineralogically, binder/ aggregate and lime inclusion related to each other and consistent with other samples from the Main Tower, other than FT002, with a wide range size, large to small with varying morphologies, consistent with the muddy marl type limestone (Tables 12 & 13). The difference in this sample was in the thin fine finish which had a completely different texture physical structure (FT004A). The complete sample was removed as a coherent thread of internal plaster, comprising of bedding/core, first coat backing and finishing mortars (Fig. 3.45). At the time of sampling, there was clear visual continuity between the bedding/core and first coat of plaster and a separation between these two and the finish, which was confirmed by petrographic thin section analysis (Fig. 3.46). The texture of the preparatory FDC thrown coat was coarse and open and

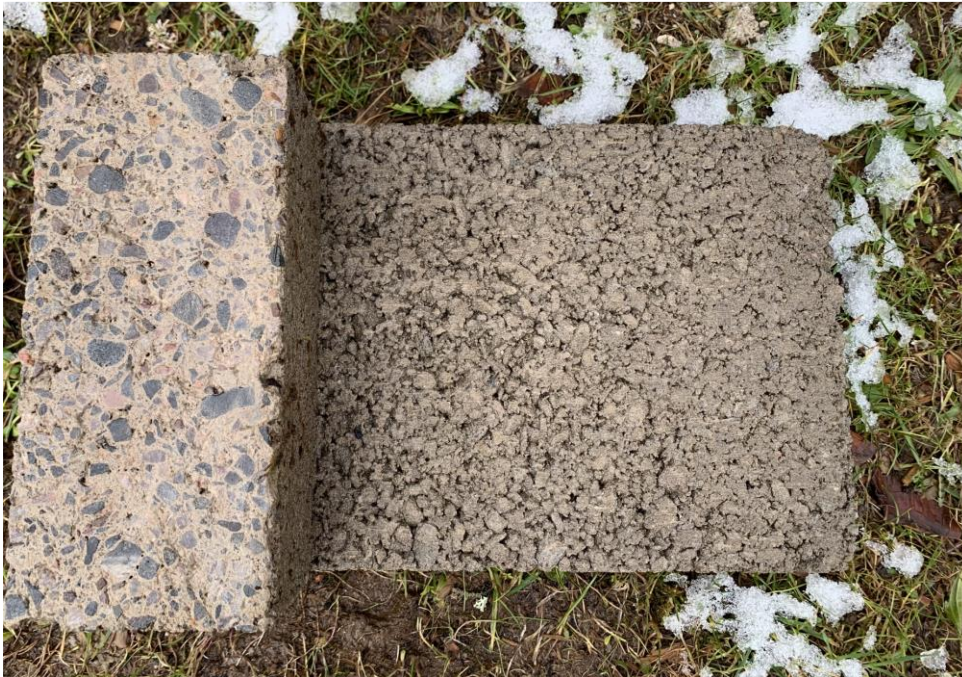
Figure 3.49. A 7.3 N concrete block: left the surface with exposed aggregate and dense binder paste. Right, the as cast open texture with the aggregates with a thin coating of binder paste and interstices between the aggregates.

A baseline value was established using 100 mm x 440 mm x 215 mm concrete block normally employed for external use in mainstream construction, manufactured to BS EN 771-3:2003 with a 7.3 N per mm<sup>2</sup> known compression strength (Fig. 3.49). Two sets of readings were taken: from the as-cast textured block surface and from the inner smooth sawn surface, the latter giving much higher LN. This correlates with previous studies (Viles *et al*, 2011) which also identified that when measuring the LH on stone a smoother surface provided higher readings but there was no consensus on whether a single or multiple location testing regime produced more impactful results. Because lime mortar is made with a high-volume binder paste and aggregate
