**Cultural and physical factors in the history and  
development of traditional external wall  
coatings in Scotland**

Timothy John Meek  
MA

Thesis submitted for the degree of Doctor of Philosophy

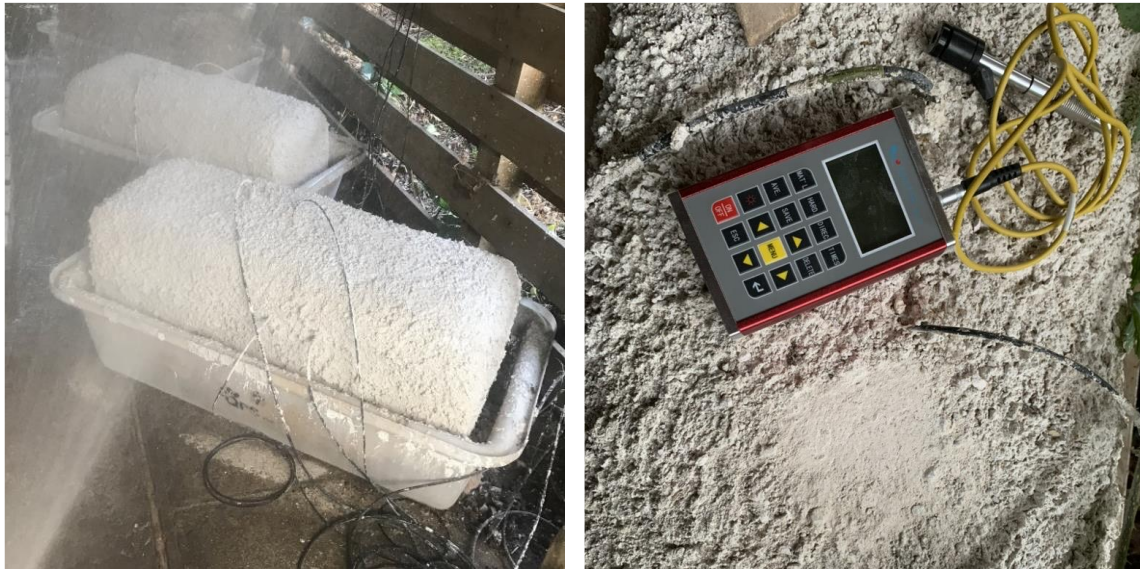
Figure 3.51. Earth blocks with Harl/Harl and limewash during LHT.

Relatively new lime mortar was also tested. Two blocks of earth wall building, constructed in the basement area of the Cottrell Building at the University of Stirling had been previously harled/harled and limewashed in 2019 as part of the experimental work encompassed by this research but had been abandoned due to access issues during the pandemic. The blocks were coated in optimum conditions for carbonation to take place and tested with Phenolphthalein and demonstrated full carbonation from outer crust to clay core. The outer surface in several areas was rubbed flat with a carborundum stone and readings taken from both flat and textured surfaces (Fig. 3.51). Within the context of a Listed Building or Scheduled Monument, this flattening of the surface would not be possible without Consent.

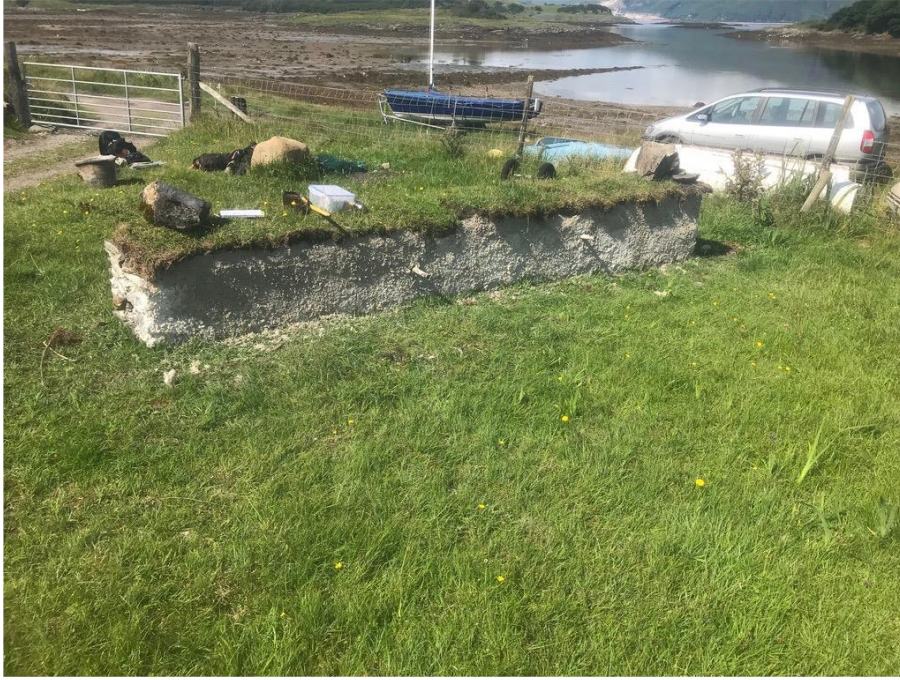
Figure 3.53. The Lismore wall, capped with turf.

The Lismore wall was orientated NE – SW, the decision made by HES/SPAB. Because the prevailing weather comes from the SW the most likely scenario was that humidity would be greater for longer on the SW elevation. The bare stone was kept on the exposed SW elevation and the harled on the NE. It was capped with clay and two layers of turf, protected by a fenced enclosure, and left for 14 months (Fig.3.53).

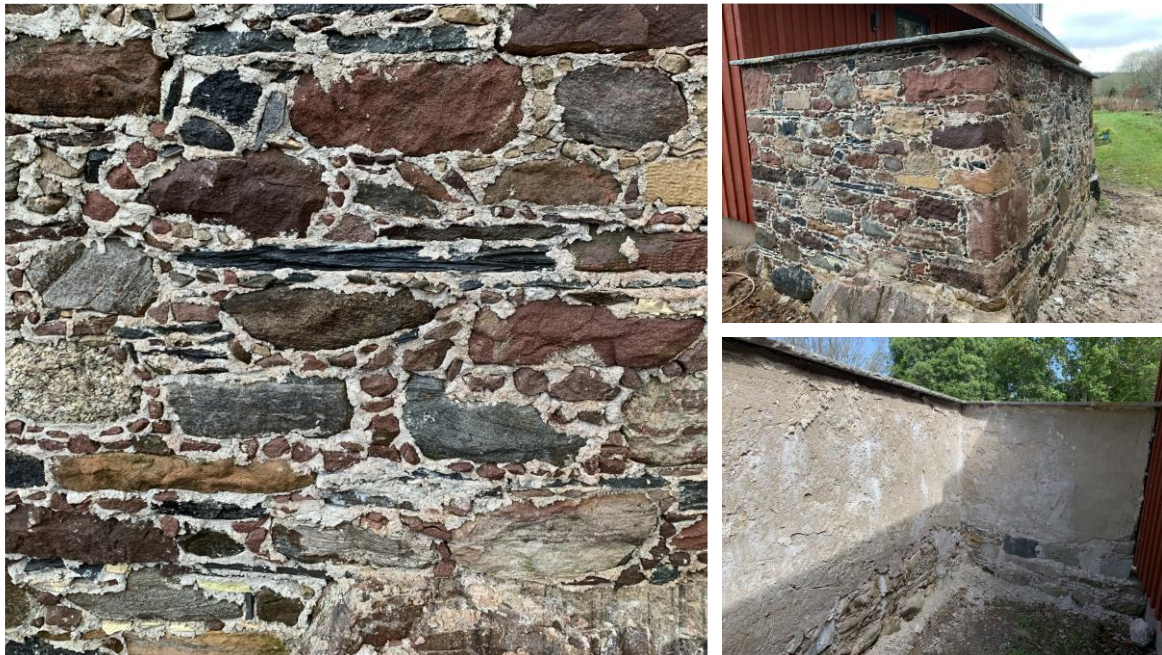
Figure 3.54. The Poyntzfield wall, large and small stones, flagstone capped.

At Poyntzfield, an 'L' shaped wall constructed with two orientations: North – East to North – West and South – East to North - East to secure a varied exposure Fig. 3.54). The width at the base of the wall was 700 mm reducing to 450 mm at the wall head. The wall head was capped with 900 mm x 600 mm x 30 mm flagstone to inhibit water penetration from above. The width of the capping stone to exceeded the wall width in all directions by ~75 mm. The external NW length was 4.0m at the base and 3.6m at the head and the NE 2.4m and the base diminishing to 2.27m at the head. The height was ~1.8 (variable ground height).

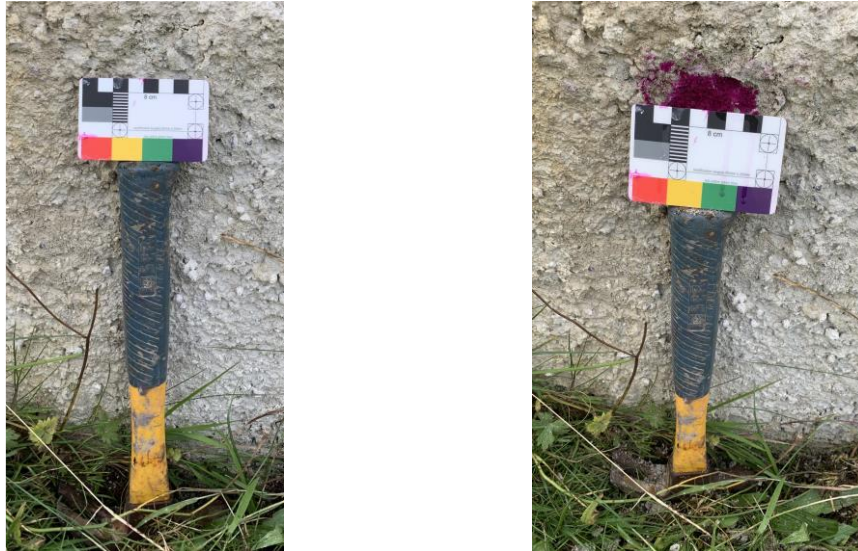
Figure 3.55. NE harled wall surface. Left: the carbonated surface sprayed with phenolphthalein. Right: with the outer crust teased away revealing the 2mm uncarbonated subsurface.

Two points on each side of the wall were selected for testing at 250 mm from ground level and at 1.8m from each end of the wall representing the centre line of masonry unit (Fig. 3.55). NE elevation <2 mm depth of carbonation was observed. In contrast, the SW bare stone gave a reading of <13 mm (Fig. 3.56).

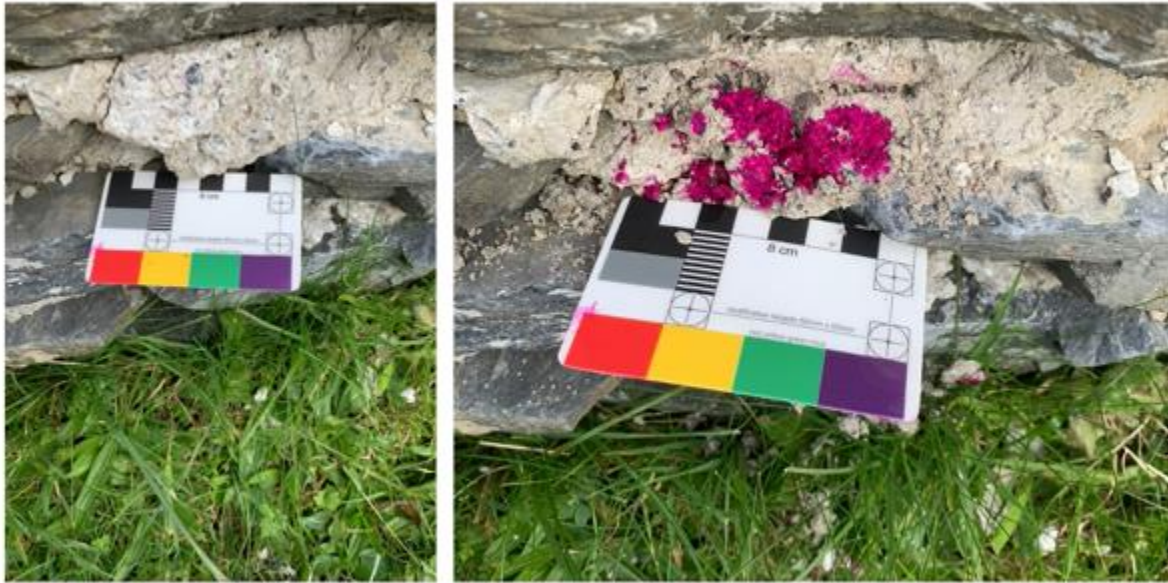
Figure 3.56. SW exposed bare wall surface. Left: Far left the undisturbed surface and right sub-surface sprayed with phenolphthalein with a carbonated depth of <13 mm. Right the uncarbonated mortar > 13 mm.

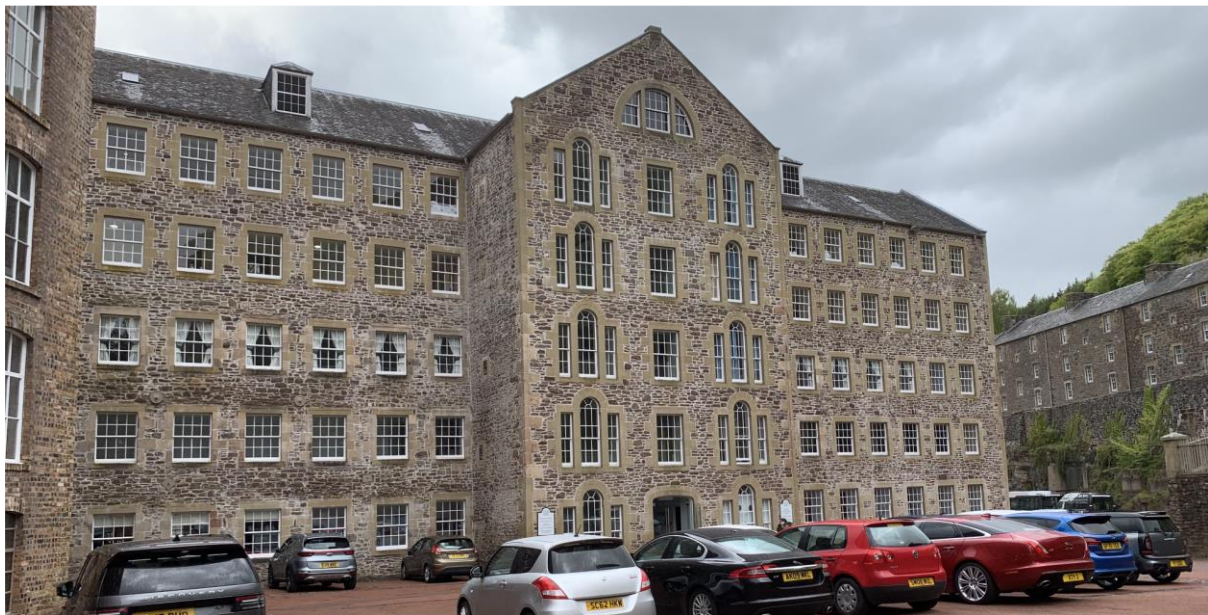
Figure 4.1. New Lanark showing the volume of masonry to glass within the context of an industrial building.

The principle of diminutive masonry volumes in favour of glass extended from residential buildings to all building types (Fig. 4.1). The survey (Figs 2.39 & 2.40) demonstrated that there was a difference in the width of masonry below the sill in residential buildings (Fig. 4.2) compared with other types – churches, factories and barracks, for example – this maintained full wall width (Fig.4.3 & 4.4). The inference is clear: the space in the window embrasure of residential buildings had a different function, it drew light in and allowed the viewer unimpeded access to the external world. The Scottish Enlightenment and the role of the Scots in shaping rational thought throughout the world is regarded positively (Herman, 2006) and led to an expansion in building throughout the Highlands (Nenadic, 2007) and urbanisation throughout Scotland in general (Harris & Mckean, 2014). While acknowledging the refinement in architecture and urban planning in, for example, Edinburgh's New Town, this chapter questions the functionality of the differing forms of architecture when combined with loss of finish.

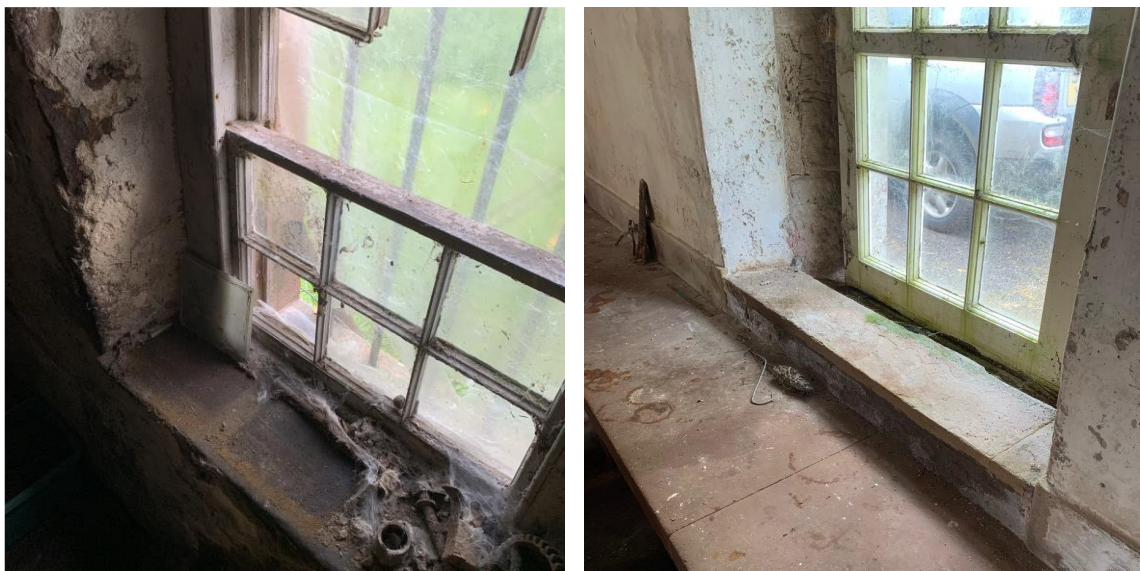
Figure 4.3. Left: Newmills, Resolis, the Black Isle, Ross shire. Right: dairy, Thornhill, Dumfries and Galloway. Non-residential building with full wall thickness below the sill demonstrating the importance of internal light, with little requirement for view.

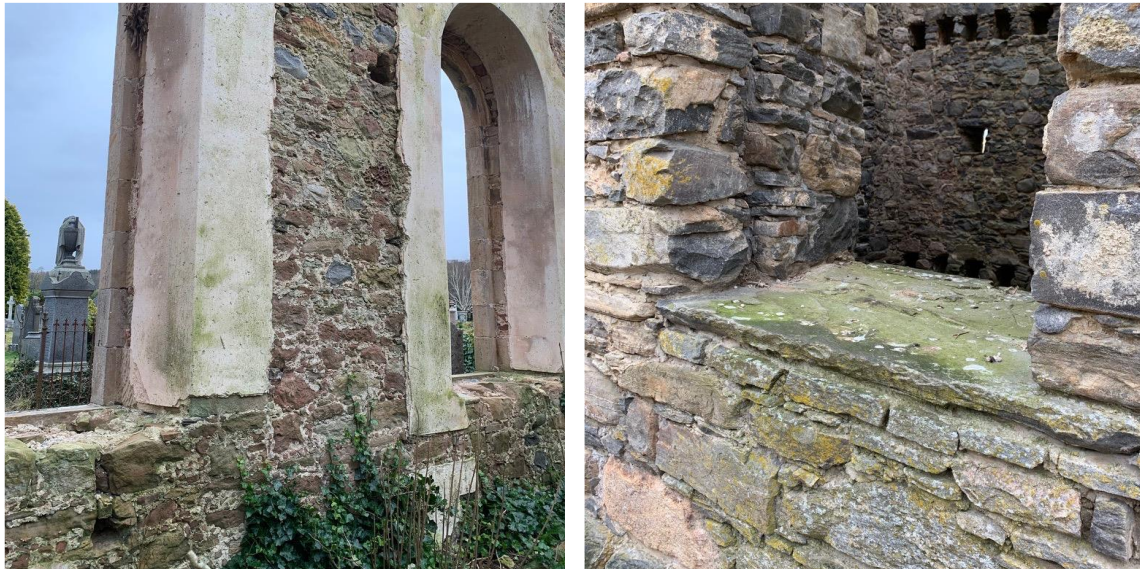
Figure 4.4. Left: the Gaelic Chapel, Cromarty, Ross shire. Right: The Ruthven Barracks, Kingussie. Full width walls where there is no requirement for a view.

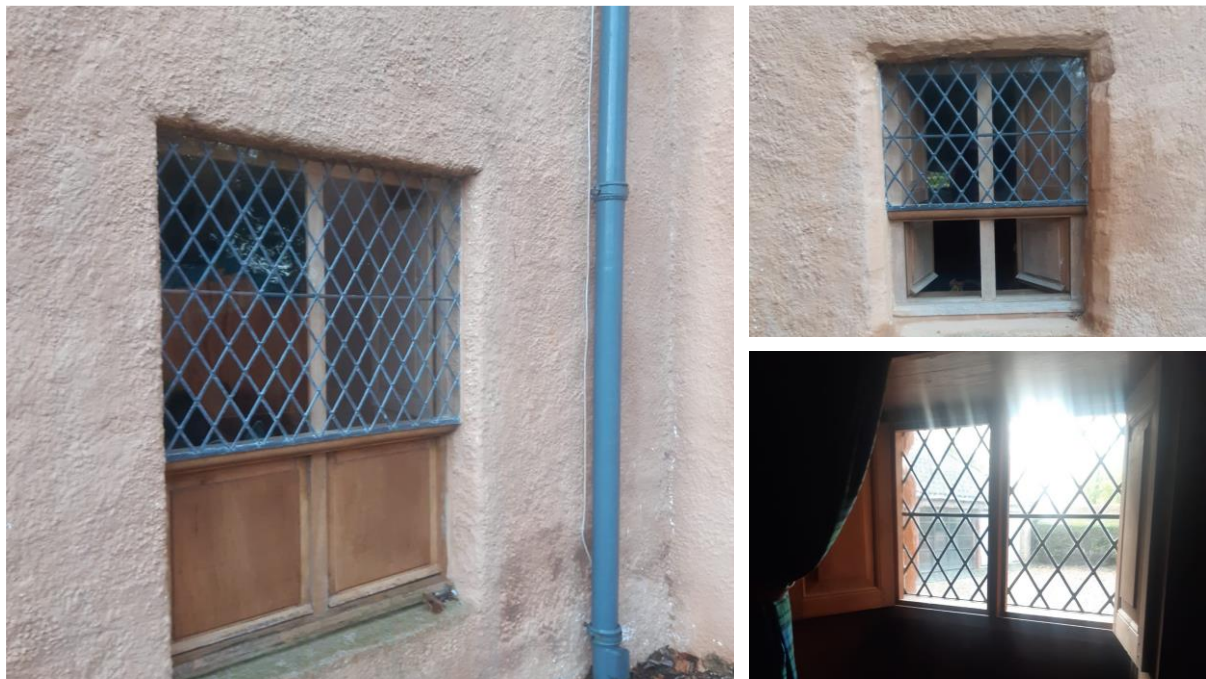
Figure 4.6. The shutterboard window providing light at the top and ventilation at the bottom.

In two of many examples within the survey, Fairburn Tower (c.1545–1780) and Dunnottar Castle (c. fifteenth and sixteenth centuries), the towers had wall thicknesses in the range 1m–2m. Window openings were irregular in their placing within each elevation and varied in width and height. The openings were functional, providing light with which to undertake domestic tasks and giving ventilation (Fig. 4.5). Evidence from buildings where the earlier window style had been retained, demonstrates that the frame was divided into two parts: an upper glazed area with lead frame, and small glazed lights of semi-opaque glass set in lead kames. The frame was set into a raggle (Pride, 1996 p 61) or chase cut into stone window jambs and lintel. The glazed area was fixed. The lower section had a wooden frame and two small wooden shutters that could be opened when conditions allowed, hence the name a ‘shutterboard’ window (Rhodes *et al.*, 2017) (Fig. 4.6).

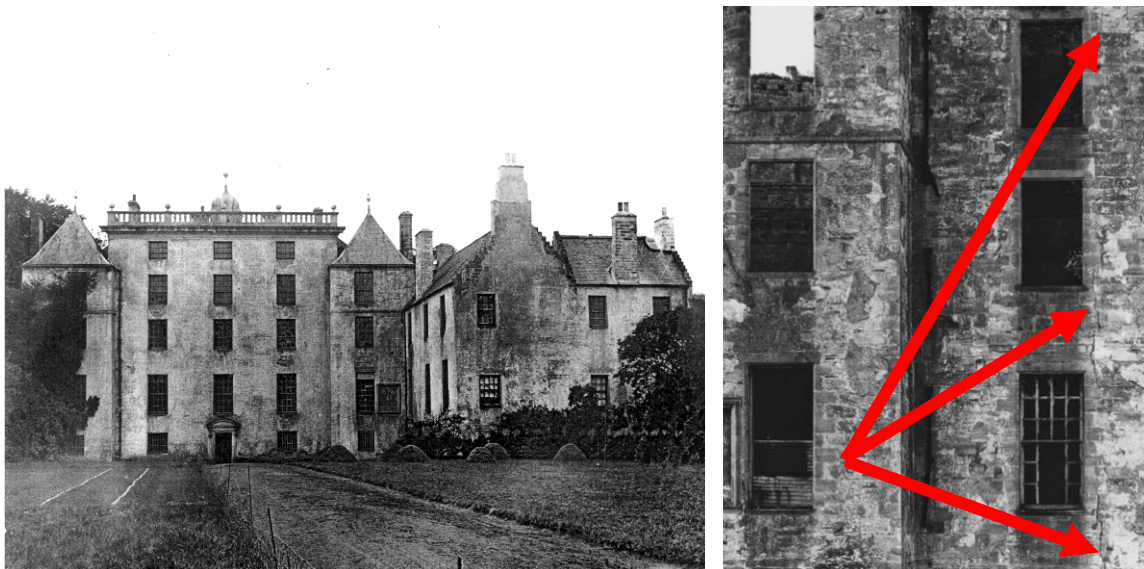
Figure 4.8. Kinniel House, Bo'ness: Left, the 16<sup>th</sup> c Main Tower, and additional flanking 17<sup>th</sup> c. wings. The symmetrical fenestration of the Main Tower punched through at the same time as the wings. Right, the red arrows indicating the cracking associated with punching through the windows.

William Douglas, the 3<sup>rd</sup> Duke of Hamilton, added two stair towers to each side elevation, so the older tower house became the central feature of a symmetrical Palladian complex (Addyman & Meek, 2019) (Fig. 4.8). At the same time, window openings were punched through walls measuring ~1m– 2m in width of the main tower to provide the space to accommodate sliding sash windows. The enormity of the task and the structural risks involved are demonstrable in the vertical cracking observed in all the areas where the alterations were made. The lack of an internally splayed window embrasure (Fig. 4.9) adds to the sense of how difficult a task this was to achieve, but it also provides an example of how important it was for the elite to be seen to be fashionable.

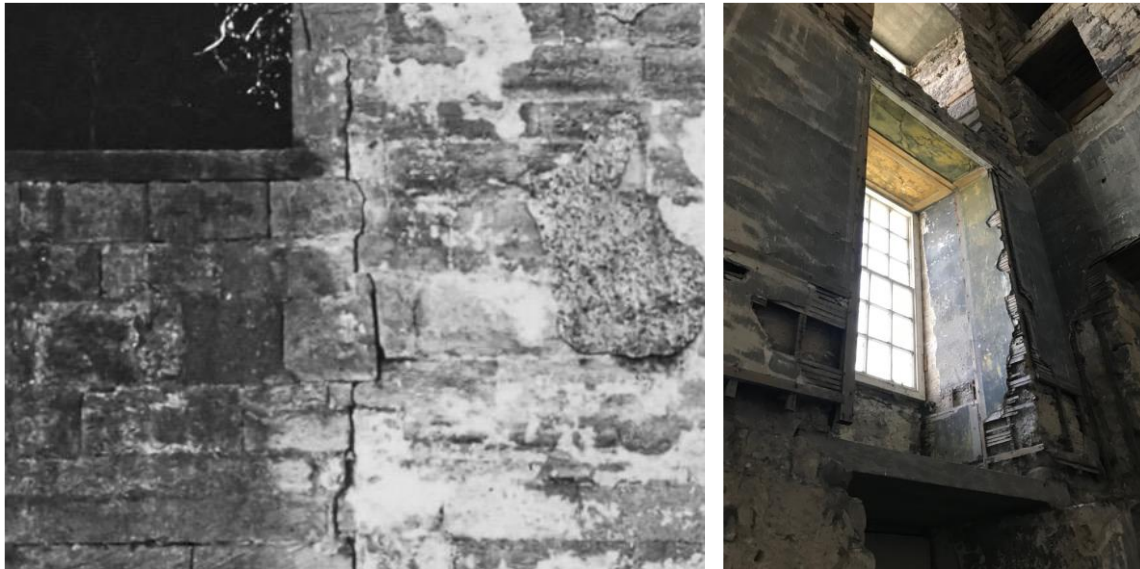
Figure 4.9. Left, detail of the cracking and right a sense of the determination to achieve symmetry despite the wall width.

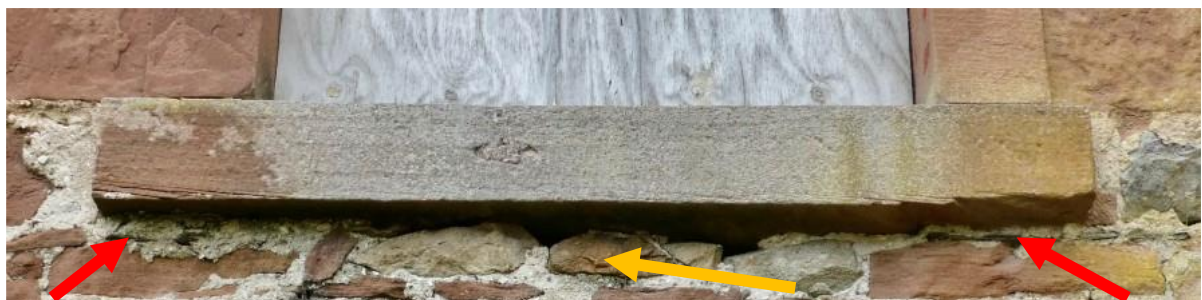
Figure 4.10. The sill placed on pads marked in red either side of the opening and the masonry below left low marked in yellow or added retrospectively.

To achieve this degree of accuracy, the survey demonstrated that a trend emerges. The general masonry was raised to a height just below what was required for the placement of the sill (Fig. 4.10). Pads were located on each side of the window opening, leaving the masonry between the pads marginally lower. Pads might be purpose made large blocks with a section cut away (Fig. 4.11) large sections of stone, small fillets, thin slivers of slate or a combination of all three. The sill was placed on the pads and the gap between the pads was filled retrospectively once the process of levelling the sill was complete. The process of point-to-point levelling made the precise placement of the sill easier. Once achieved, the other elements of window aperture, the inband- and outband-rybats, and lintel incorporating the margin, were placed accurately with the fine joints. The fineness of the joints restricts a mason's capacity to adjust plumbing (checking that the face of the stone is vertical) and levelling the rybats, hence the need to make the sill level and the rybats square.

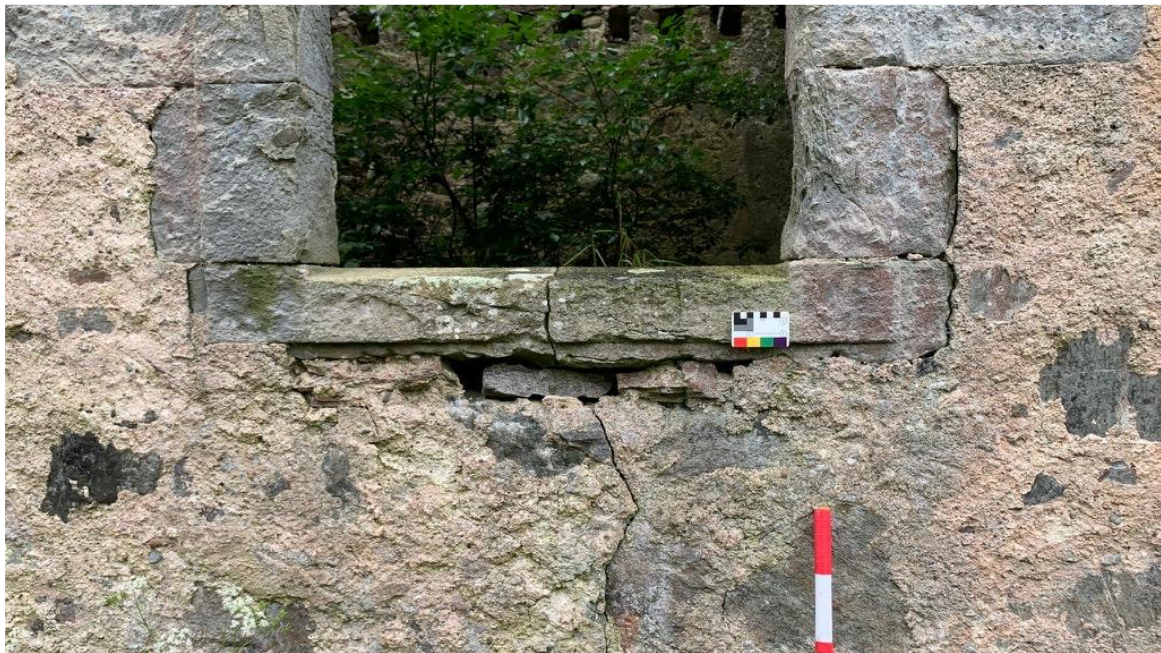
Figure 4.12. The sill joint not in compression, gives way when there is deflection. Note the cracks on each side of the window opening.

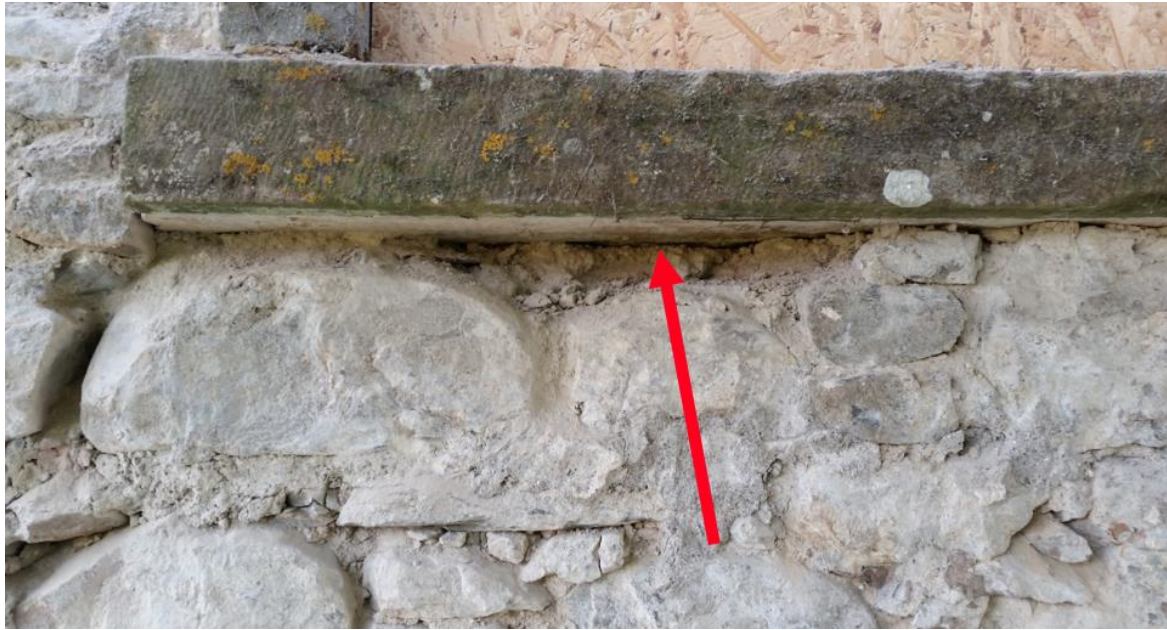
Figure 4.13 Large stone and slate support the sill: where the sill is unsupported a small crack has formed.

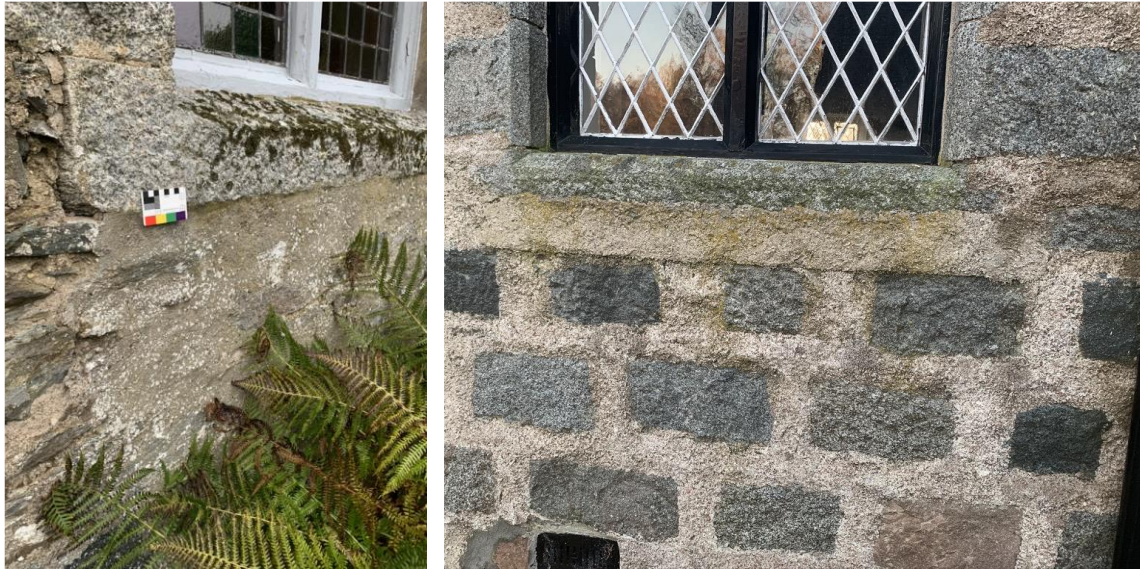
Figure 4.15. Left: St Michael's 7 All Angels Church, Ballintum, Blairgowrie. Right: Deeside Church, Torphins, Aberdeen shire, showing reinforcement to the under-sill areas and additional sneck harl.

The susceptibility of this area of a wall was apparent at a number of sites where the pointing below the window area had to be reinforced (Fig. 4.15). In some eighteenth and nineteenth century illustrations of Ballyowen Castle, Lucan, Dublin, vertical slate hangings have been added to resist water inundation below the sill (Fig. 4.16).

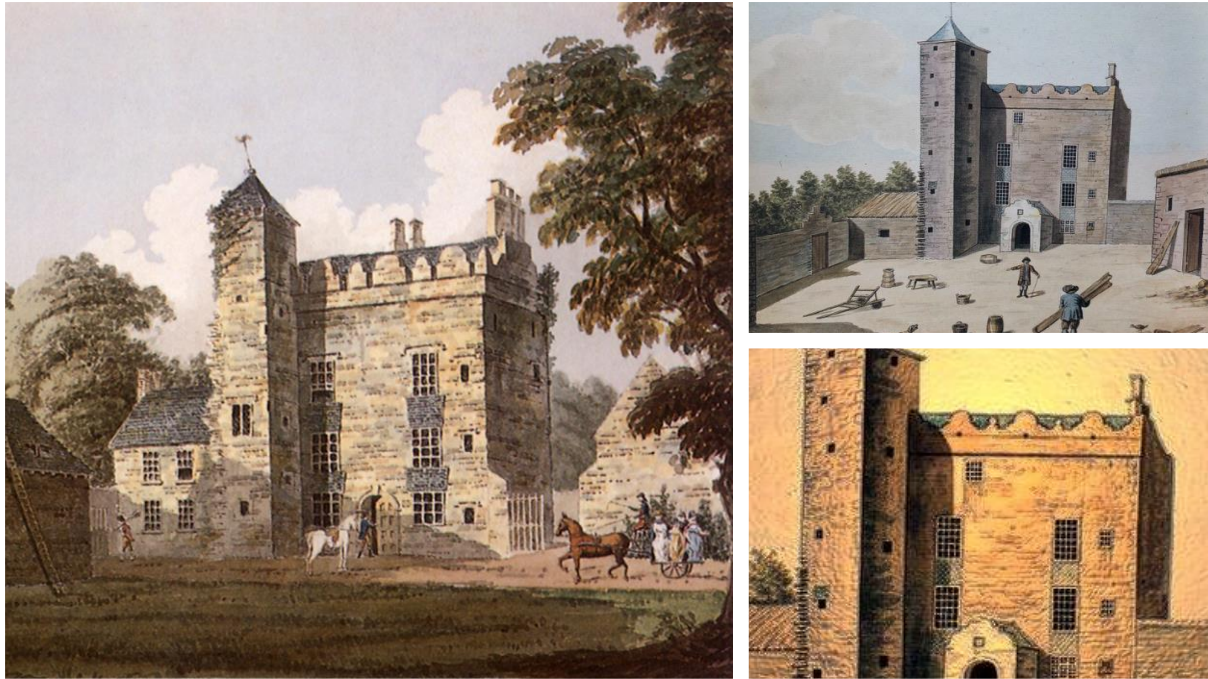
Figure 4.16. Ballyowen Castle, Lucan, Dublin, vertical slate hangings between windows.

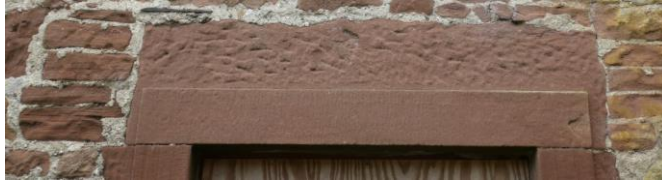
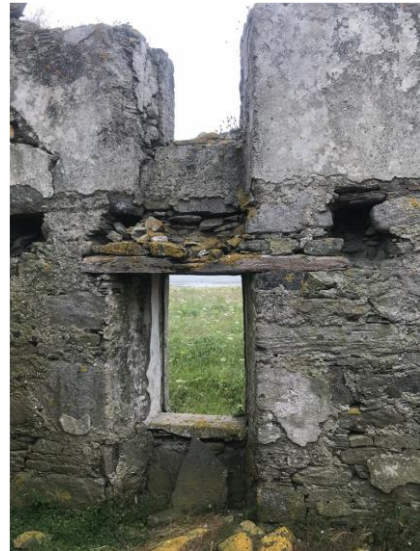
Figure 4.17. Left: Newhall House steadings. Lintel with droved raised face and stugged and broached set-back for harl. Right: Old Vallay House timber safe lintels.

The top of the window opening was bridged with a single stone lintel. This had two outward faces: the first the droved finished surface that corresponded with inband-outband-rybats and the second located lower, with a stugged/broached surface. In section, the width of the lintel that carried the load of masonry above the opening was in the region of ~100mm–120mm, thus not wide enough to accommodate the full ~600mm wall width of masonry above the window opening. In practice the rest of the wall width was bridged with a series of timber lintels set to the rear of the stone lintel. These were called timber safe lintels (DSL). The load of the masonry above the window was distributed onto the external narrow stone lintel and the internal timber lintels. The area above the lintel also has a transverse joint, although while this joint is under compression the masonry (lintel) is diminished, with the timber safe lintels located behind it. Floor joists are located on the timber safe lintels.

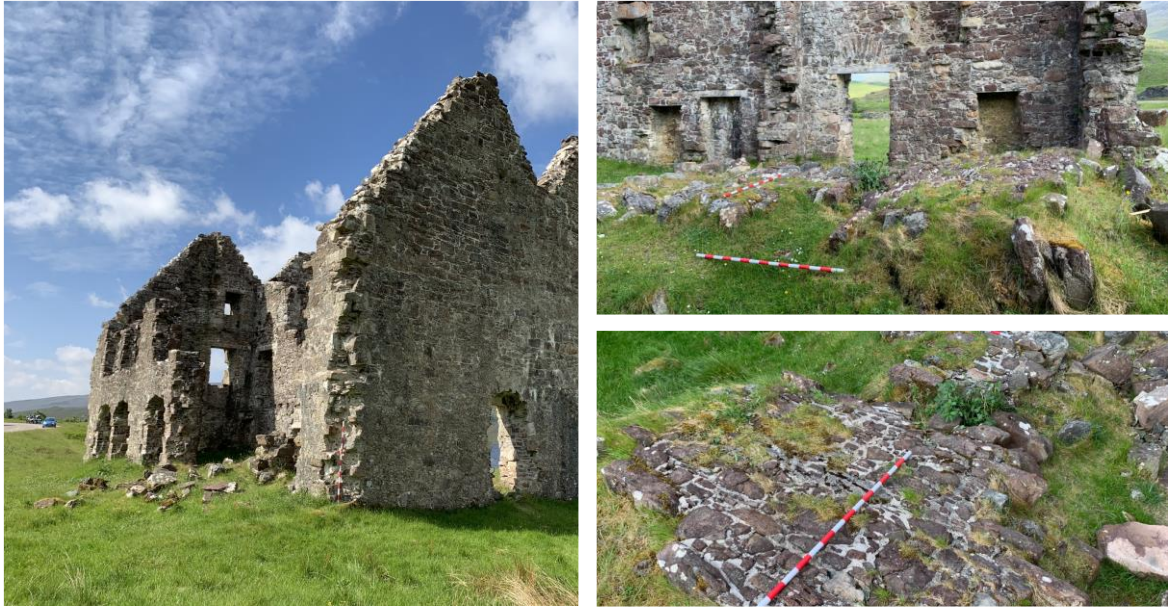
Figure 4.22. Calda House, Sutherland, early 18<sup>th</sup> c. showing the collapse of panels of masonry, severed at the insubstantial ties.

can collapse as was the case at Calda House, Sutherland (Fig. 4.22) and on occasion the only remaining upstanding element was the triangulated corners (Fig. 4.23)

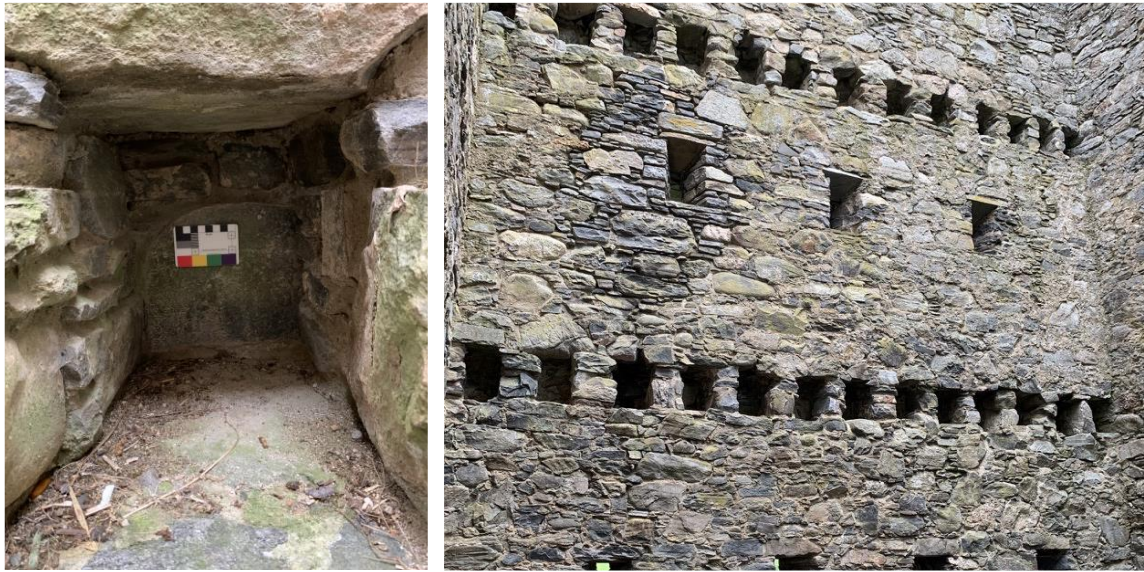
Figure 4.25. Ruthven Barracks: joist slots extending ~400mm into a wall depth of ~600mm.

The masonry and timber work in parallel: without the restraint of floor joists and roof trusses the resistance of the walls would be dependent on the buttressing of the corners alone (Fig. 4.24). Traditionally floor joists were built into the wall during construction (Fig.4.25) and floorboards laid at right angles to the joists. The depth of the placement of the joists was variable, depending on the size of the timbers and span across the room/building. In four examples – the Ruthven Barracks, Old Vallay House, Vallay; The Mill, Newhall, Ross shire; and Asknish House Lochgilphead, Argyll – the depth range was between ~300mm and 400mm within a ~600mm wall, so the depth of exterior masonry cover was always diminished in this area. In the window embrasure the joists were located either directly on the timber safe lintels – as was the case at Old Vallay House, North Uist – or on masonry placed on the timber safe lintels, which was the position at Asknish House Argyll (Fig. 4.26). In all cases the lintels (Fig. 4.27) and floor joists (Fig.4.28) were vulnerable, and any decay would cause displacement of adjacent masonry because the decay leaves unsupported pockets within the structure. The process is exponential until water inundates all areas on windward elevations (Fig. 4.29). All the building components are reliant on each other (Fig. 4.30) and as this thesis argues the first moderating buffer was complete lime cover.

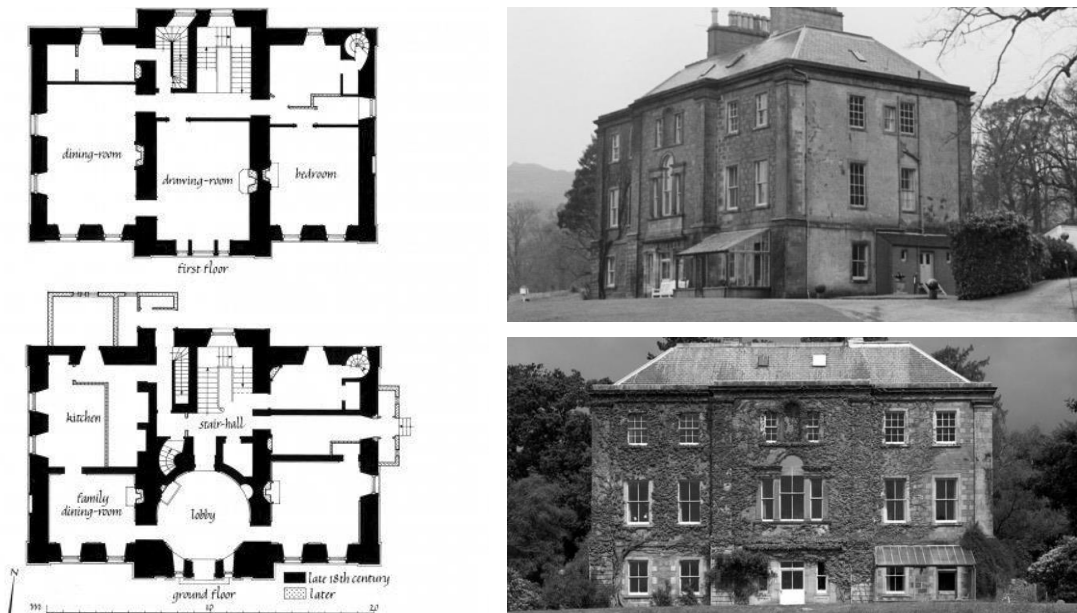
Figure 4.26. Asknish House, Lochgilphead, Argyll. Plans and south-west elevations (Image credit: Canmore).

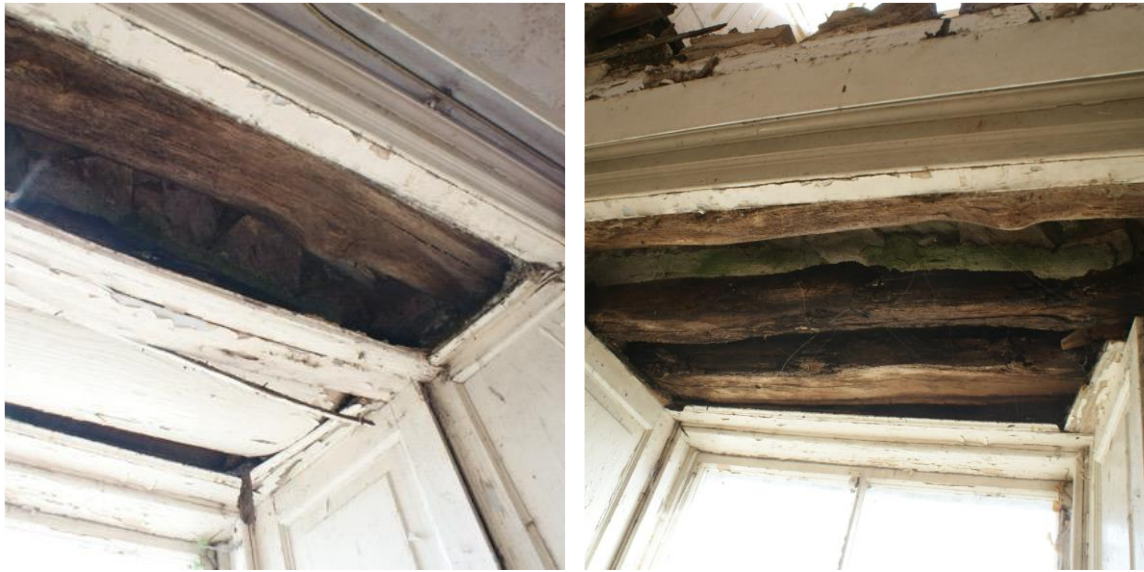
Figure 4.27. Decayed timber safe lintels.

Because the timbers were embedded in the walls and placed on timber safe lintels, they were vulnerable generally, and specifically in areas of diminished masonry. It is hypothesised that without finish these single skin areas were vulnerable to inundation and therefore decay. Decay initiated slumping of the structure that in turn led to cracking of masonry fabric. Cracking caused further inundation. The sum of the observations is that domestic architecture of the Long Eighteenth-Century has a potential flaw.

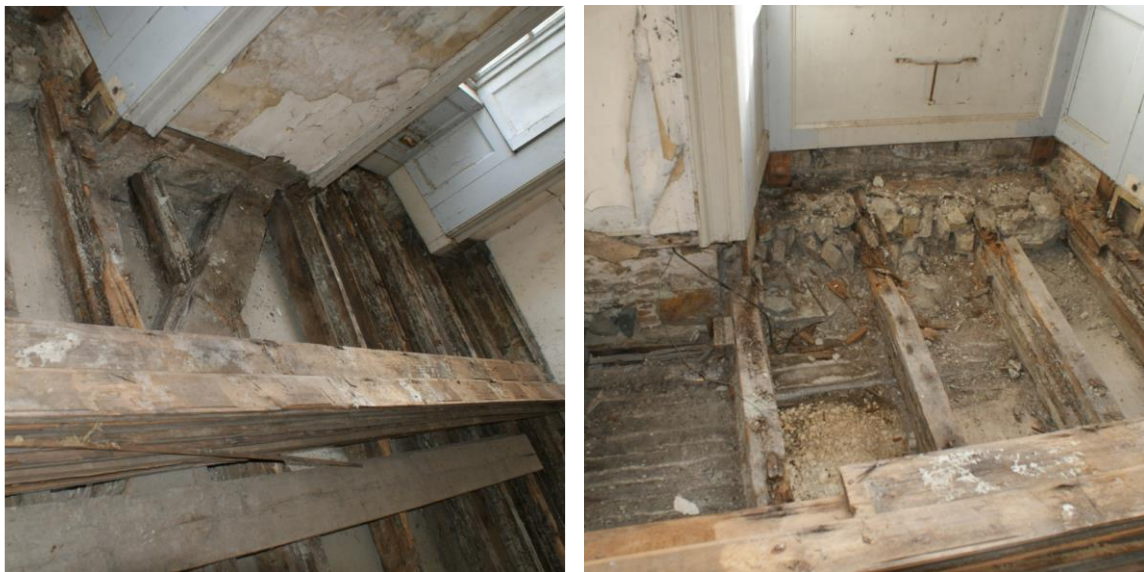
Figure 4.28. The floor joists have decayed after being set into diminished masonry window openings.

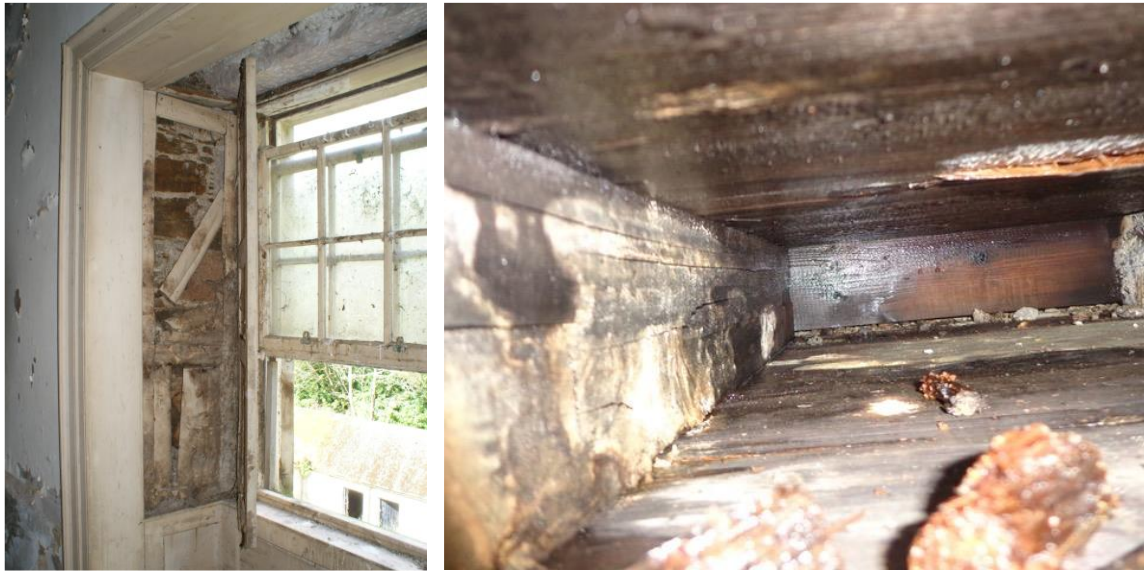
Figure 4.29. Left: window shutters removed revealing damp and decay. Right: In between the floor joists above the window, saturated and much of the water running down the ingoes wetting behind the shutters.

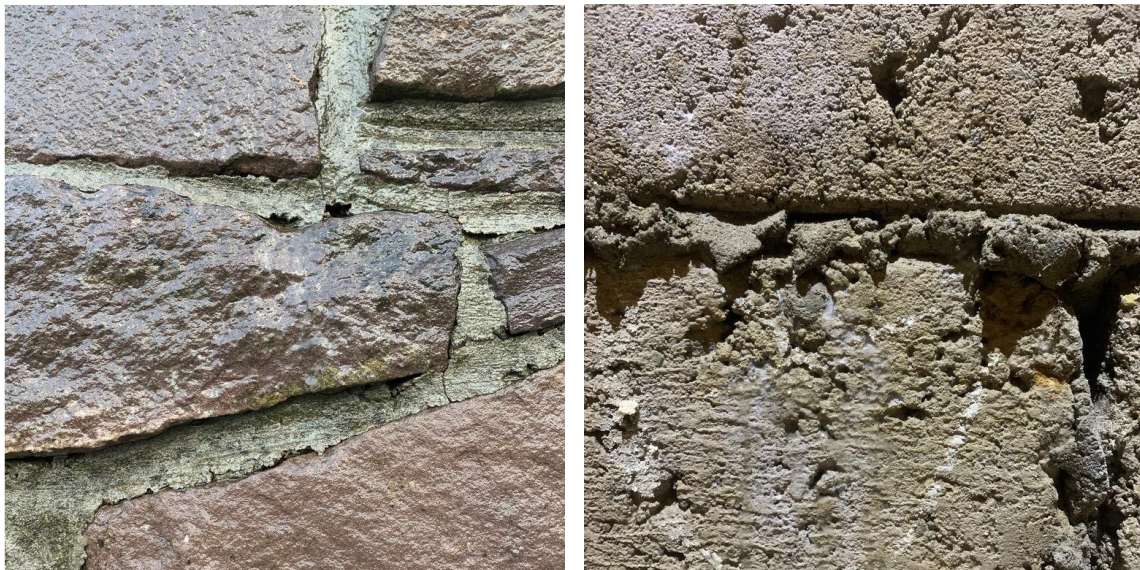
Figure 4.35. Left showing the cracking in cement pointing; Right showing water rivulets running down a cladding of internal blockwork.

During storms Ciara (8<sup>th</sup>–9<sup>th</sup> February 2020) and Aiden (1<sup>st</sup>–2<sup>nd</sup> November 2020), water flooded the south-westerly gable of a cottage in Greenloaning, Dunblane, Stirlingshire (Fig. 4.35). The problem had been long-term because the ~600mm stone thickness had been unsuccessfully internally clad with 100mm of concrete block as a remedial measure. Internal/external pressure readings were taken using a digital manometer (Comark c9500), an instrument used to measure and indicate pressure. Gusting pressure differences of between 10Pa and 280Pa were recorded, with wind speeds of between 70–80 mph and rainfall 100mm–177mm in a 24-hour period (Source: the Met Office).

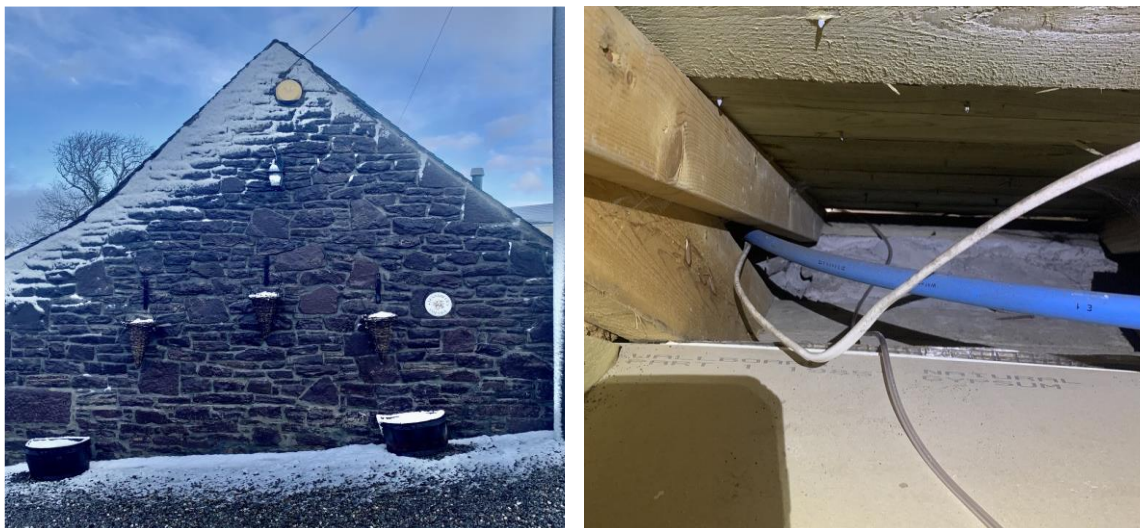
Figure 4.36. Showing the south-west gable of the cottage and the gap between the wall head and underside of the sarking. Note the plastic tube from the manometer directed through the gap to the gable where the pressure readings were taken.

The readings were made possible because there was an 8mm gap between the upper edge of the eaves tabling (the wall head on the side elevations) and the underside of the sarking (the boards that run at right angles to the roof trusses) (Fig

4.36), allowing a 6mm plastic tube to be threaded through the gap, around the corner to the exposed gable and fixed to the external gable wall face using electrical cable clips. The opposing end of the tube was attached to one of two ports on the manometer. The second port had a short length of pipe measuring pressure within the loft space, so the difference in pressure between the external wall face and the interior of the loft was measured. The cracking in the mortar joints was obvious but very small. The space between the wall head and sarking was sufficient to show daylight down the whole length of the building on both sides. The space facilitated exfiltrating air to escape the roof space. In addition, air was able to exit the slate roof between the sarking boards and slates. The sum of the exfiltrating air and pressure was therefore greater than the sum of infiltrating air and pressure on the windward gable end, resulting in lower pressures generally within the roof space and extreme pressure differences during gusting.

While Chapter 4 and 5 have focused on the vulnerability of the under-sill area, it is also possible to consider a scenario where a broader wall with external and internal skin, measuring ~600 mm cannot always be regarded as sufficient to resist inundation in storm conditions. This was highlighted in Chapter 5 when pressure differences during storms Aiden and Ciara led to penetration across the full width of the wall with no external finish (Fig. 4.36). The problem is likely to be exacerbated

A parapet wall presents several difficulties: they are applied to prominent architectural features, often in exposed locations and located at the top of the building. As Figure 4.36 shows, where positive pressure is exerted on the windward side of a structure, the leeward side experiences negative pressure, a position replicated on a parapet wall. Parapet walls are less than the full width of the masonry below roof level and often a single skin. A single skin masonry wall has multiple transverse joints, and pressure-driven water inundation is a likely source of water damage within the building. This is because there is no horizontal damp proof course between the main body of the wall and the parapet, so water pulled through the parapet is likely to percolate down during storm conditions and for several days after. The exposure of skewes and crowsteps present the same scenario where they are windward facing.

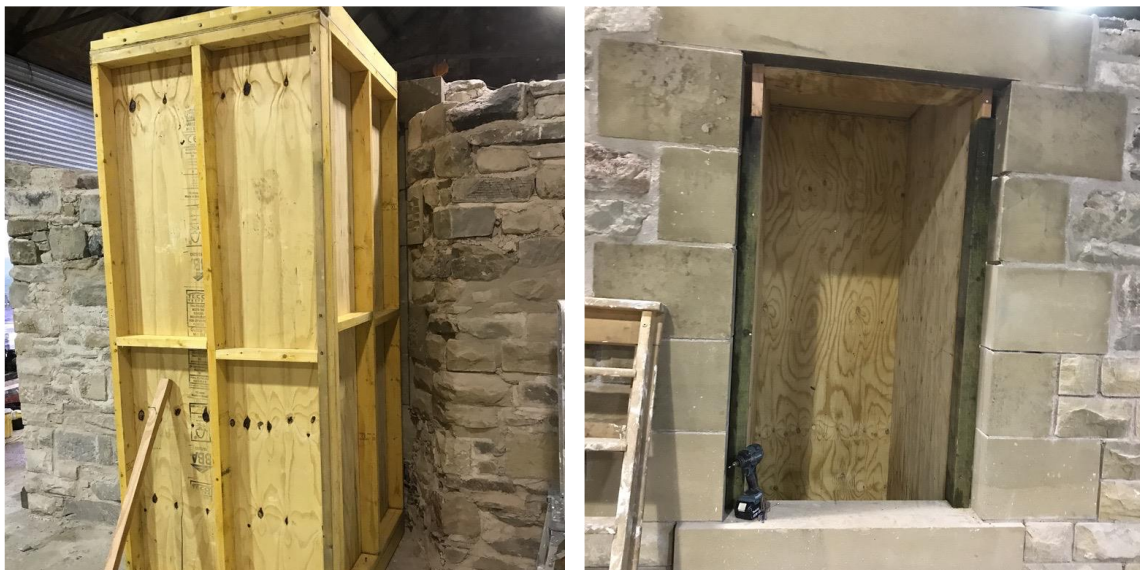
Figure 5.3. Left: The chamber located within the enclosure. Right: Chamber seen from "outside" the window.

was used during assembly and as a secondary application in the internal angle of the corners once construction was complete. The completed chamber was abutted to the internal stone embrasure (Fig. 5.3). Any remaining discrepancies in the wall profile were also filled with expanding foam (Fig. 5.4).

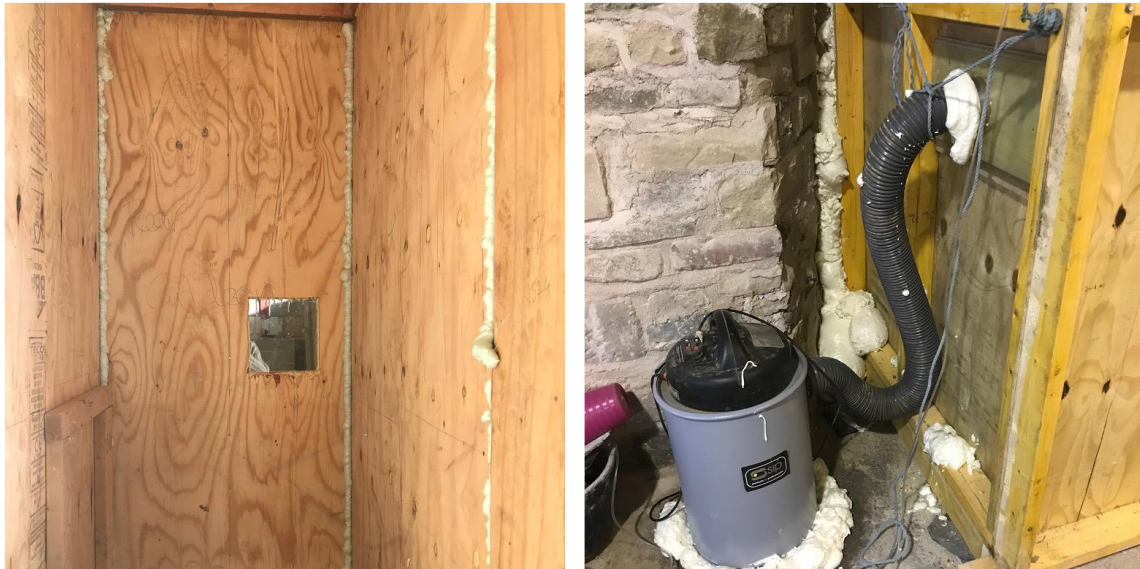
Figure 5.4. Left: the panels, sealed with foam. Right: The installation of the dust/air extractor and the discrepancies between the scribed chamber and stone wall, filled with expanding foam.
