**Cultural and physical factors in the history and  
development of traditional external wall  
coatings in Scotland**

Timothy John Meek  
MA

Thesis submitted for the degree of Doctor of Philosophy

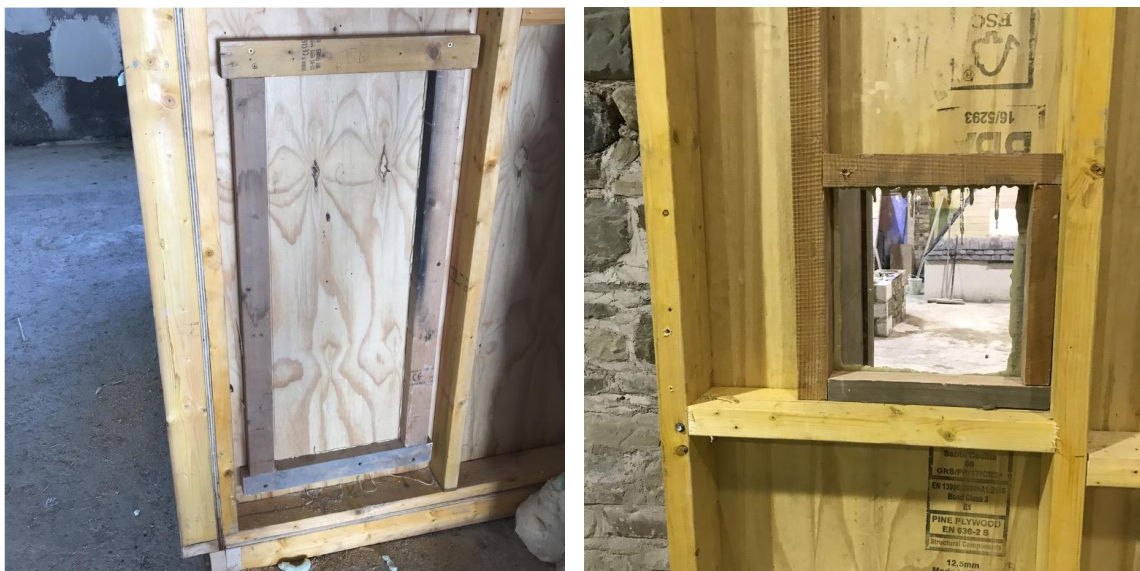
Figure 5.5. Left: the door. Right: The window.

A side 'door' was also cut into the right-hand side of the chamber, using CLS to create an internal frame. Once the ply was freed from the opening an internal frame was made using CLS. The frame was 25mm smaller in width and height than the newly-cut opening and secured back to the panel using Gorilla Glue and 4.8 mm x 50mm screws. Once the glue was cured the sheathing ply panel could be relocated with something to resist against and stop it falling back into the chamber. To secure the 'door', a second external frame was made, adhered to the door panel and allowed to cure. No hinge mechanism was used for opening and closing the door as this would have been impossible to make airtight. Instead, the door was secured with screws each time it was opened and closed (Fig. 5.5).

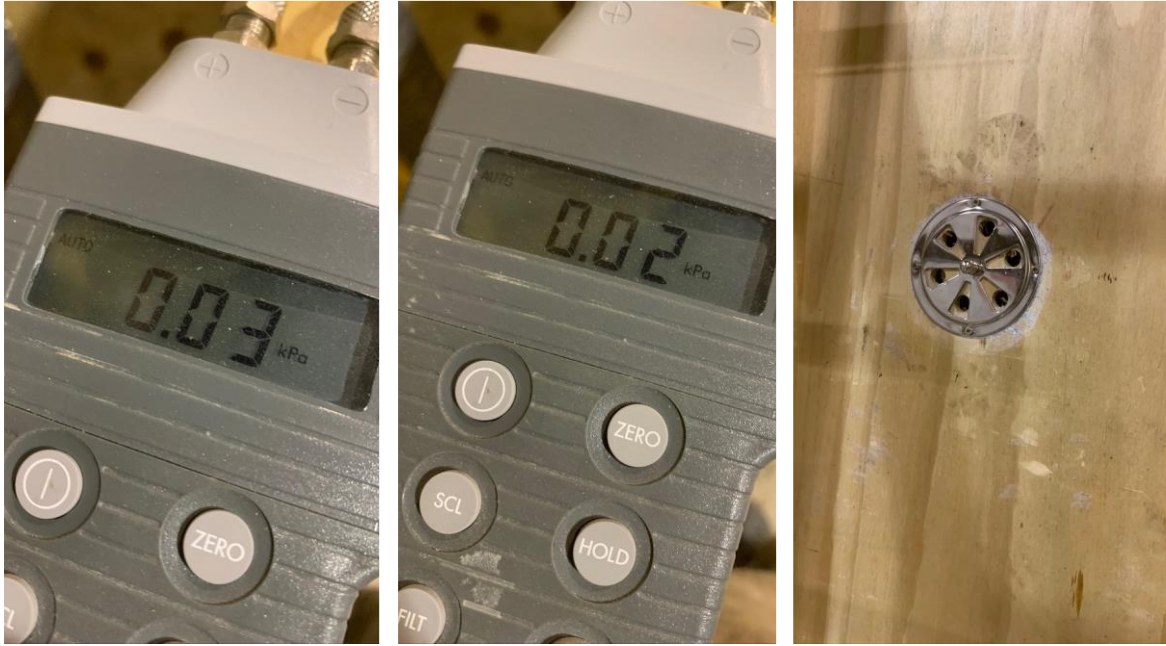
Figure 5.6. The boat vent (right) allowing pressure to be regulated to 20Pa, with a resolution of ~10Pa intervals.

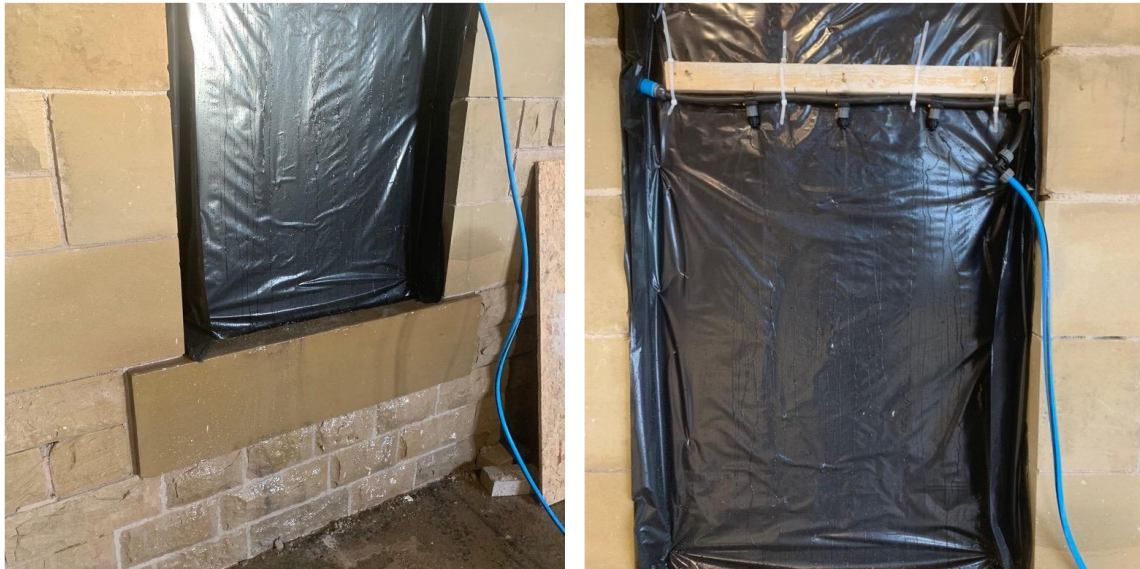
Figure 5.7. The 'window' frame showing the Visqueen membrane sealed to sides and base to simulate the windowpane. Right: Irrigation system.

Given the amount of water to be delivered to the window opening over a prolonged period, it was deemed important to ensure a regulated supply of water. An independent hose system using an off-the-shelf Hozelock garden irrigation system from the tap to the ruinette, (a distance of 12m) was installed. A universal pressure reducer (HUPR7022) was fitted to the tap and joined to a 13mm Ultraflex hose pipe. At the wall face this was joined to a 13mm flexi hose (HFH7021) via a hose repair connector (HPC44928) and detailed into the window opening using 13mm elbow bends (HEB7019) to ensure accurate fitting within the window opening. A short length of the flexi hose was cut to the width of the window opening and terminated with a universal end plug (HUEP7016). At intervals of 175mm, three universal drippers (HUD7011) were secured to the hose with universal sealing clips, (HUSC7014). These sealing clips have integral cutters so that when they are tightened, they puncture the hose. The drippers were set to deliver water downwards and have twist-cap controls so when fully tightened they do not release water. By turning the caps anti-clockwise water is released. The volume of water discharged is controlled in this way. This short length of hose fitted with the drippers was fastened to a timber baton that in turn was secured to the ply and Visqueen cover (Fig. 5.7). The baton with hose remained in place for the duration of the experiment. When the hose system was not operational it was disconnected and stored away, allowing the SLCT to function normally.

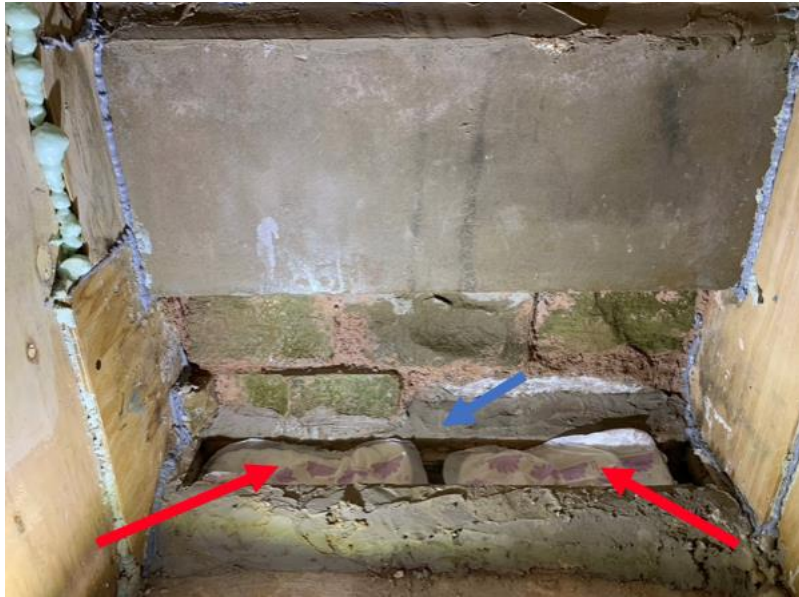
Figure 5.8. The trough permanently fixed with water tabling. The pads in place and joints in the chamber sealed. Red arrows indicate the mats: blue arrows indicate the water tabling.

A system of direct water capture and measurement was developed, and pursuant to this a fixed trough with water tabling was installed (Fig. 5.8). A trough made of galvanised steel with stopped ends was fitted to the floor of the chamber at 60 mm from the face of the wall. The gap was necessary because of the uneven texture of the internal stone wall face. The trough was fixed permanently within the chamber: firstly with expanding foam to secure it in place, then more permanently it was built in with stone bedded in fast-setting, water-resistant floor and wall tile adhesive conforming to C2FT EN12004. This micro-building work was raised higher at the inside of the wall face and ran down to the edge of the trough. It was then provided with a smoothly troweled finish, so any water was tabled into the trough.

Two Tena 'Discreet Maxi Incontinence Pads' (hereafter referred to as 'pads') were placed in the trough (Fig. 5.8 ). Each pad is made from a combination of paper pulp and a propriety 'super-absorbent' polymer with 340ml capacity. Additionally, a 'Tena Bed Super Incontinence Mat' 60 x 90 cm (hereafter referred to as 'mat') was placed against the wall during the two-minute trial because at 70Pa pressure differential, spray was noted entering the chamber. A Tena mat is similarly superabsorbent, with a capacity of 700ml. The mat was slightly oversized, so it sat *in situ* without being fixed. The purpose of the pads was that they absorb water instantly so that it can be weighed. The mat was employed to account for any spray that might not be visible and was also used to 'mop up' after each test was completed. In this way all the

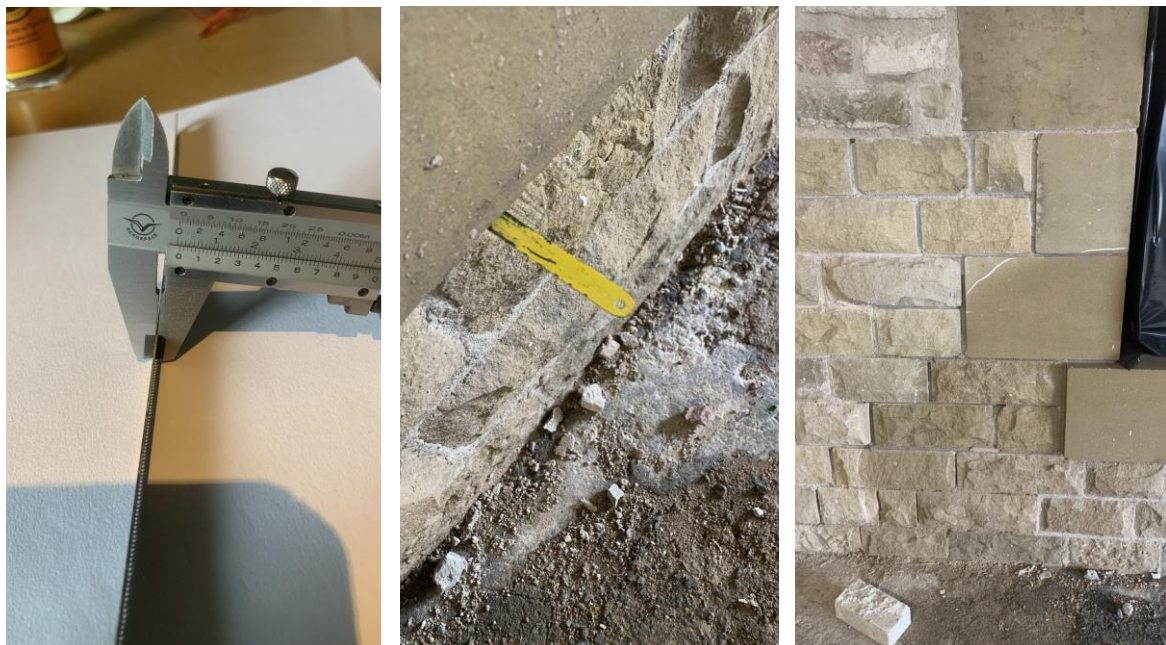
Figure 5.9. Replicating the under-sill crack with manufactured slot using a modified saw blade.

The mortar joint below the sill was cut away with an angle grinder, the finished slot size varying from 2 to 5 mm and extended 478 mm along the width of window opening. Once the slot was cut, the PD between the chamber and ambient air was adjusted to 70 Pa using the vents. To represent fine cracking the slot was reduced using a Prompt-based mortar mix. Prompt is a natural cement and offers a swift, controllable set. Prompt was mixed with silica sand at a rate of 1:2 by volume. This was followed by taking a standard ~1mm hacksaw blade and filing it down to ~0.65mm thickness to make a narrow slot while retaining a degree of strength and rigidity in the blade. The mortar was firm but not hard (state that is referred to as “leathery” in the construction industry), the filed down blade was pushed through the Prompt mortar and ‘sawn’ across the 478 mm slot, reducing it to ~0.65 to ~1 mm width (Fig. 5.9).

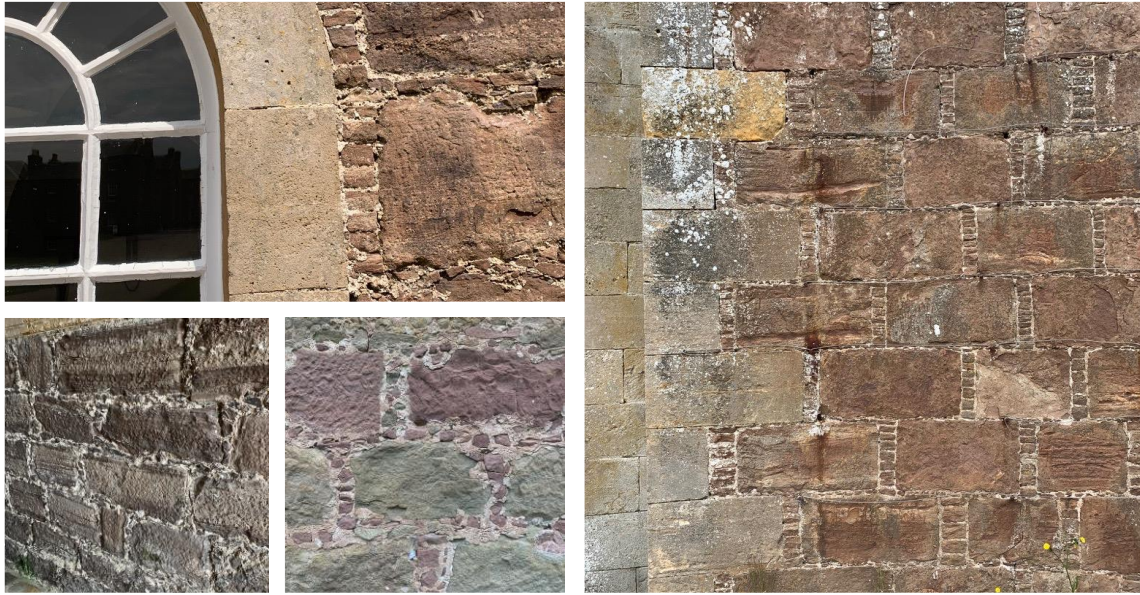
Figure 5.15. Eighteenth-century cherry-cocking/galletting used between the blocks to reduce water penetration.

Minor cracks in walls of diminished single skin masonry are problematic because they increase the pressure difference when the sum of infiltrating air on the windward elevation is greater than exfiltrating air on the leeward elevation. It is significant that the survey showed that shrinkage in lime mortars was a recognised phenomenon in the eighteenth century, as evidenced using cherry-cocks/gallets (Fig. 5.15).

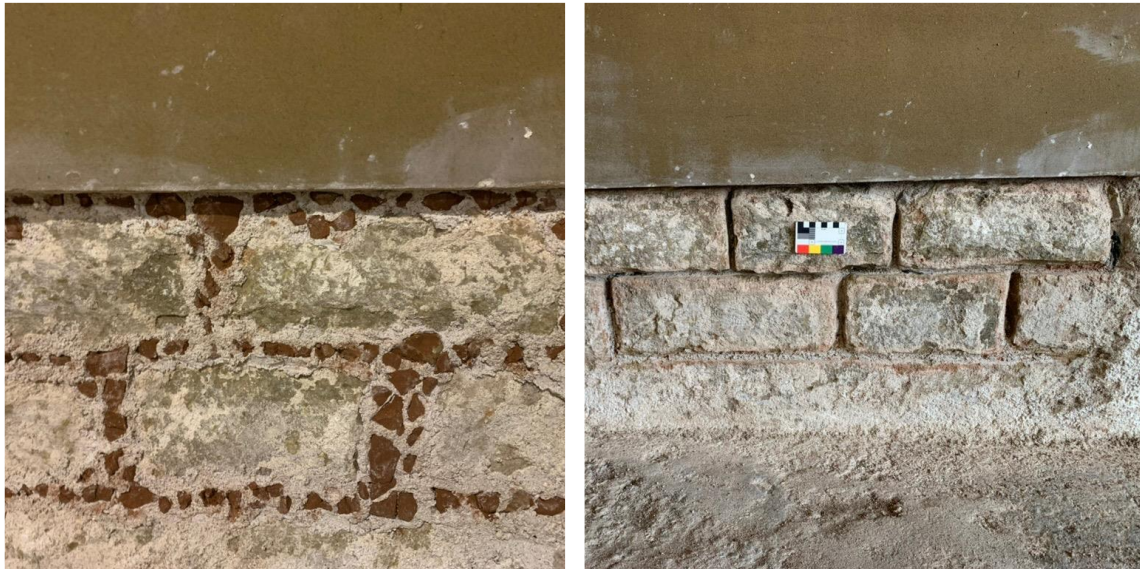
Figure 5.16. Galletting, the latest iteration of the HMM trial that has negated shrinkage at this stage of the process.

As the thesis demonstrates, there are vulnerabilities in reducing wall widths between windows which are clearly visible, often from ground level and travelling up through the structure. Given that these represent movement it is reasonable to assume that there will be smaller invisible cracking taking place. The water bubbles observed within the chamber are illustrative of the micro-cracking expected when buildings make imperceptible shifts. The experiment at the SLCT is ongoing: the HMM harl removed and the joints cleaned, repointed and tightly cherry-cocked/galletted with HMM. It is too early to provide trendlines, but the process of packing out the mortar joints has negated all visible shrinkage from the building process (Fig. 5.16). Given the structural movements noted in the survey, the use of cherry-cocking/galletting with lime mortar would be a means of effecting repairs to the crack without the risk of shrinkage, the joint less reliant on mortar and more on packing with a solid material. This would have the extra benefit of reducing the time of curing/carbonation because there would be less mortar.

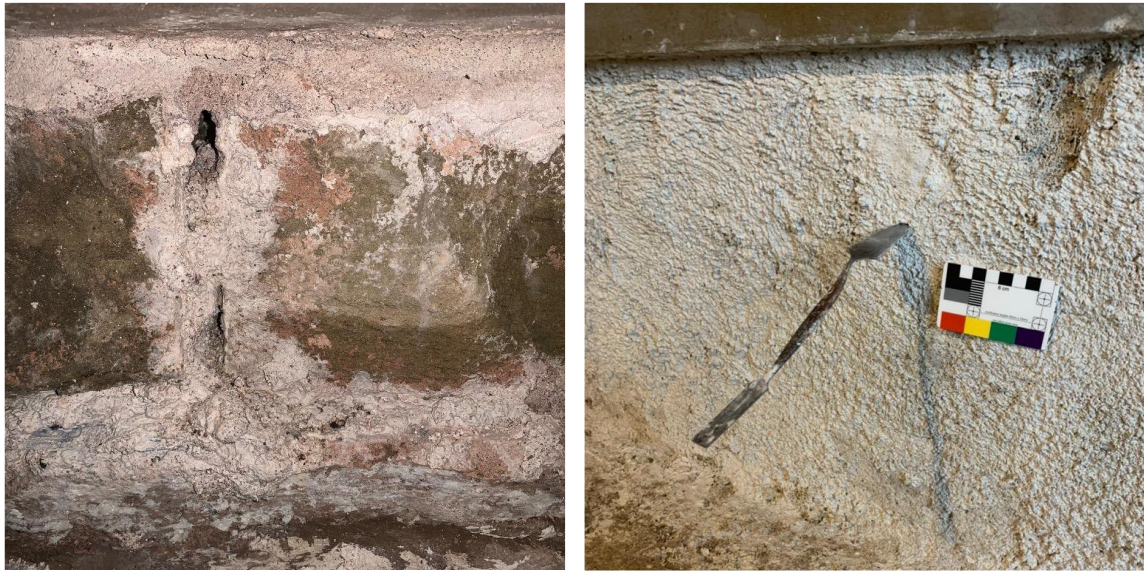
Figure 5.17. Breakdown (left) and softness (right) of the HMM harl and building mortars after repeated PD runs.

Once cured the NHL 2 mortars remained resilient throughout the programme of works. This contrasted with the HMM that at all stages – sneck harl, harl, harl and limewash – had significantly degraded after each pressurised test, and it is likely that had the trials continued, they would have washed away from the surface and some of the joints. Furthermore, had the experiment been subjected to freezing, the saturated mortars would likely have been further damaged (Nunes & Slížková, 2016; Török & Szemerey-Kiss, 2019). This observation correlates with the findings from the wall construction at Lismore (Chapter 3), where mortar remained plastic below a thin crust in a damp environment. The SLCT mortars were cured in near perfect conditions, protected from sun and temperature extremes, but the 90 days between runs was insufficient for the mortar to have achieved the full robustness (Fig. 5.17).

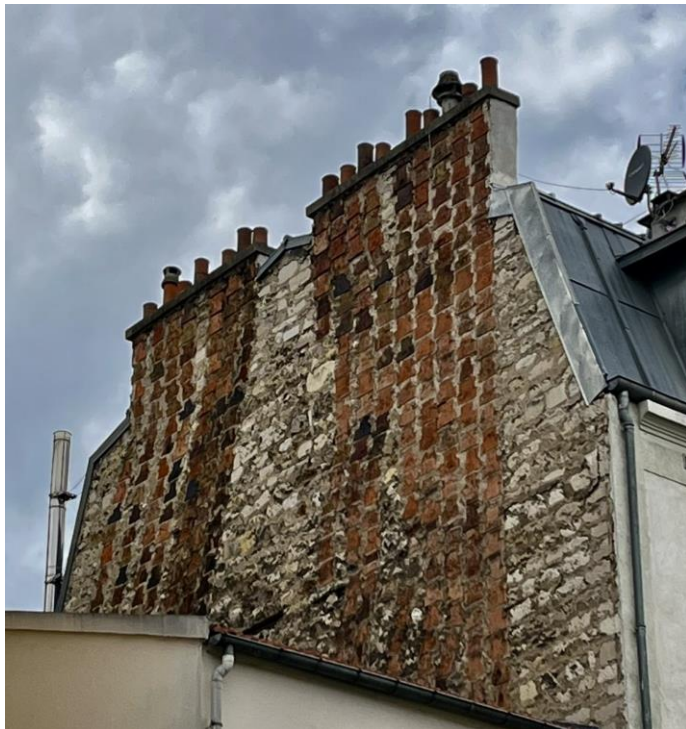
Figure 6.0. Multiple chimney flues in a gable

Chimney flues are often multiple and represent significant reductions in wall widths (Fig. 6.0). . The stack effect in this context will lead to significant pressure differences

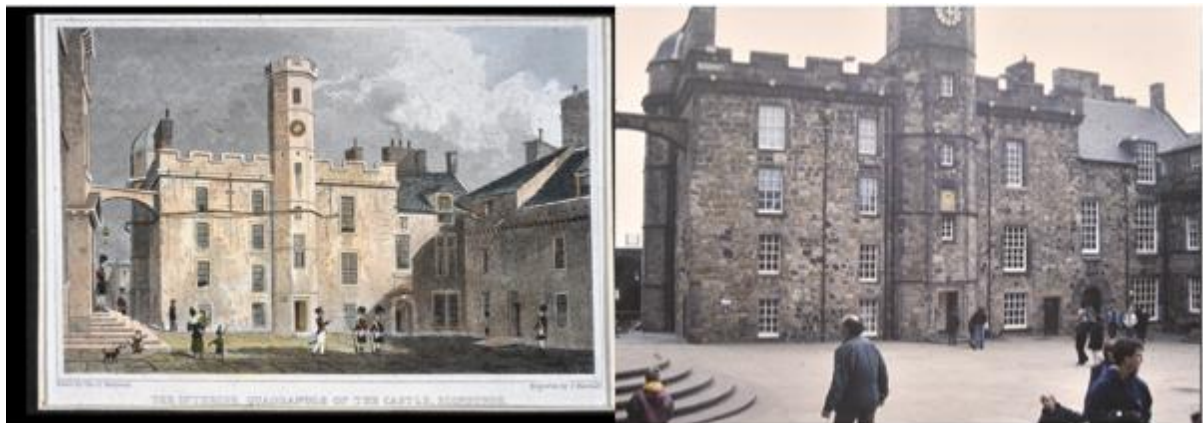
Figure 6.9. Edinburgh Castle Quadrangle c. 1820 and the present. In the former image, harl and limewash are clear to see. Left: a postcard reproduced from Britton (1829); right: author's image.

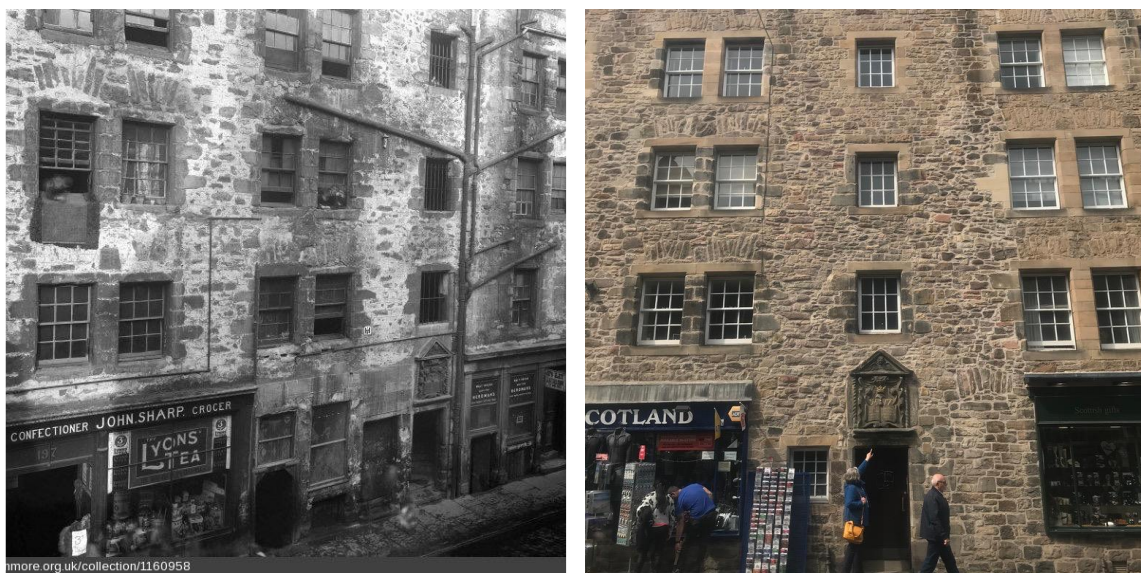
Figure 6.11. Bible Land, the Canongate, Edinburgh. Left: 19<sup>th</sup> century worn, ruled plaster (Image credit: <https://canmore.org.uk>). Right: the Edinburgh World Heritage interpretation of rubble with recessed pointing (Author's image).

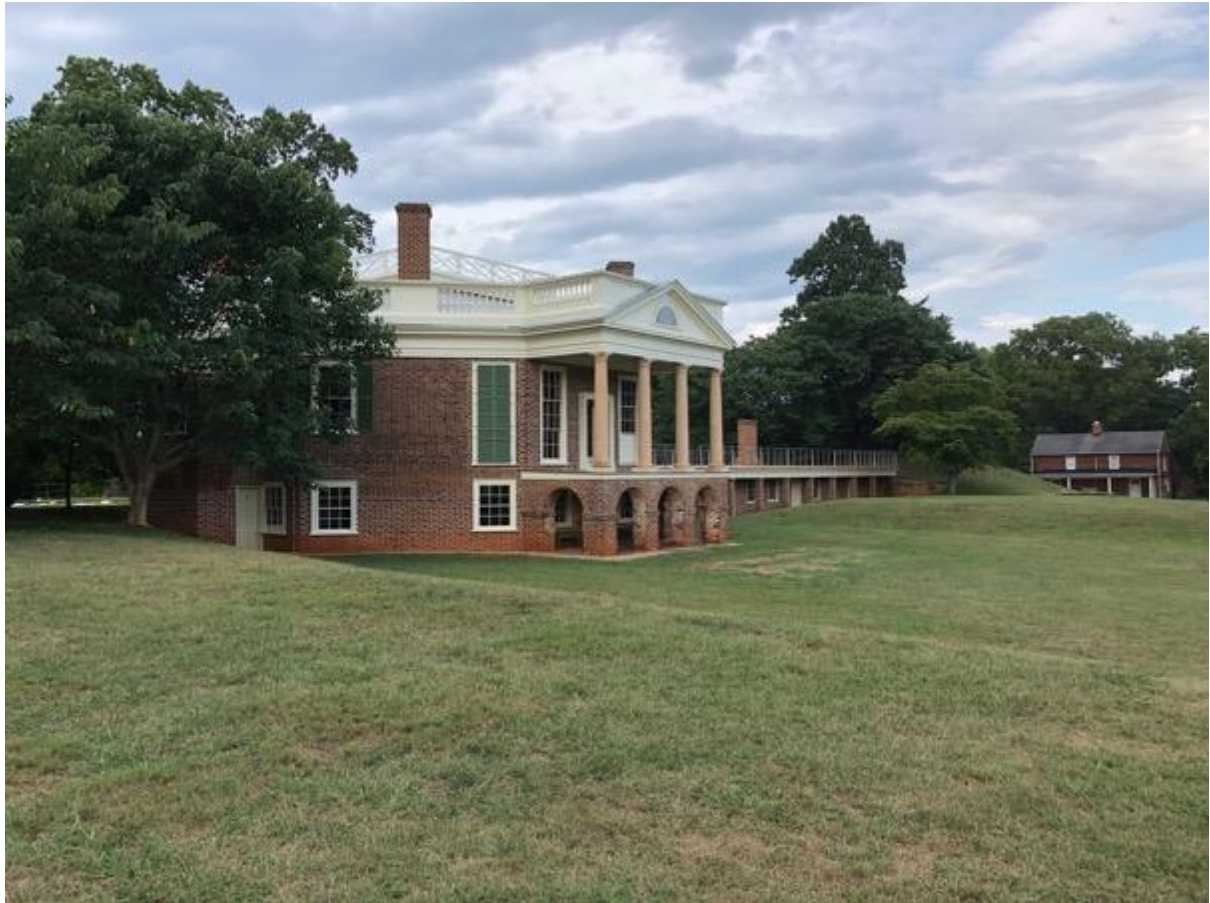
Figure 6.12. The Poplar Forest Octagon, presented as bare brick. Image credit, Tarvis McDonald.

Poplar Forest was to be Jefferson's small but perfect private retreat (McDonald, 2000), and is being considered in its bare brick presentation. . The brickwork at Poplar Forest is of strikingly poor quality; in each elevation, the bricklayers have been unable to keep the brickwork level as work progressed around each face of the octagon, which has necessitated the bricks to be rotated from their natural bedding plane to placing them on their sides (Fig. 6.13). In some areas close to doors and windows, the bricklayer has had to reverse the process to gain height swiftly within the space of 6 courses and accommodate the door head and corner (Fig. 6.14). The brickwork above the door had to be trimmed down ('snap headers') to accommodate the inexpert coursing and at the corner return, what should have been a full brick has been reduced to a 'Queen closer', a mechanism normally used within the wall to maintain bond. It is of note that despite heavy cleaning, there are traces of lime plaster/wash on all elevations.

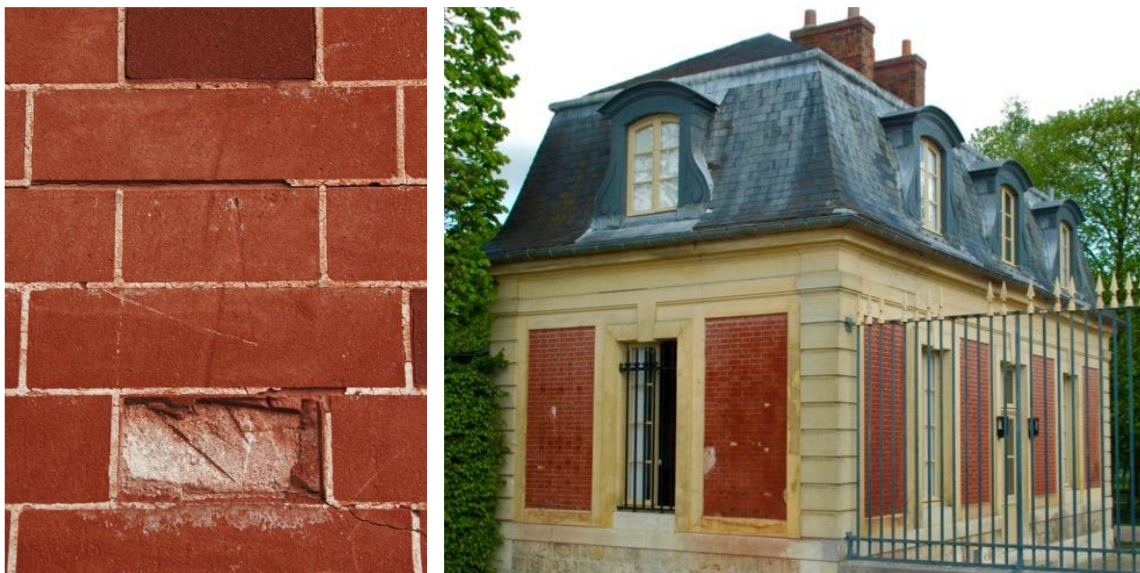
Figure 6.15. The gate lodge from the garden to the alley that leads to Grand Trianon, Versailles. Common brickwork, overlain with plaster, ruled out and white lined to accurately represent fine work. Image credit, Brian Pfeiffer.

Given his skills as a keen observer of detail as well as the form and geometry of neoclassical architecture, it becomes harder to imagine that he did not notice the French method of building in roughwork and common brickwork, but presenting it as urbane and soave as is the case at Versailles (Fig. 6.15), Place des Vosges, Paris. c.1605-1612 (Fig. 6.16), and Château de Carrouges, Normandy c.14<sup>th</sup> century. Given Jefferson's respect for the work of Clérisseau, Rousseau, and Palladio and his experience of the finishes at Versailles, the idea that Poplar Forest is an aberration or folk-art, lacks credibility.

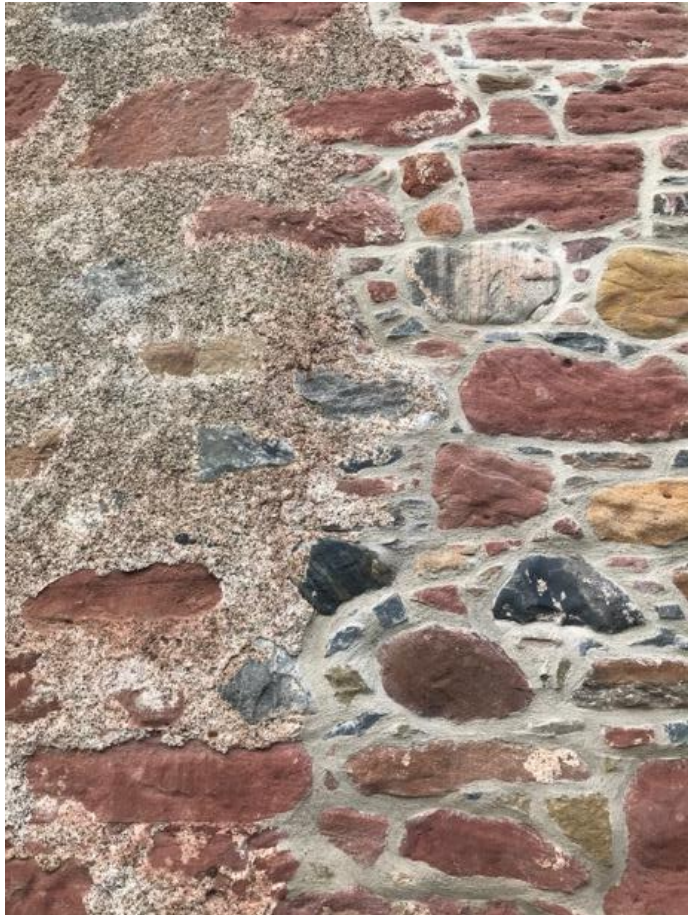
Figure 6.18. New repointing work to worn sneck harl using a style universal throughout Scotland.

and exposing the aggregate. It is a method that replicates binder aggregate dissolution, and therefore seeks to add age value, rather like stripping workaday pine doors and furniture. It is a style with a single justification: we have learnt to admire it (Fig. 6.18).

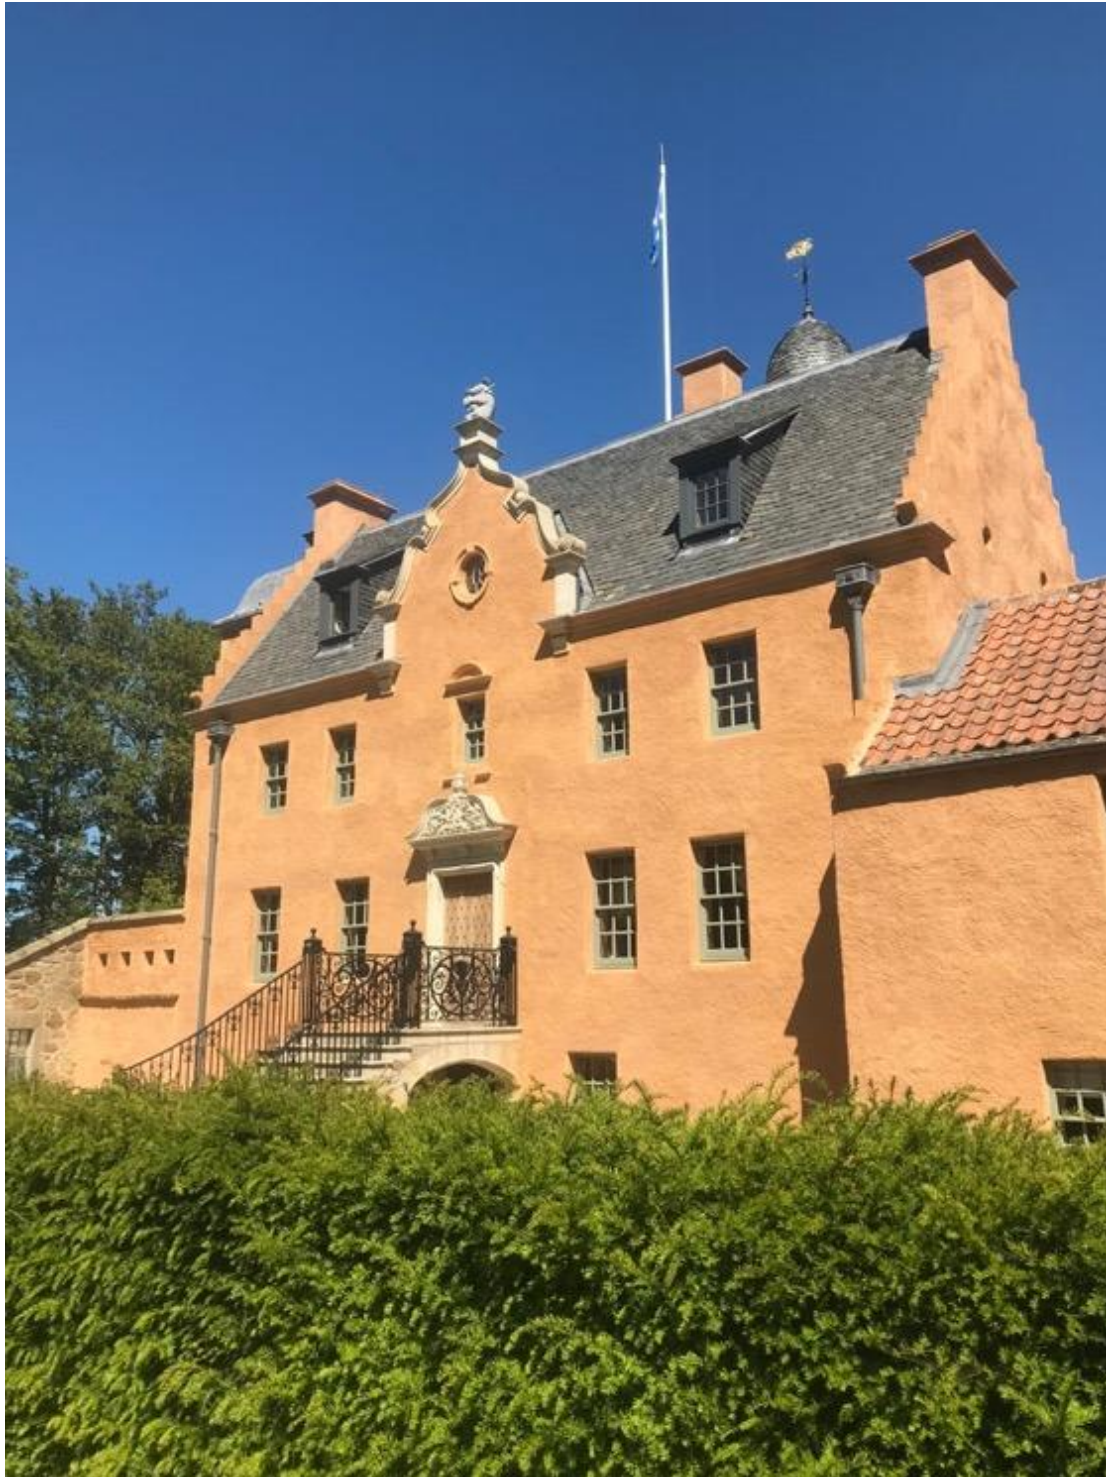
Figure 6.19. Newly harled and limewashed Wormistoun House, Crail, Fife. New work and old blended, protected, seamless and in contemporary world still demonstrating the 'arrival' of the current owners.

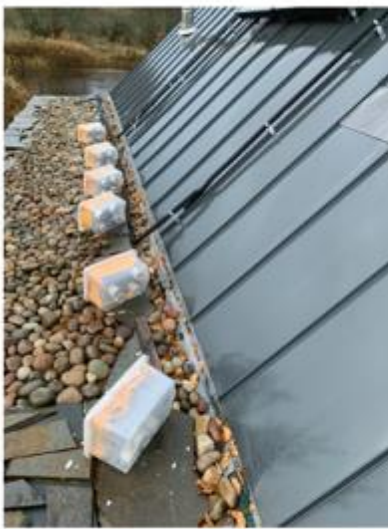
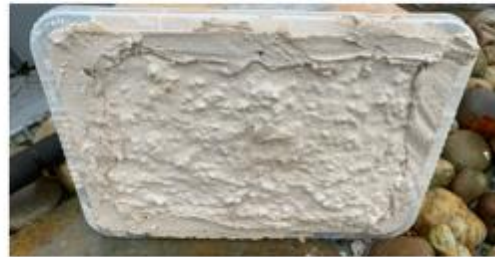
The research included an experiment that examined the humidity and temperature regulatory effect of hot mixed and natural hydraulic lime harl and limewash applied to sandstone blocks. In May 2019, the twelve blocks of Dunaverig sandstone were drilled to a depth of 50 mm to accommodate a IButton DS1923 Hygrochron Temperature/Humidity Data Loggers, (<https://i-button.co.uk/humidity-ds1923>). The blocks were left to cure for eighteen months and then exposed in actualistic conditions at Poyntzfield, Ross shire.

Figure 7.0. The stone samples located at 3.5 m adjacent to a metal roof, each container sealed against WDR.

For several reasons the experiment was unsuccessful, however, the experiment showed the unambiguous, significant temperature regulatory effect that HMM harl and limewash has on sandstone. Bare stone temperatures were always higher than when coated and this was true of harl and harl and limewash. On the 06/08/2020 the bare stone roofline temperatures reached 47° while the harled samples were 11° lower at 36°. The application of limewash lowered the temperature again by 4° to 32°. There was a consistent difference in temperature of 15° between the bare stone and harled and limewashed blocks. The NHL harled blocks showed similar moderating characteristics over the same period. However, at the highest temperatures the NHL blocks were slightly less effective with a degree of difference of 2°. The higher temperatures the greater degree of separation between the HMM and NHL. The trials demonstrated that lime coats make a significant impact, in regulating temperature, a benefit taking on greater significance as daytime temperatures rose to 40.3° on the 19<sup>th</sup> July 2022
