**Ground Penetrating Radar Survey**

**Four areas of Dunfermline Abbey**

**The South Aisle, Memorial Chapel, North Transept and  
North East Dais**

**University of Stirling**

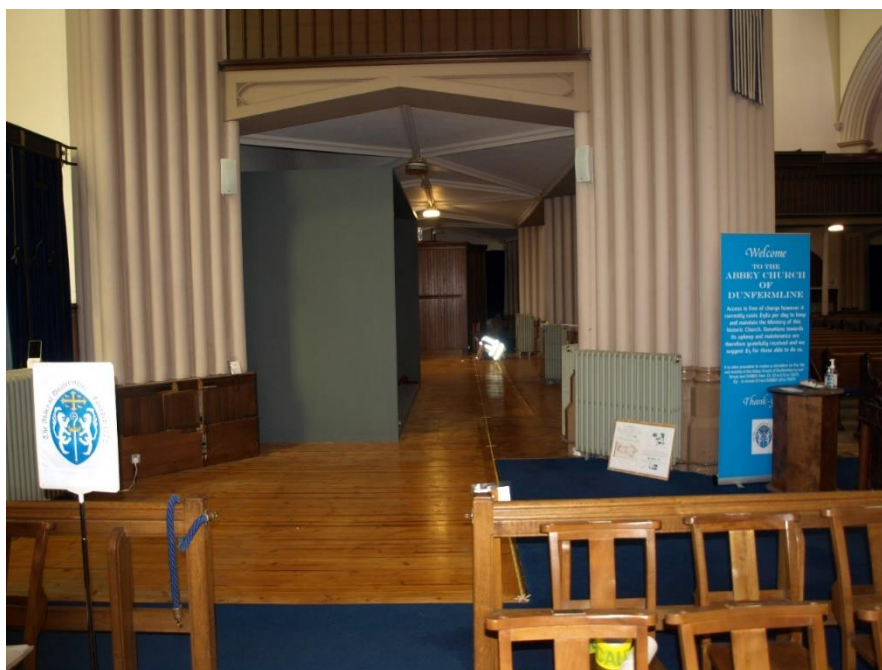
Figure 2: The South Aisle, from the Memorial Chapel looking to the West. Survey line 1 is visible to the right of centre.

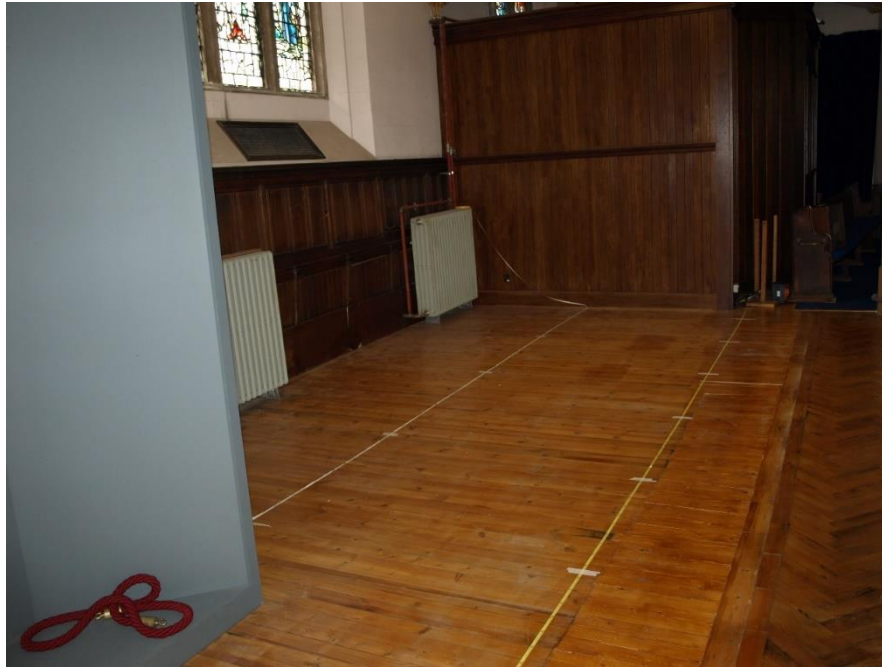
*Figure 3: The position of survey line 2 (white), parallel to and to the south of line 1 (yellow).*

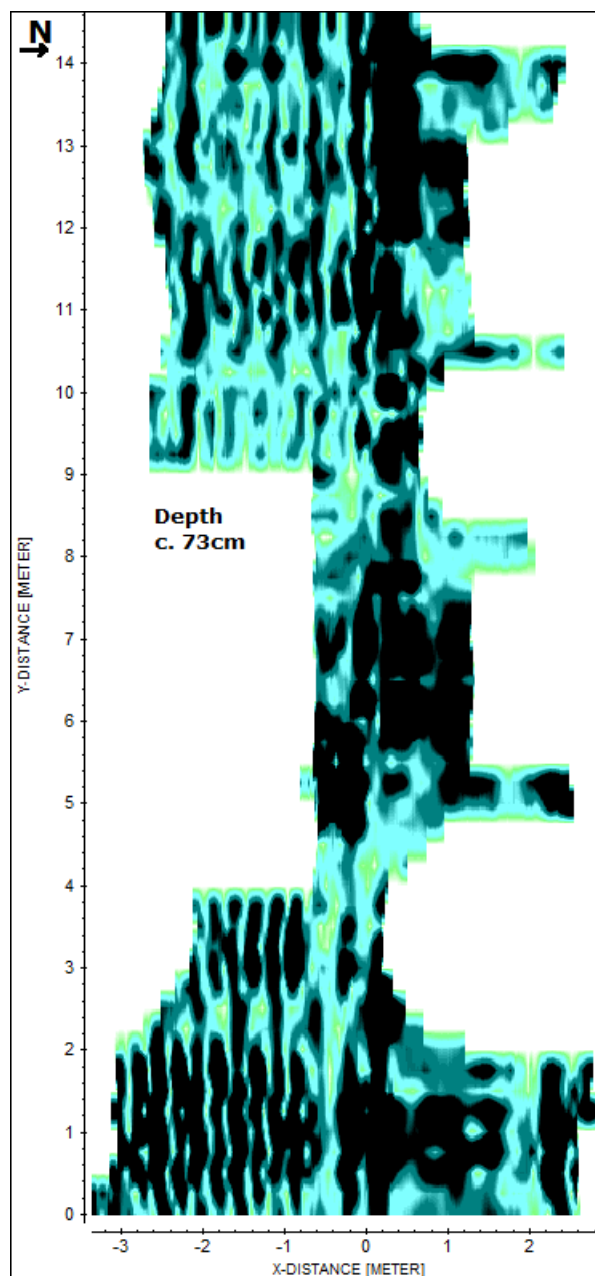
The first change in patterning occurs at c. 73cm (Figure 7). The echo effects from the modern floor are clearly visible on the left hand side of the image. A different pattern of rectangular anomalies is visible between reference line 1 (x =0) and 1.3m to the north (Figure 7).

*Figure 7: Time Slice at c. 73cm depth*

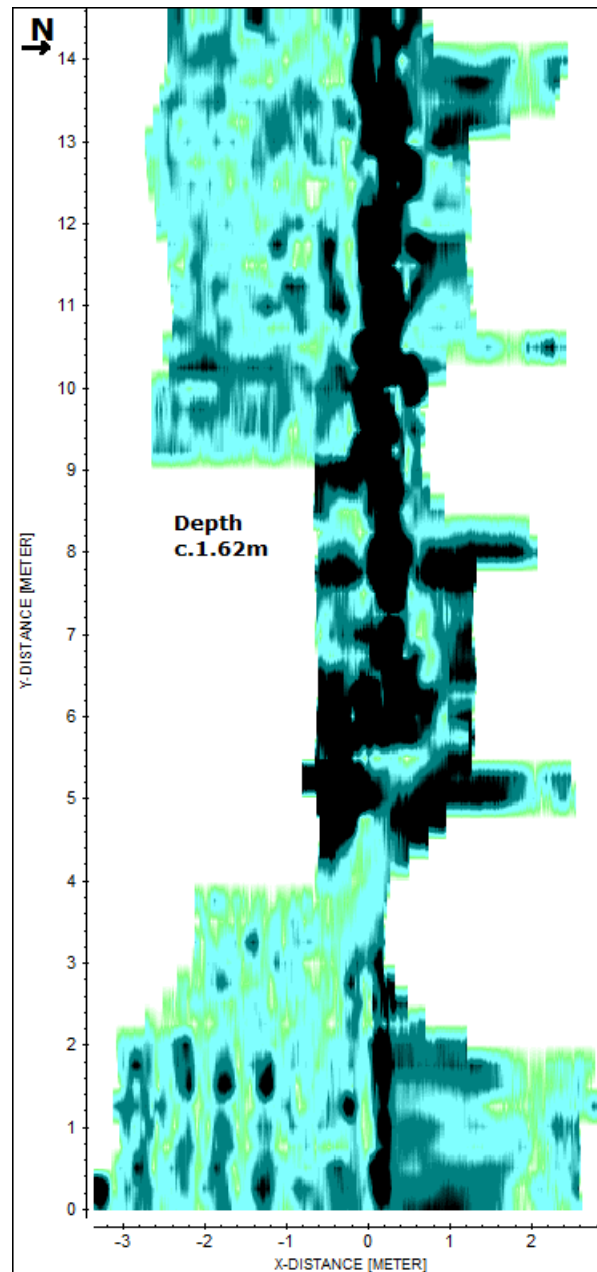
All of these, except for the one centred on  $(x=0.3\text{m}, y=9.25\text{m})$ , appear to be ringing (echo effects) from features closer to the surface. The sole exception could be a partial layer of material, but its position and short length make it impossible to be sure. There is a possibility that this is also ringing.

*Figure 11: Time Slice at c. 1.62m depth*

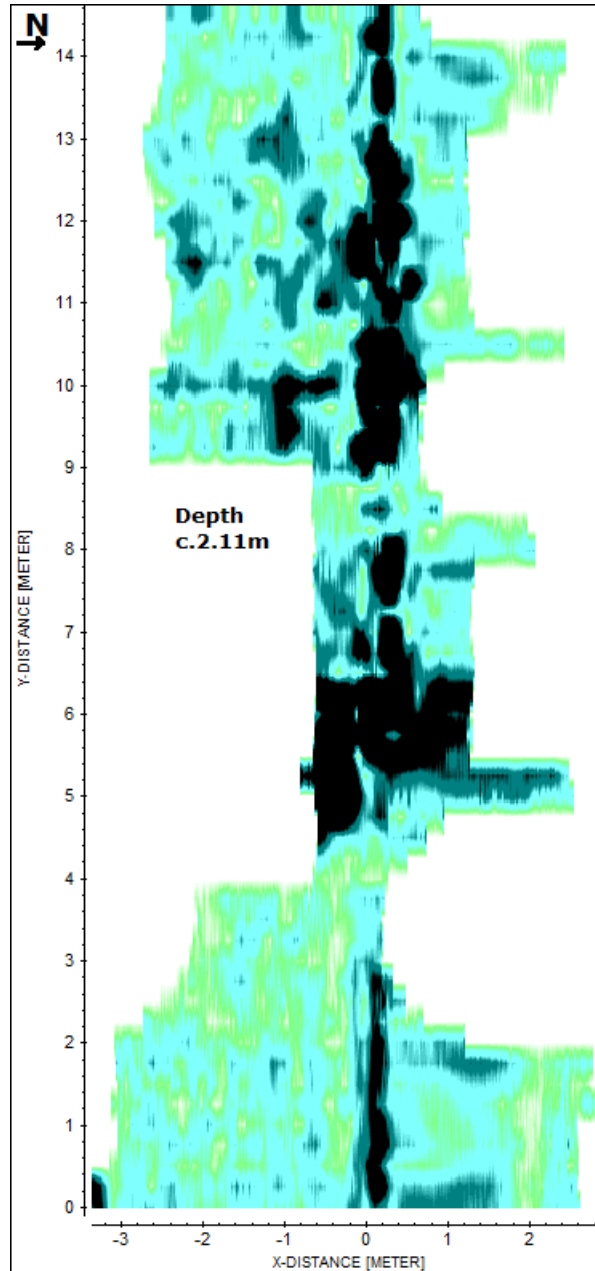
The principal difference between this time slice and the previous ones is the addition of a right angled feature around (x=-1, y=10.25) which might also extend as a linear feature towards the south although the signal returns are weaker along this line (Figure 13). There is still a scatter of anomalous remains in the western section.

*Figure 13: Time Slice at c. 2.11m depth.*

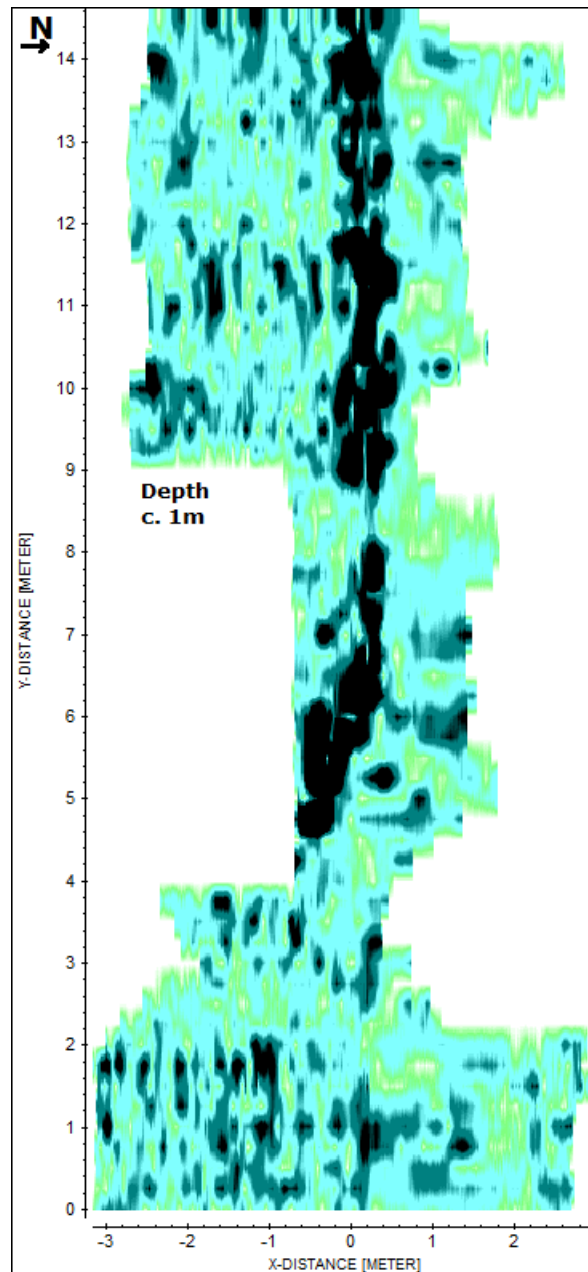
The time slice at c. 1m depth is very similar. It refines the definition of the linear East/West feature(s) and the feature adjacent to the display unit (Figure 17).

*Figure 17: Time Slice at c. 1m depth.*

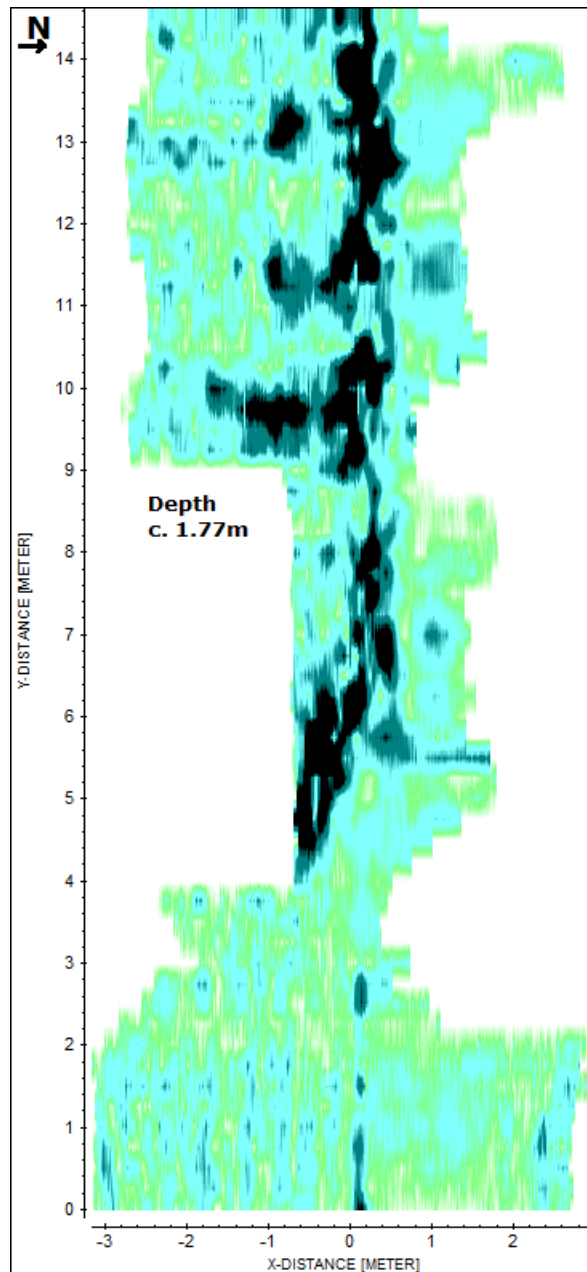
The features visible vary from layer type signals to short stumps of columns and it is reasonable to assume that they are what remains following destruction before the current Abbey church was built.

*Figure 20: Time Slice at c. 1.77m depth.*

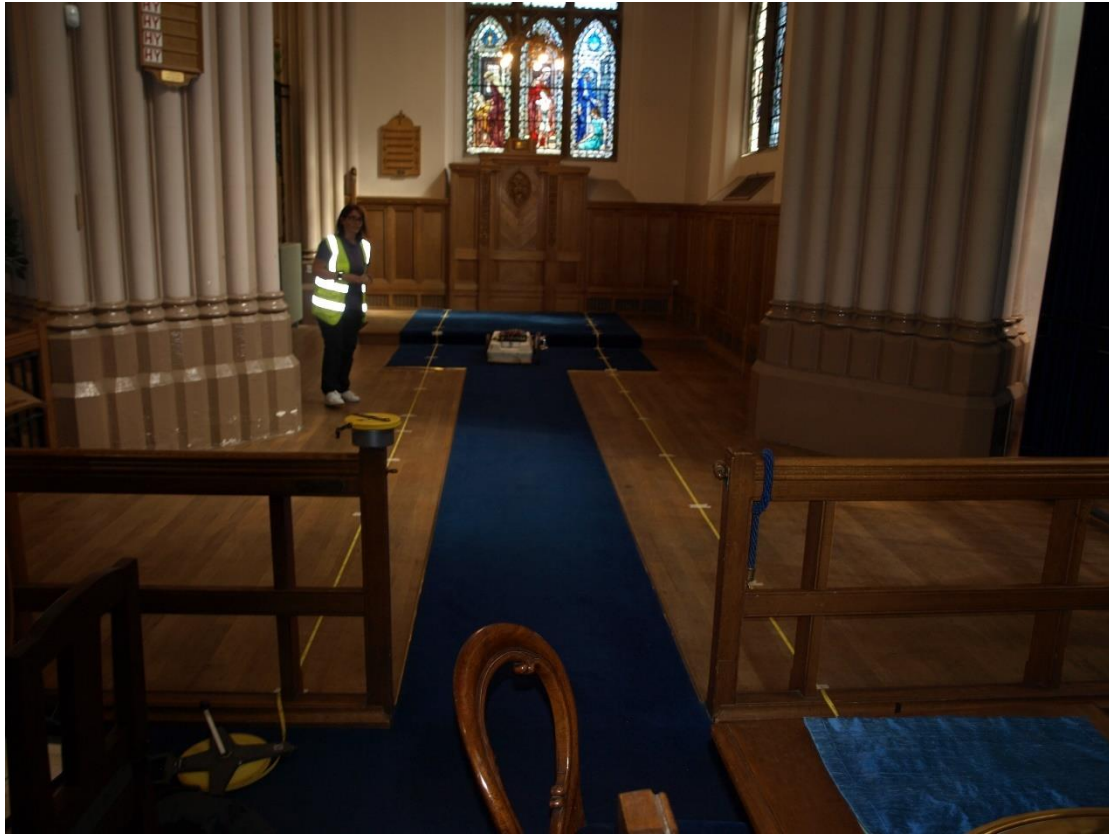
Two parallel survey reference lines were laid out along an East/West orientation, tape 1 to the north and tape 2 to the south (Figure 24). As with Area 1, where a marker 1 or 2 has been placed on the 2-dimensional data, this indicates the position at which the radar crossed this survey reference line. Tape 1 aligns approximately with survey reference line 1 in Area 1. The position of the survey lines were defined by measurement from fixed features as shown in Appendix B.

*Figure 24: Survey Reference lines in the Memorial Chapel Reference line 1 to the left, line 2 to the right.*

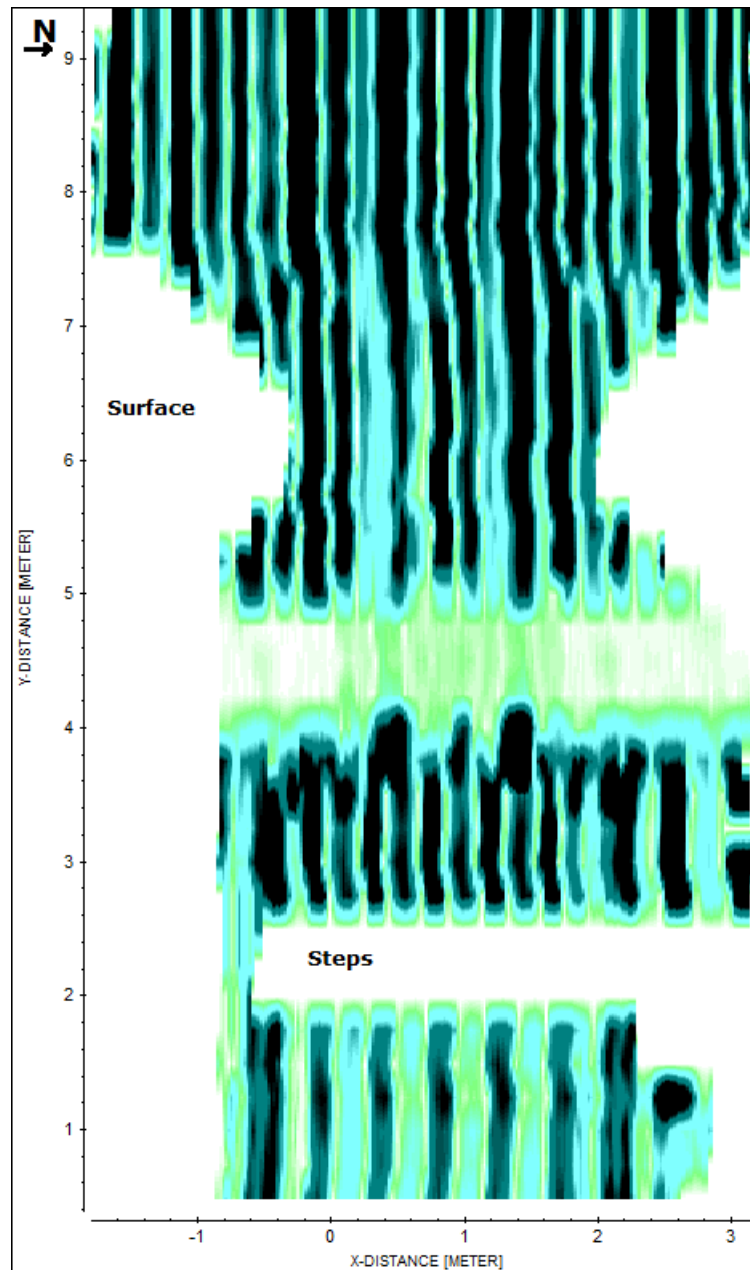
The surface time slice has been included to illustrate the elements of the floor composition which give rise to echo effects lower down. These affect all areas except for a band in the centre of the survey area (Figure 26).

*Figure 26: Surface time slice showing the surface variations which give rise to echo effects lower down.*

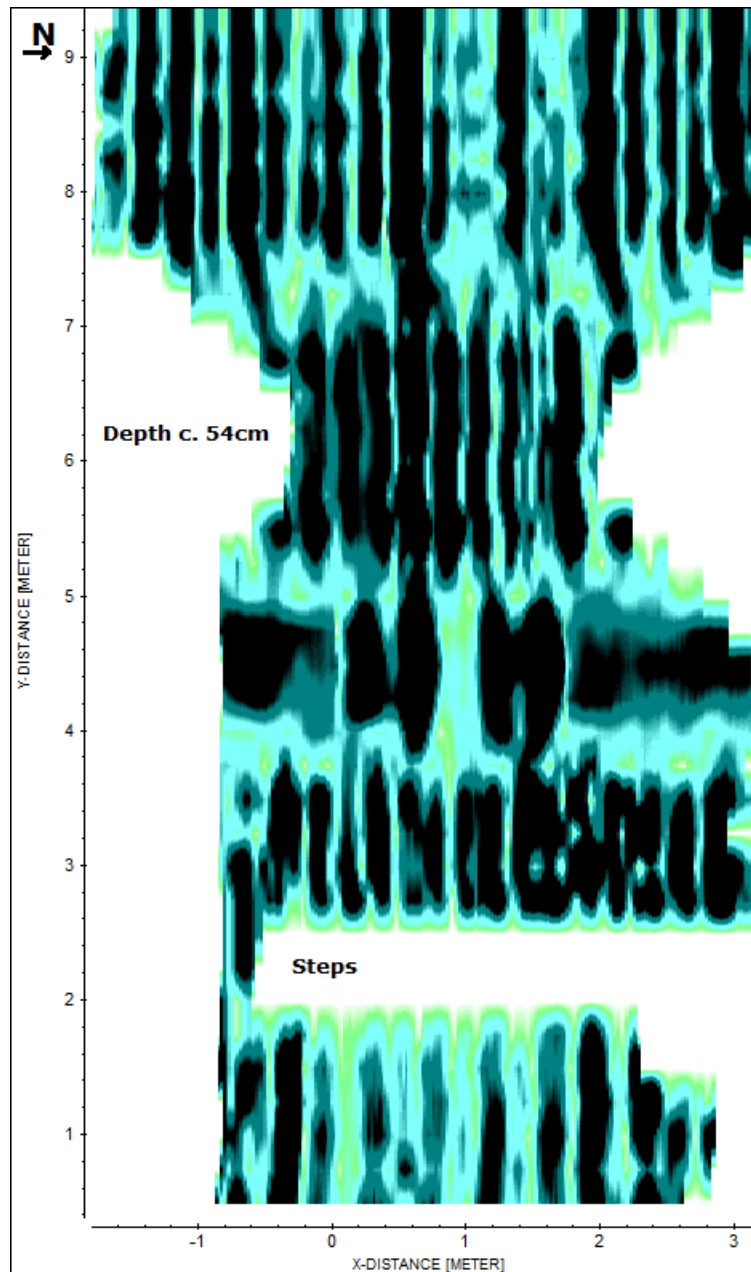
The two central broad linear features coincide in the 2D data with the edges of the carpet. The metal edges to the carpet set up echo effects. Both the outer and inner broad linear features originate in a near surface object at this depth, but these objects also give rise to echo effects below. The resulting pattern is a double column of echoes (Figure 28). It is very likely that the physical features these represent relate to the current parish church.

*Figure 27: Time slice at c. 54cm showing near surface features in the central section.*

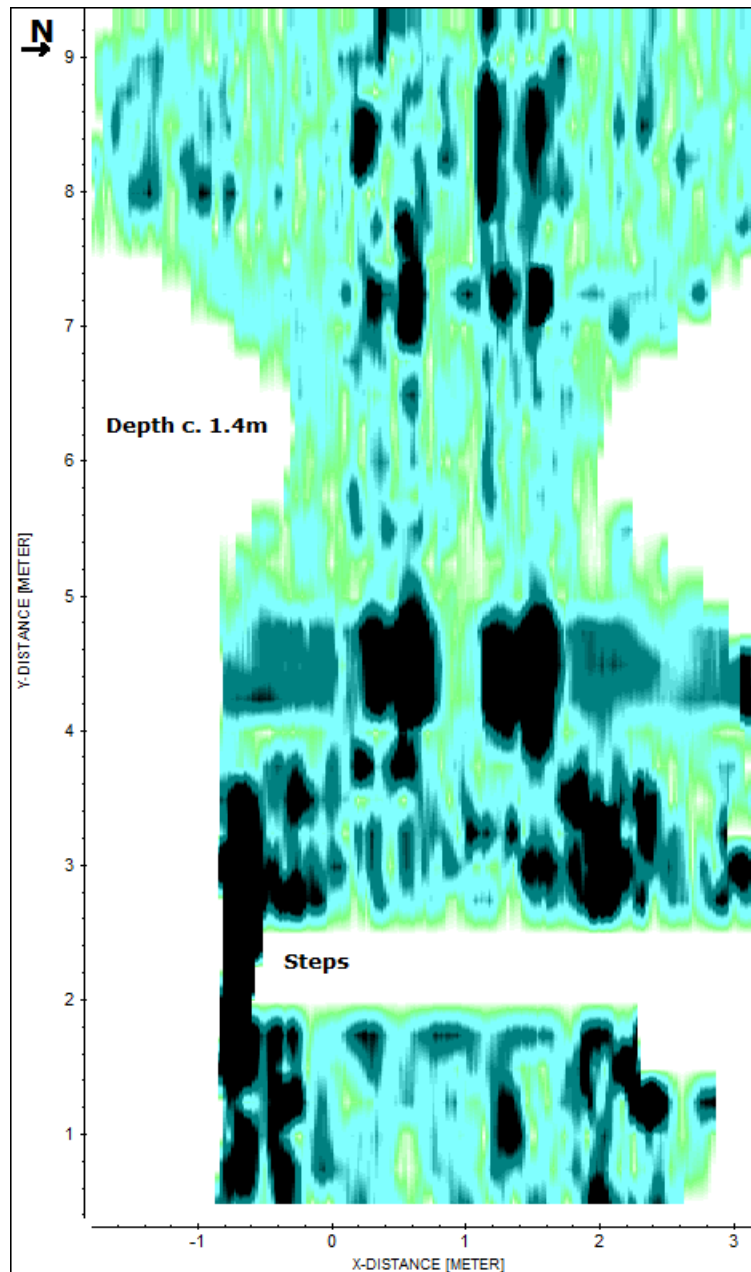
The irregularly shaped feature, from comparison with the 2D data is composed of a short length of column which is close to but separate from the overlying material and therefore may indicate archaeological material. An example can be seen in Figure 25, line 208 at x = 2m (also Figure 33). Alongside this are small remnants of material. The impression is of a damaged section of construction, possibly a wall or partial floor, oriented East/West surrounded by remnants of associated material.

*Figure 32: Time Slice at c. 1.4m depth.*

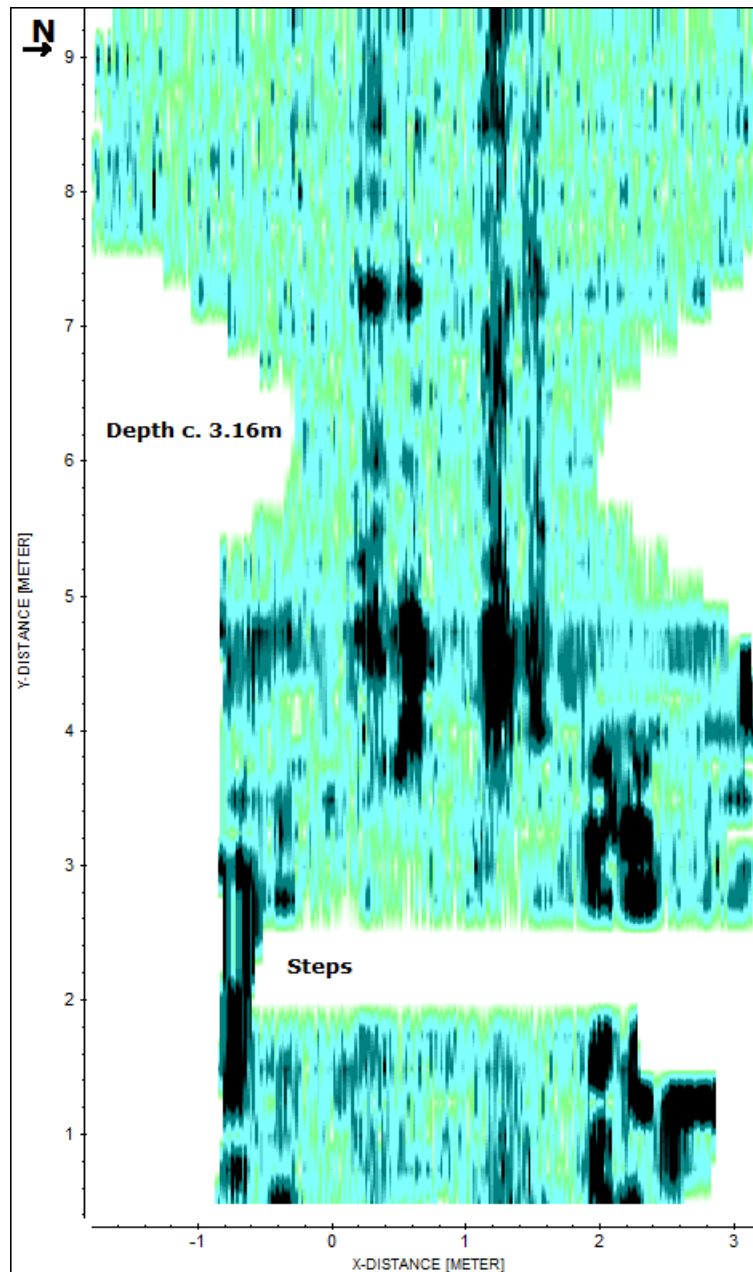
Below this level there are changes in patterning, but these reflect echo effects from multiple near surface features in the layers above. Given the scarcity and small size of potential medieval remains, it is possible that there are others within this data set effectively obscured by surrounding echo effects.

*Figure 34: Time Slice at c. 3.16m depth (echo effects)*
